BLAKENEY BRIDGE REPORT #PW-26-2022

Public Works Committee
October 26, 2022

BLAKENEY BRIDGE ENHANCED INSPECTION REPORT

Lanark County – October 2022

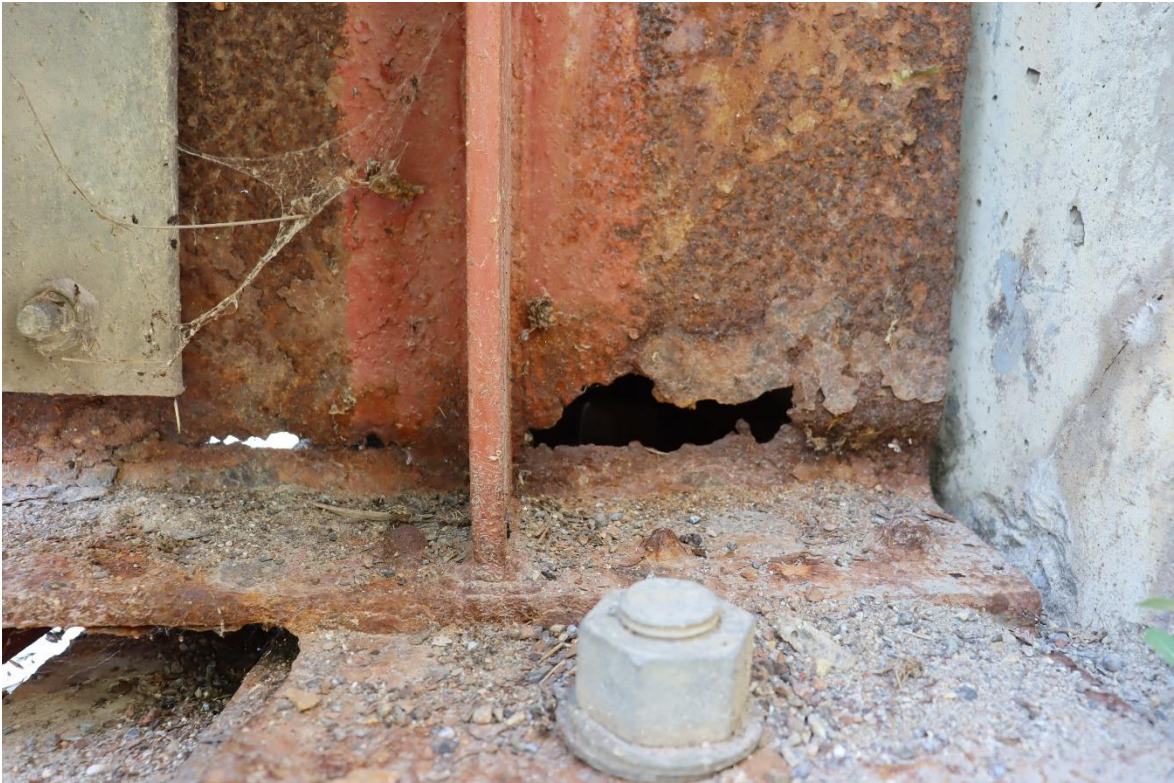
Image 2 Perforated main girder north side of west span at west abutment, with strengthening added

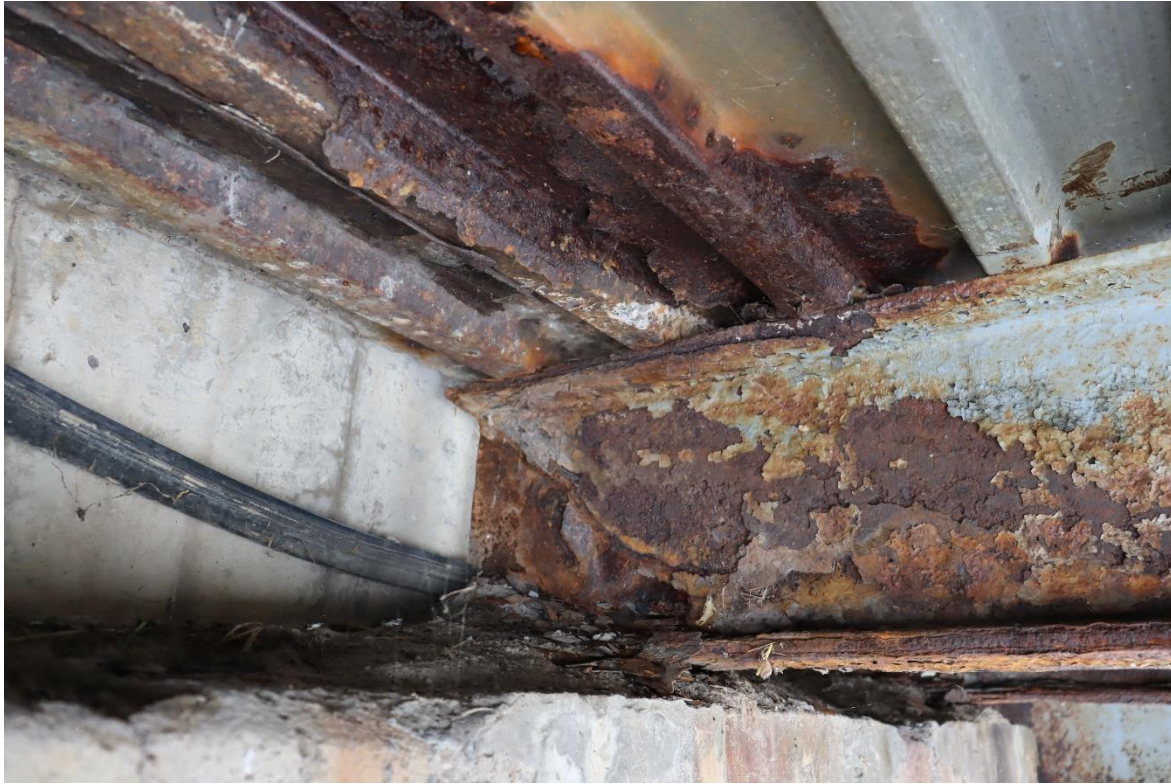
Image 3 Severely corroded stringer end on middle bridge, west end

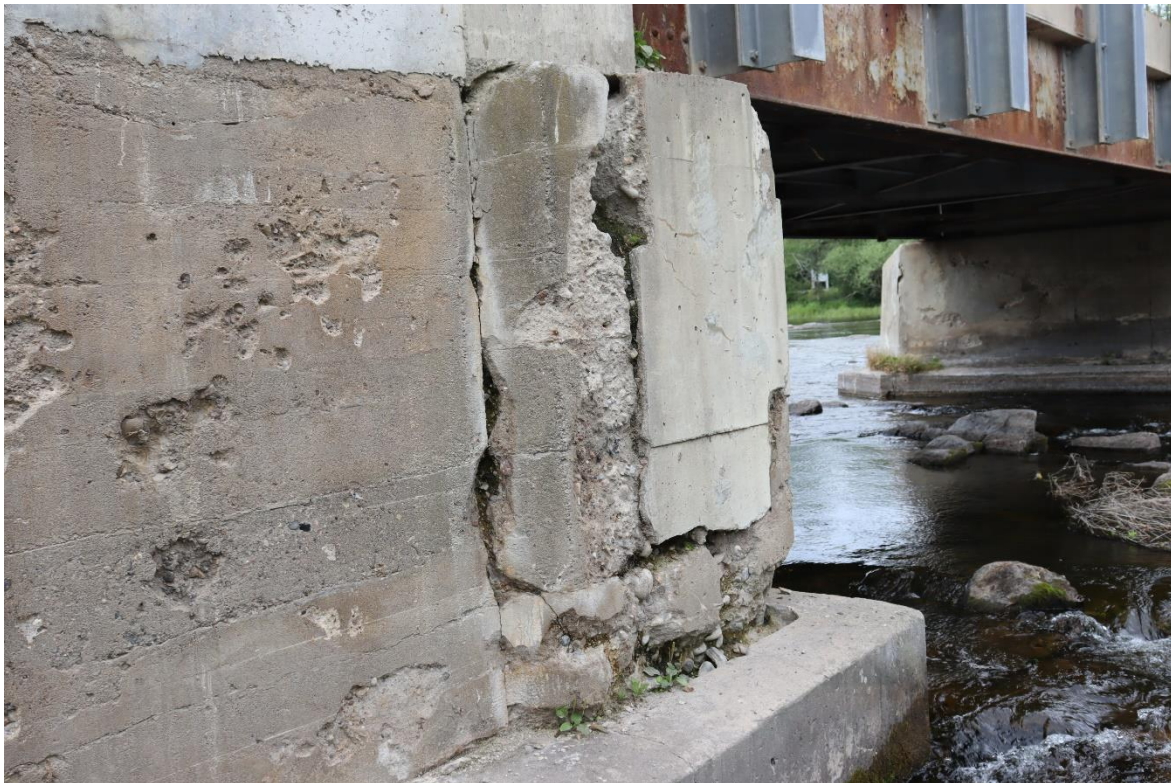
Image 4 Severely deteriorated substructure concrete with prominent patch

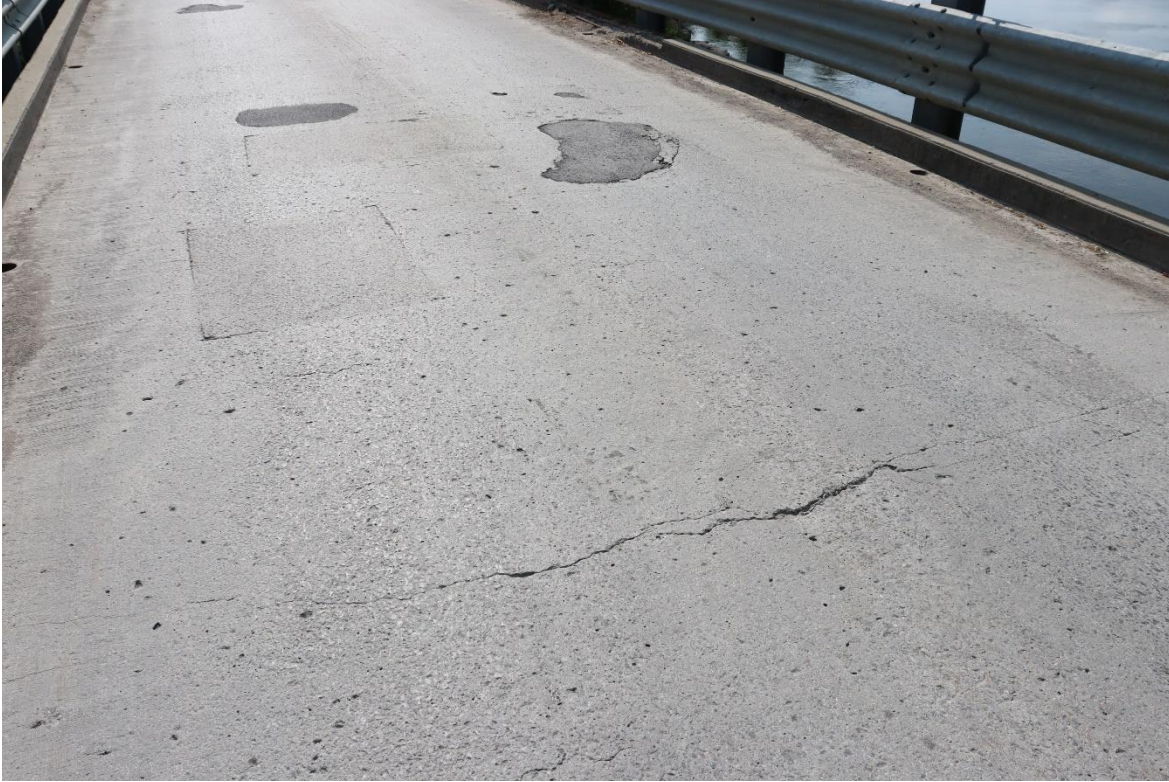
Image 5 Typical deck with concrete patches, cold patches, cracking, and delamination

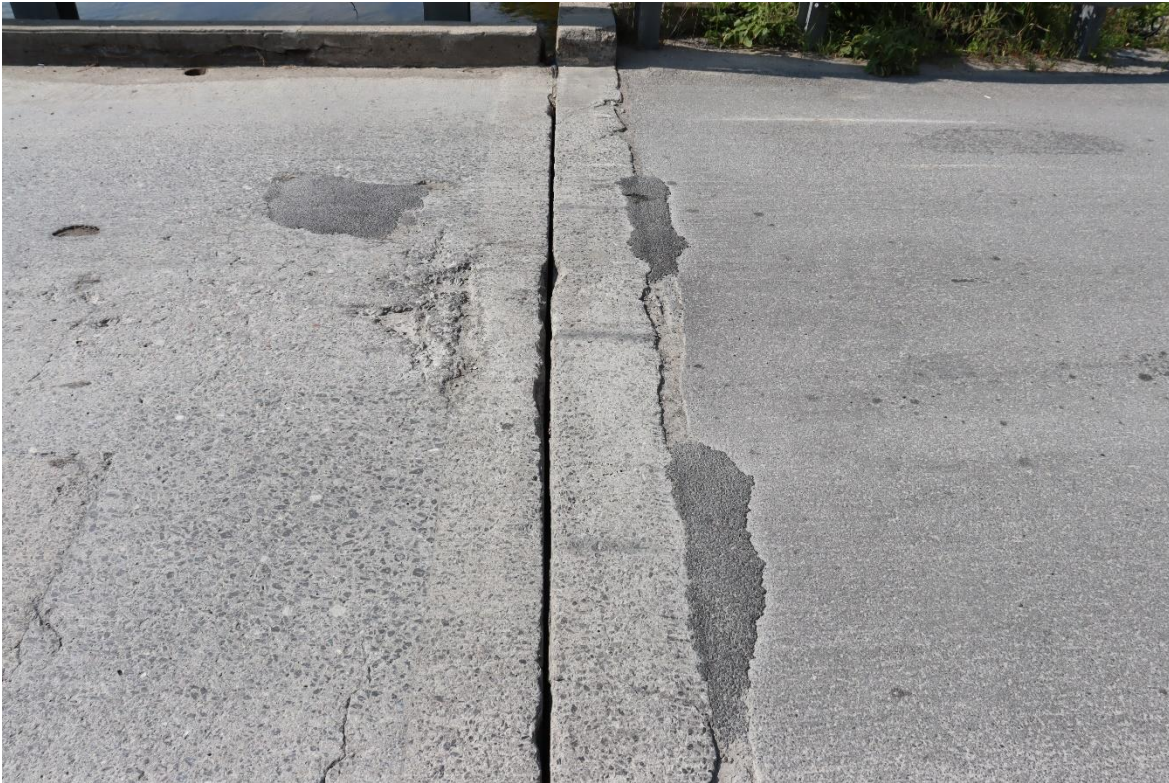
Image 6 Typical deck end and open expansion joint that admits chlorides to girder ends

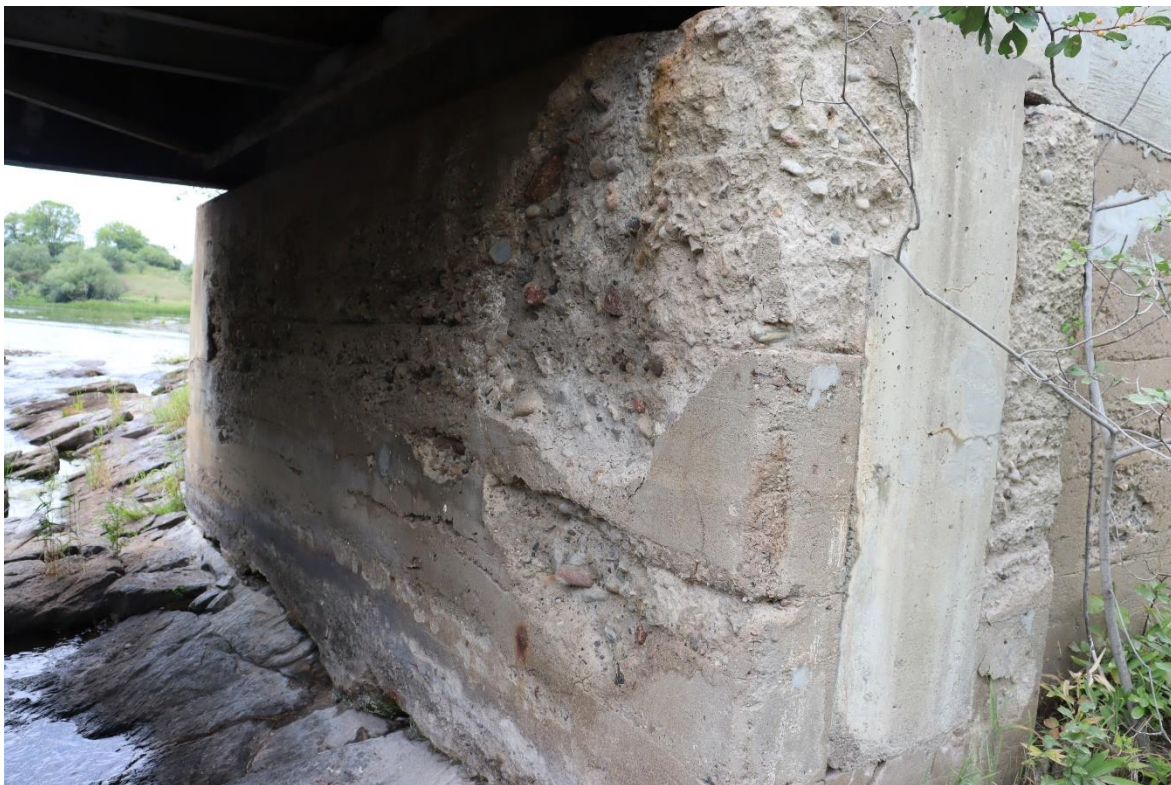
Image 8 Severe disintegration of 1912 concrete and undercutting of foundation at bedrock surface

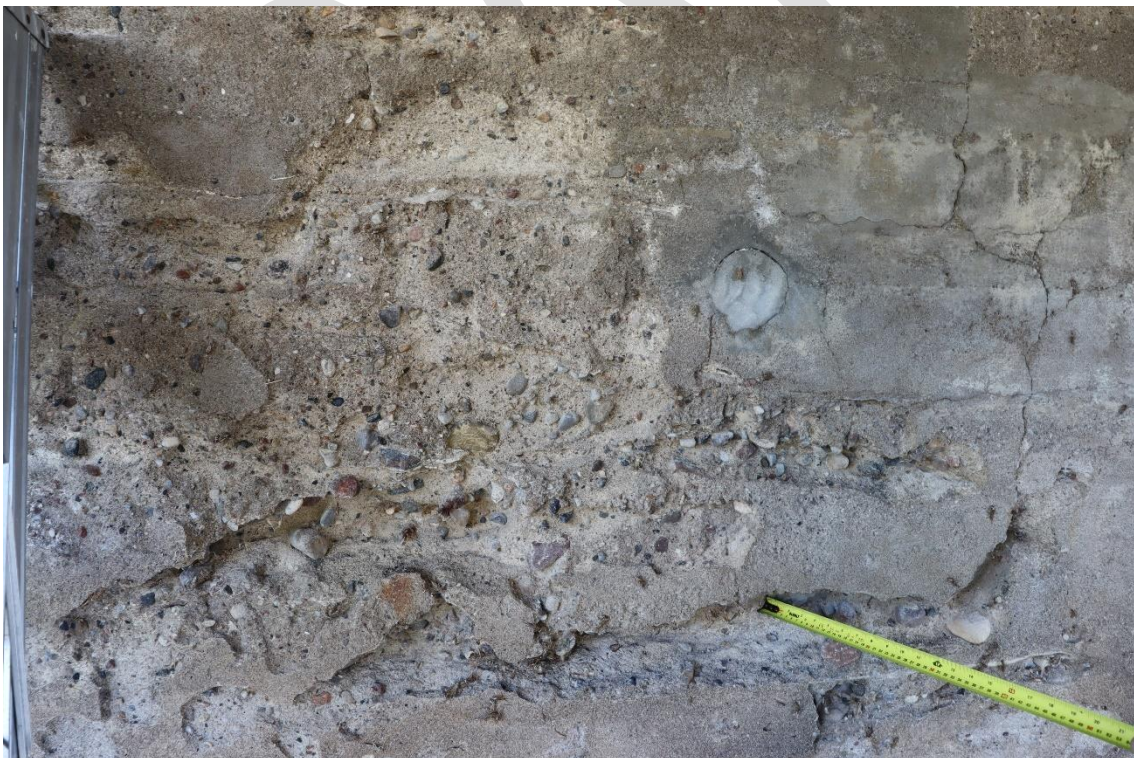
The substructure concrete is in mostly poor to fair condition. The worst concrete is associated with the east bridge. The east abutment of the east bridge has areas of the exposed face where up to 100 mm of section loss is present. See Image 8. The west abutment of the east bridge is undercut from cavitation

Image 8. East abutment disintegration and spalling of east bridge to 100 mm depth

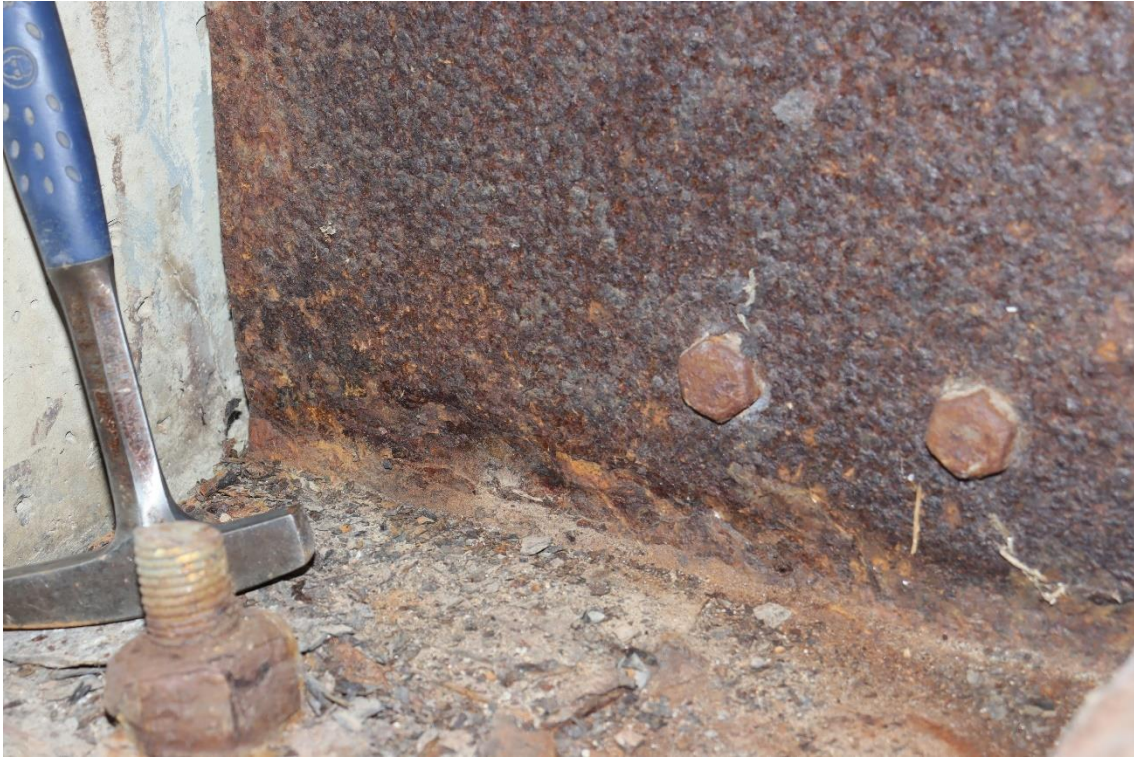
Image 11. Web thinning of south girder east end of east bridge

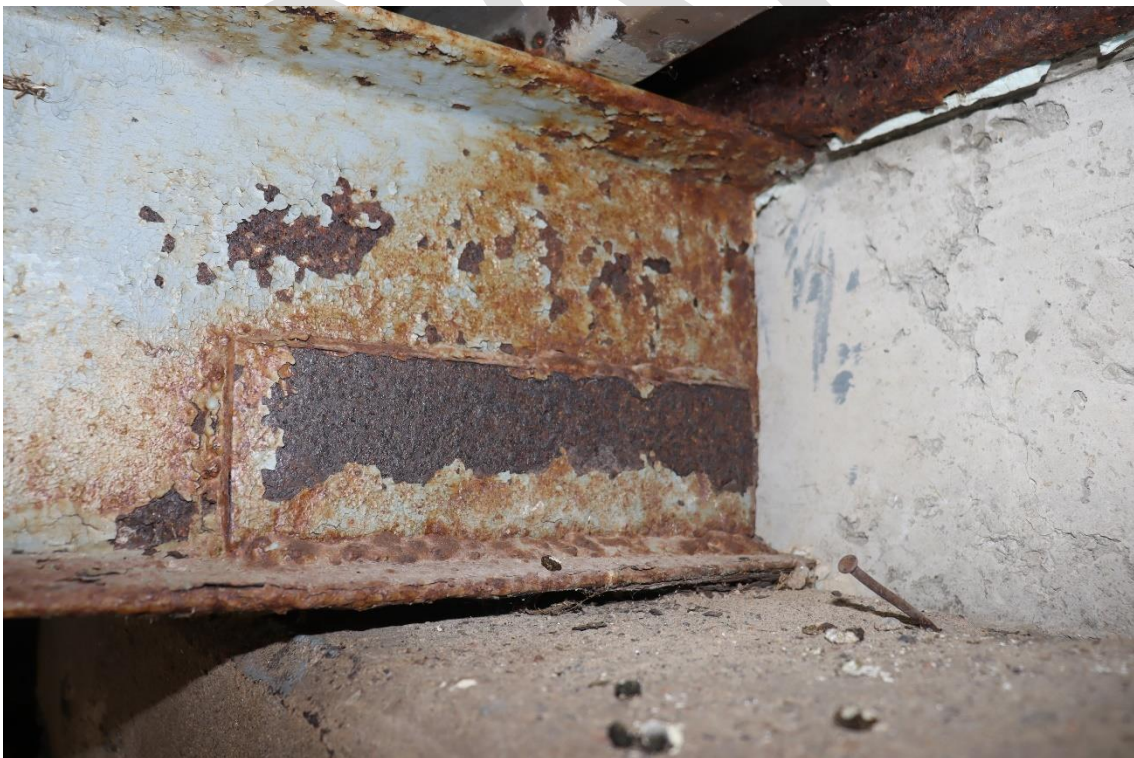
Image 12. Web patch on 3rd stringer from south on east abutment of east bridge

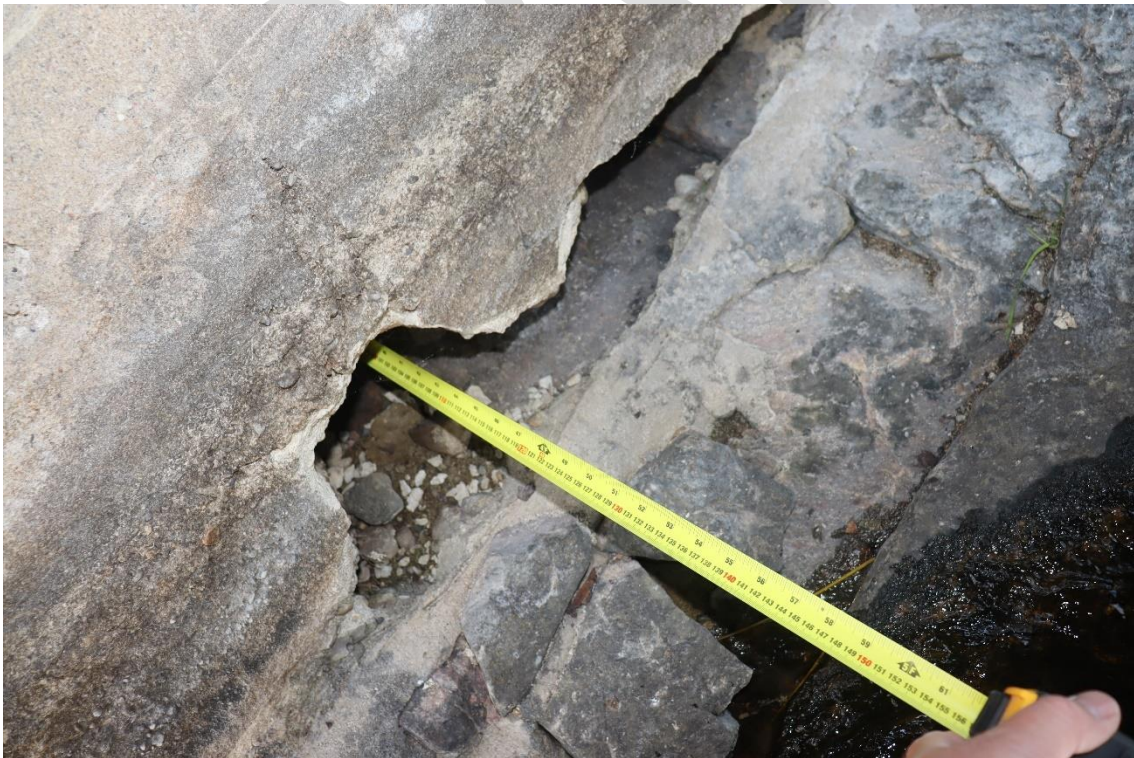
to a depth of 1200 mm in two locations. See Images 13 & 14. The concrete is slowly disintegrating and possibly eroding from hydraulic scour forces. Repair concrete placed in 2000 has debonded and failed in some areas but is largely still in place on the west and middle bridges.

Image 14. West abutment 1.2 m deep cavitation undercut, east bridge

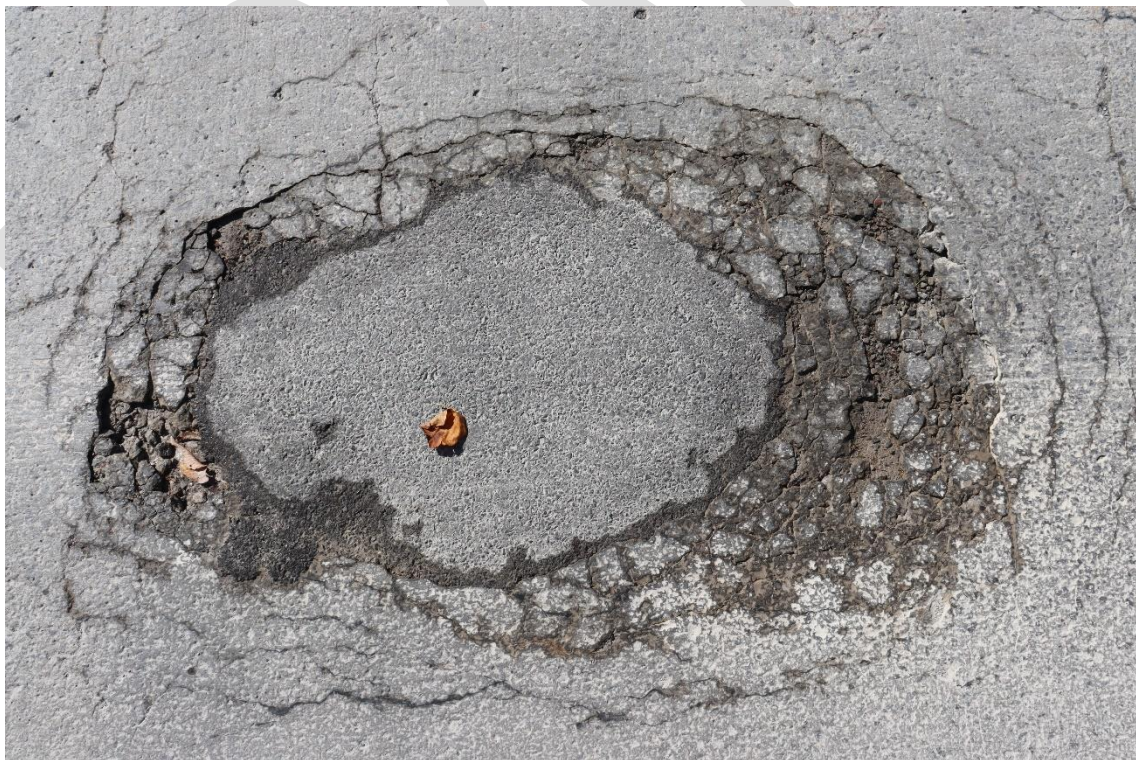
Image 5. Concerning pothole cracks with asphalt patch on deck of middle bridge

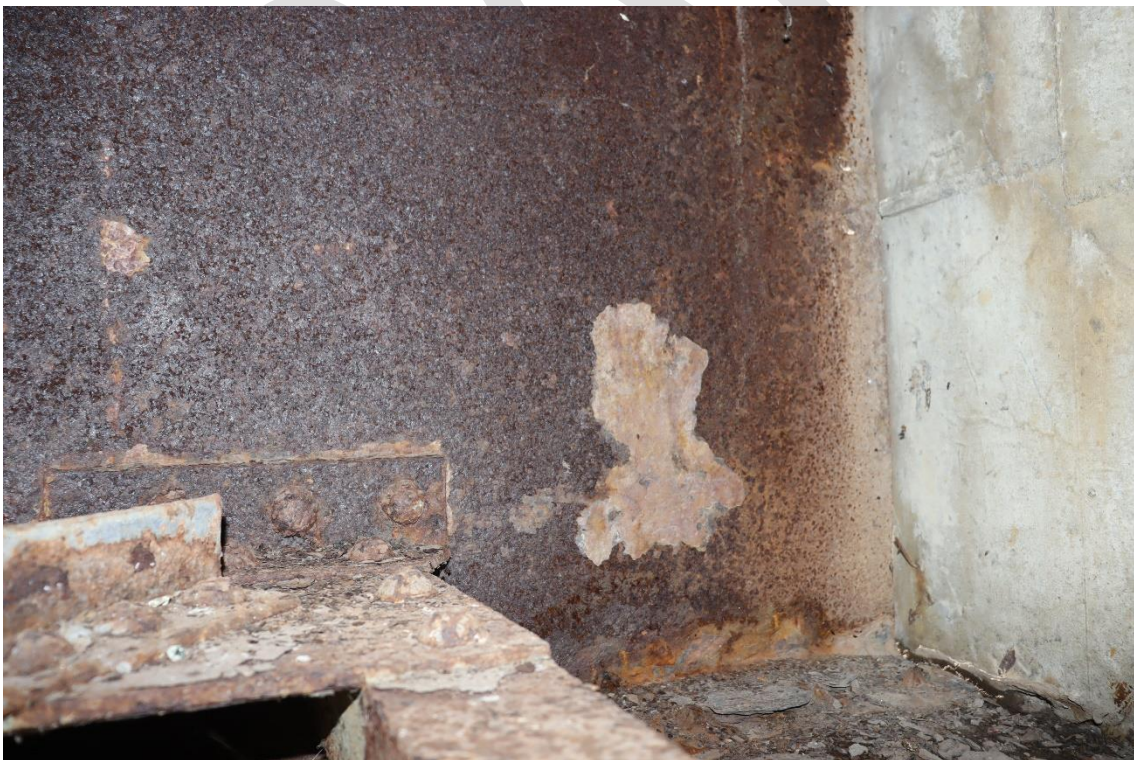
Image 30. Web thinning of south girder end of middle bridge west abutment

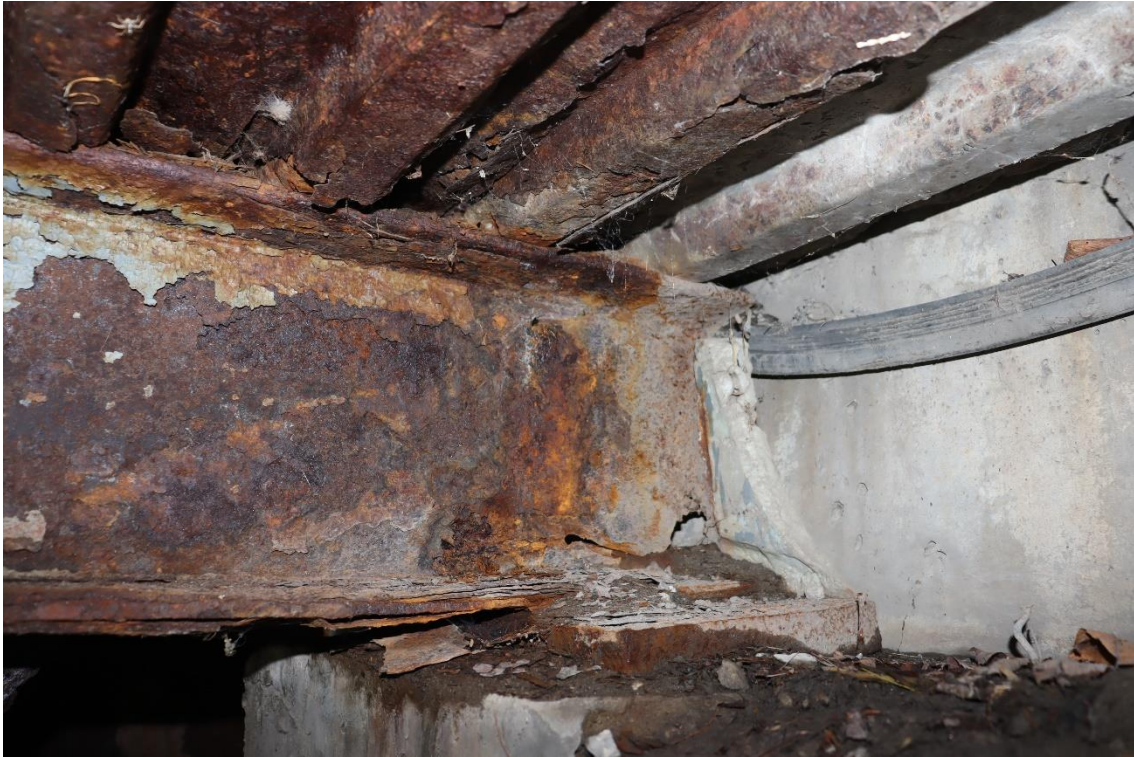
All the stringer ends, and girder ends at the west abutment of the middle bridge are seriously corrosion damaged with web thinning and perforation. Three consecutive stringer ends are severely perforated, and the deck support is very compromised at this location. See images 31, 32, & 33.

Image 13. Perforation of 1st stringer from south of middle bridge west abutment

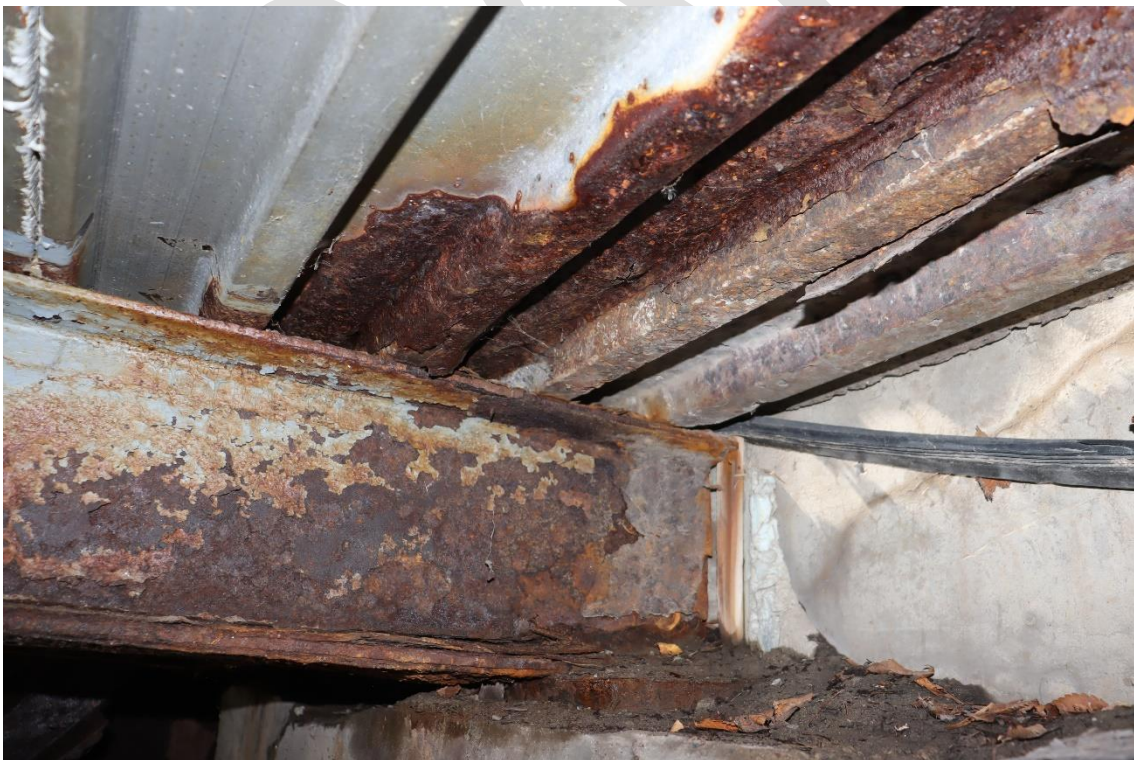
Image 14. Perforation of 2nd stringer from south of middle bridge west abutment

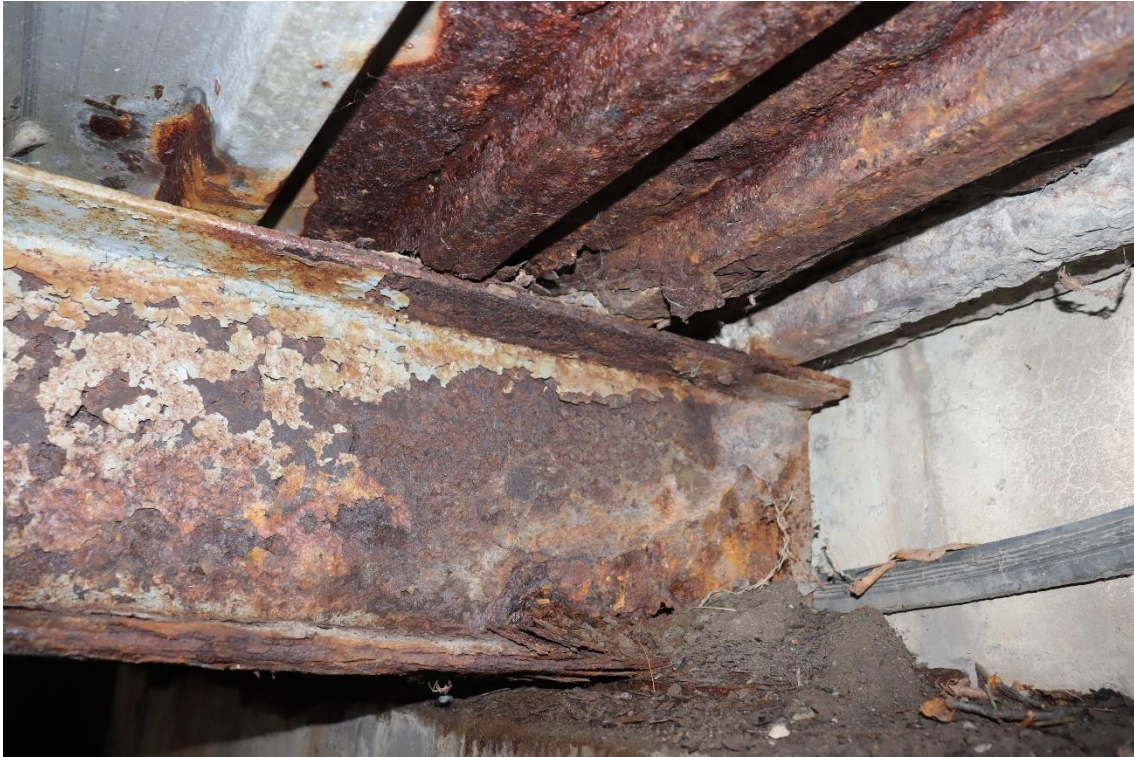
Image 15. Perforation of 3rd stringer from south of middle bridge west abutment

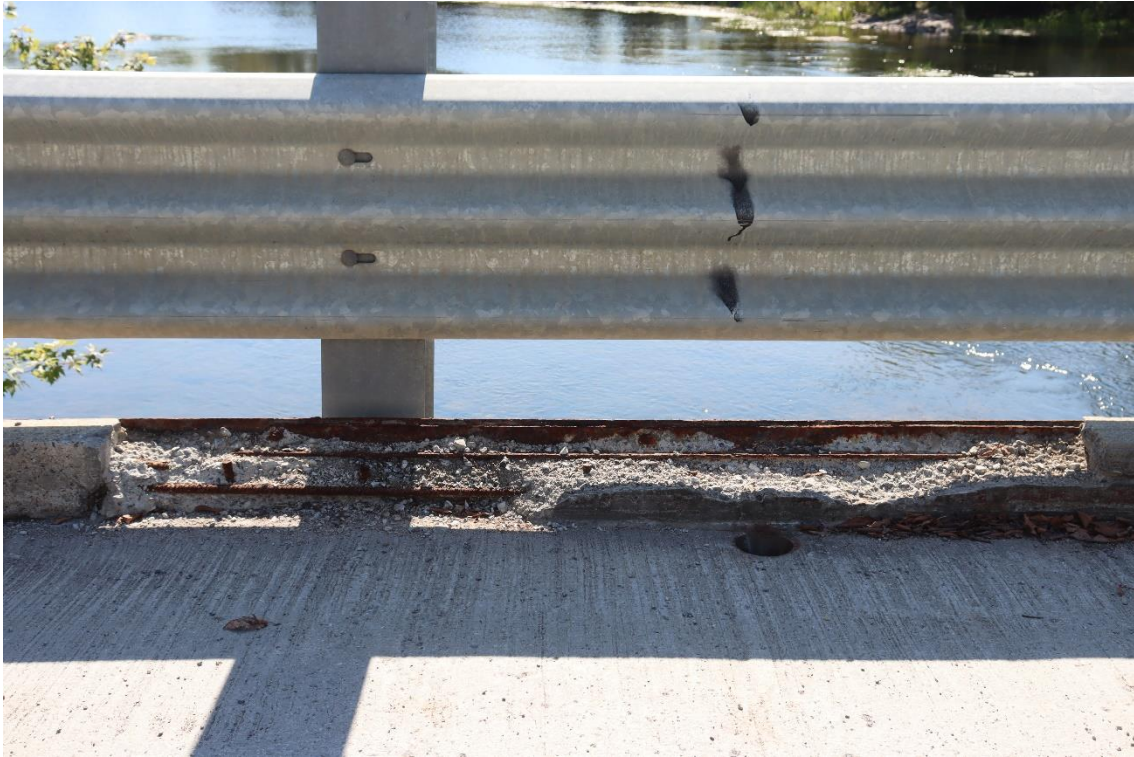
Image 39. Disintegration of south curb of west bridge

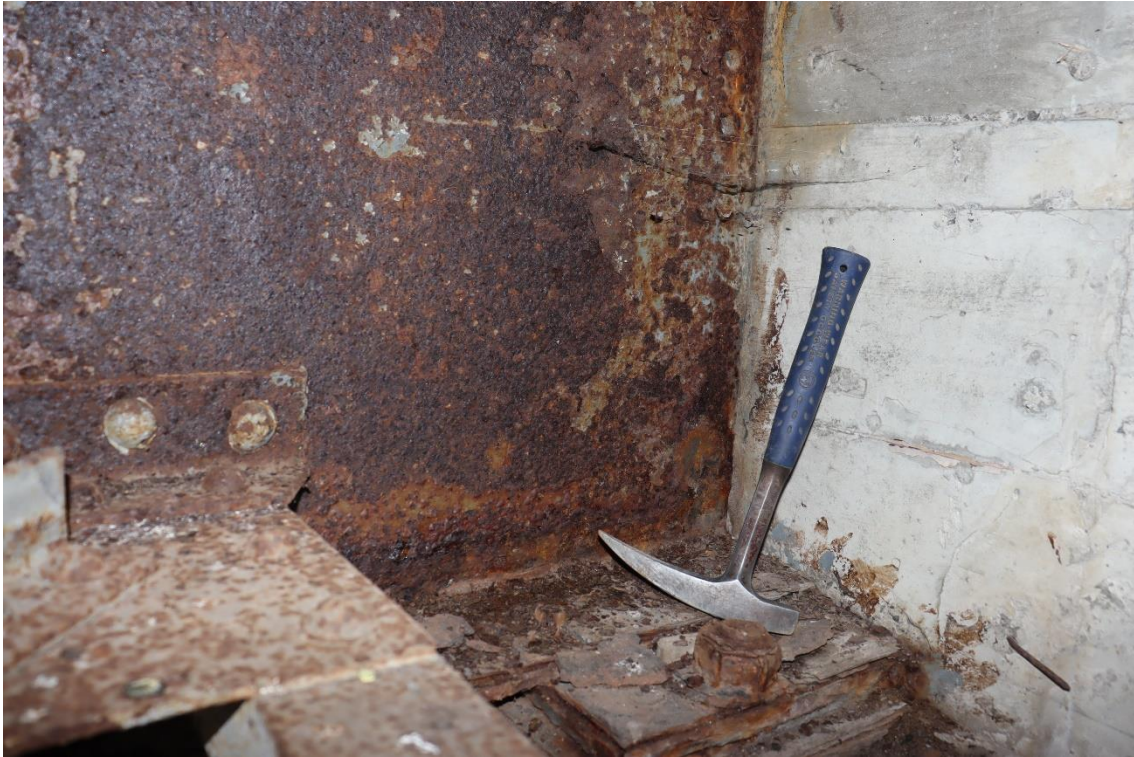
Image 43. Web thinning of north girder end on east abutment of west bridge

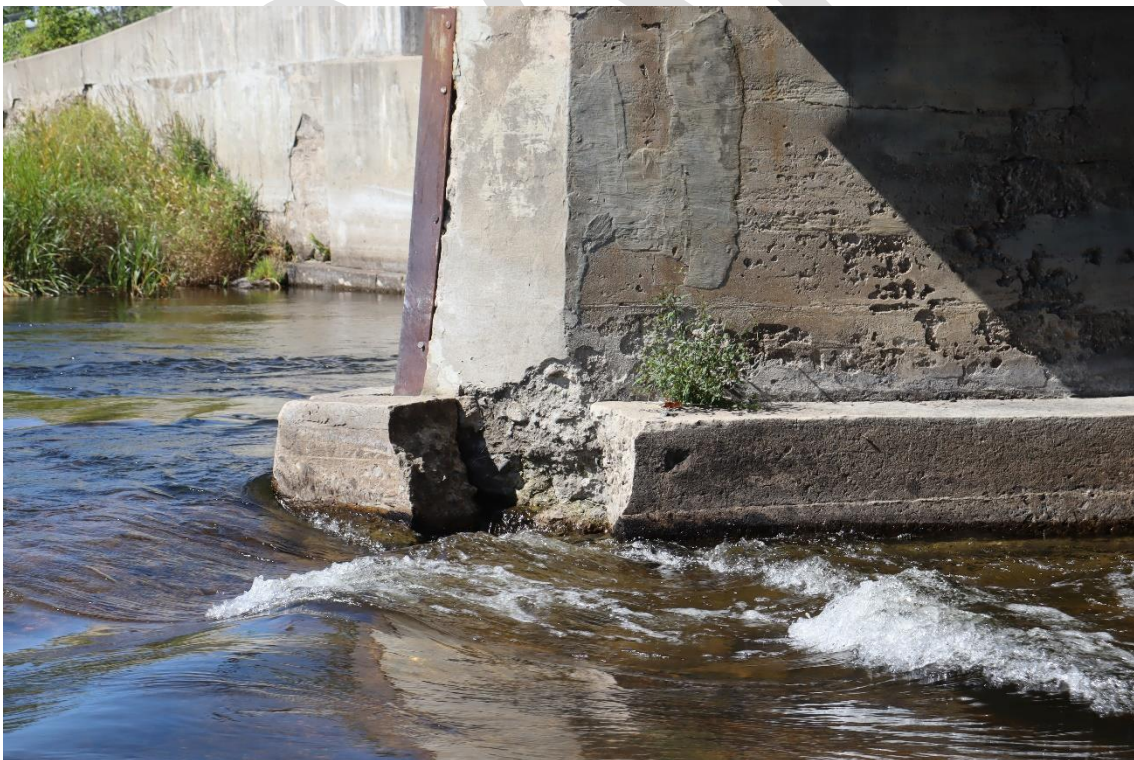
A concrete collar presumably placed in 2000 to protect the base of the west bridge pier has partly broken away on the upstream east side. (Image 46).

Image 46. Fractured pier collar of west bridge pier east side

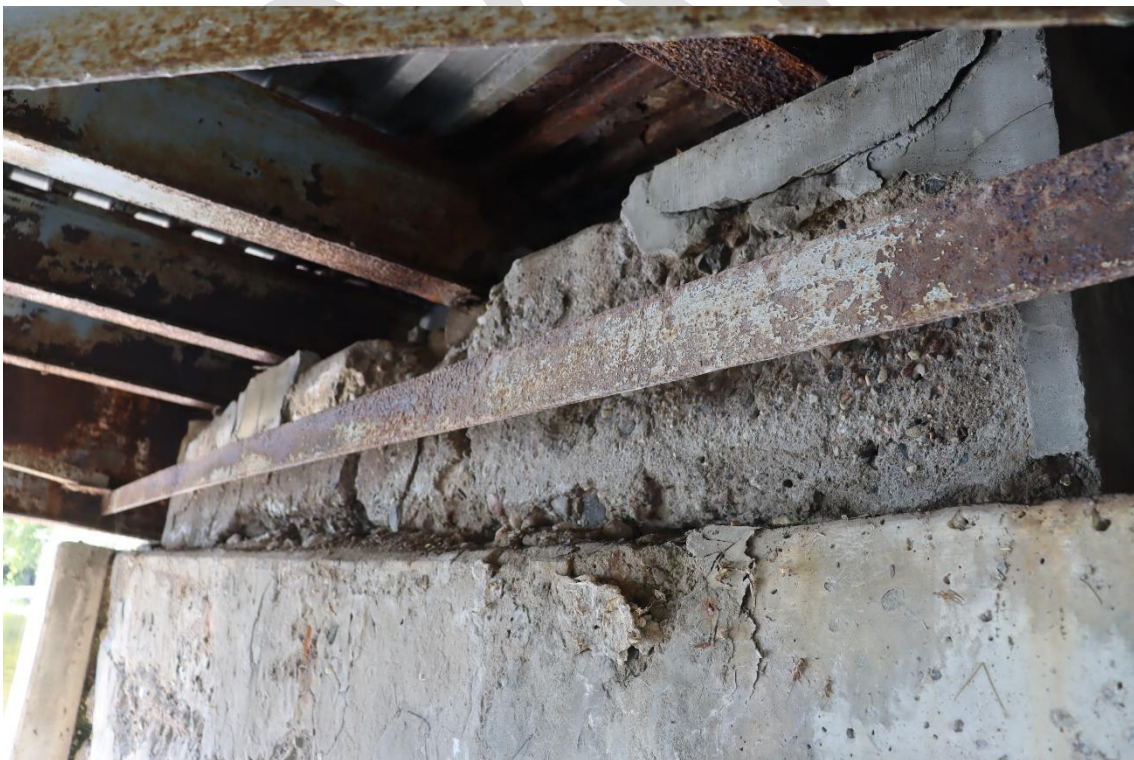
Image 25. Disintegration of ballast wall above west abutment of west bridge

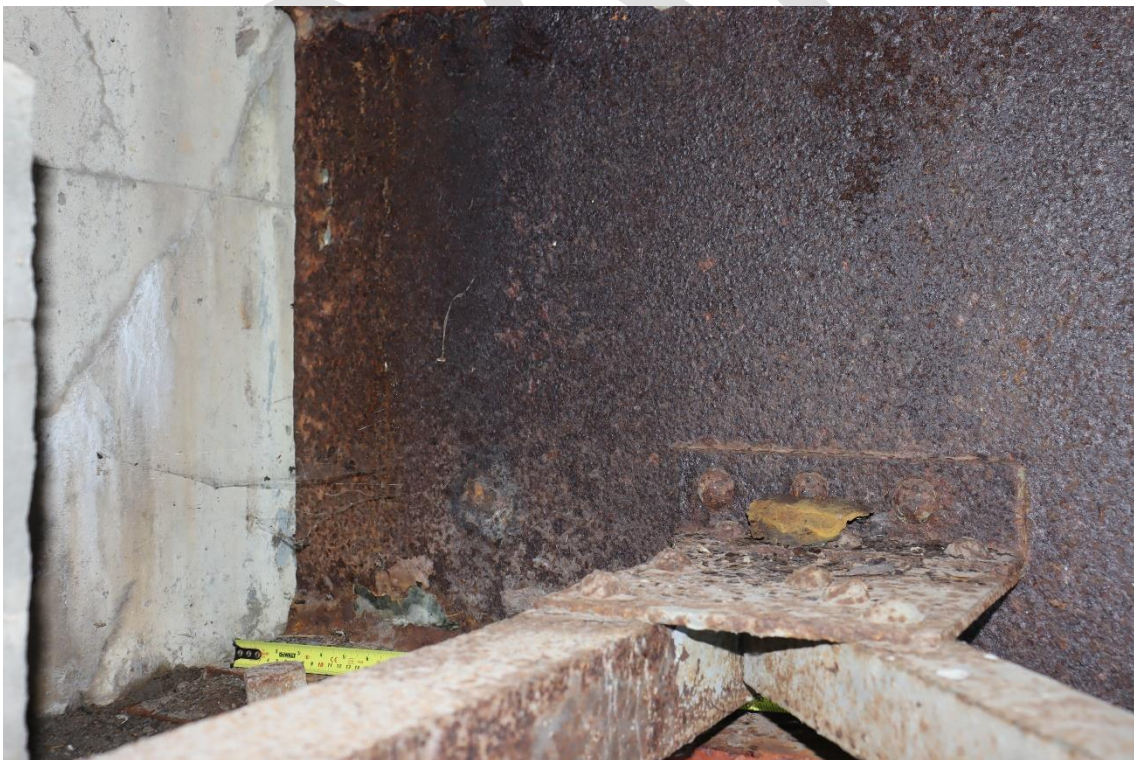
Similarly, all the stringer ends and girder ends at the west abutment of the west bridge are seriously corrosion damaged with web thinning and perforation. One stringer end is fully perforated (Image 51), and the north girder end is significantly perforated to the point that it received emergency repairs in 2019.

Image 52. Perforation of north girder end on west abutment of west bridge

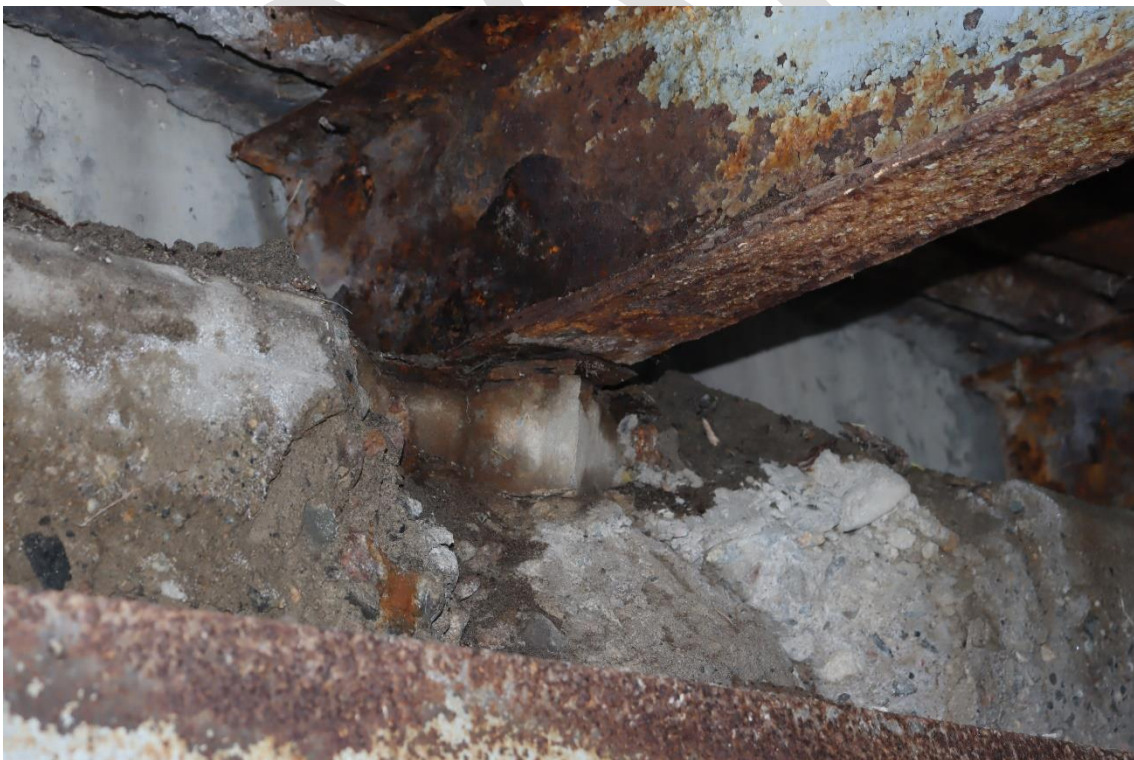
Image 27. Disintegration of west bearing seat of west bridge at Stringer 3
