URBAN FORESTRY & FOREST MANAGEMENT CONSULTING

## **RE: TREE PRESERVATION PLAN FOR 254 LAKE AVENUE, CARLETON PLACE**

DRAWING: Tree Location Plan

PROJECT: 254 LAKE AVENUE  
CARLETON PLACE

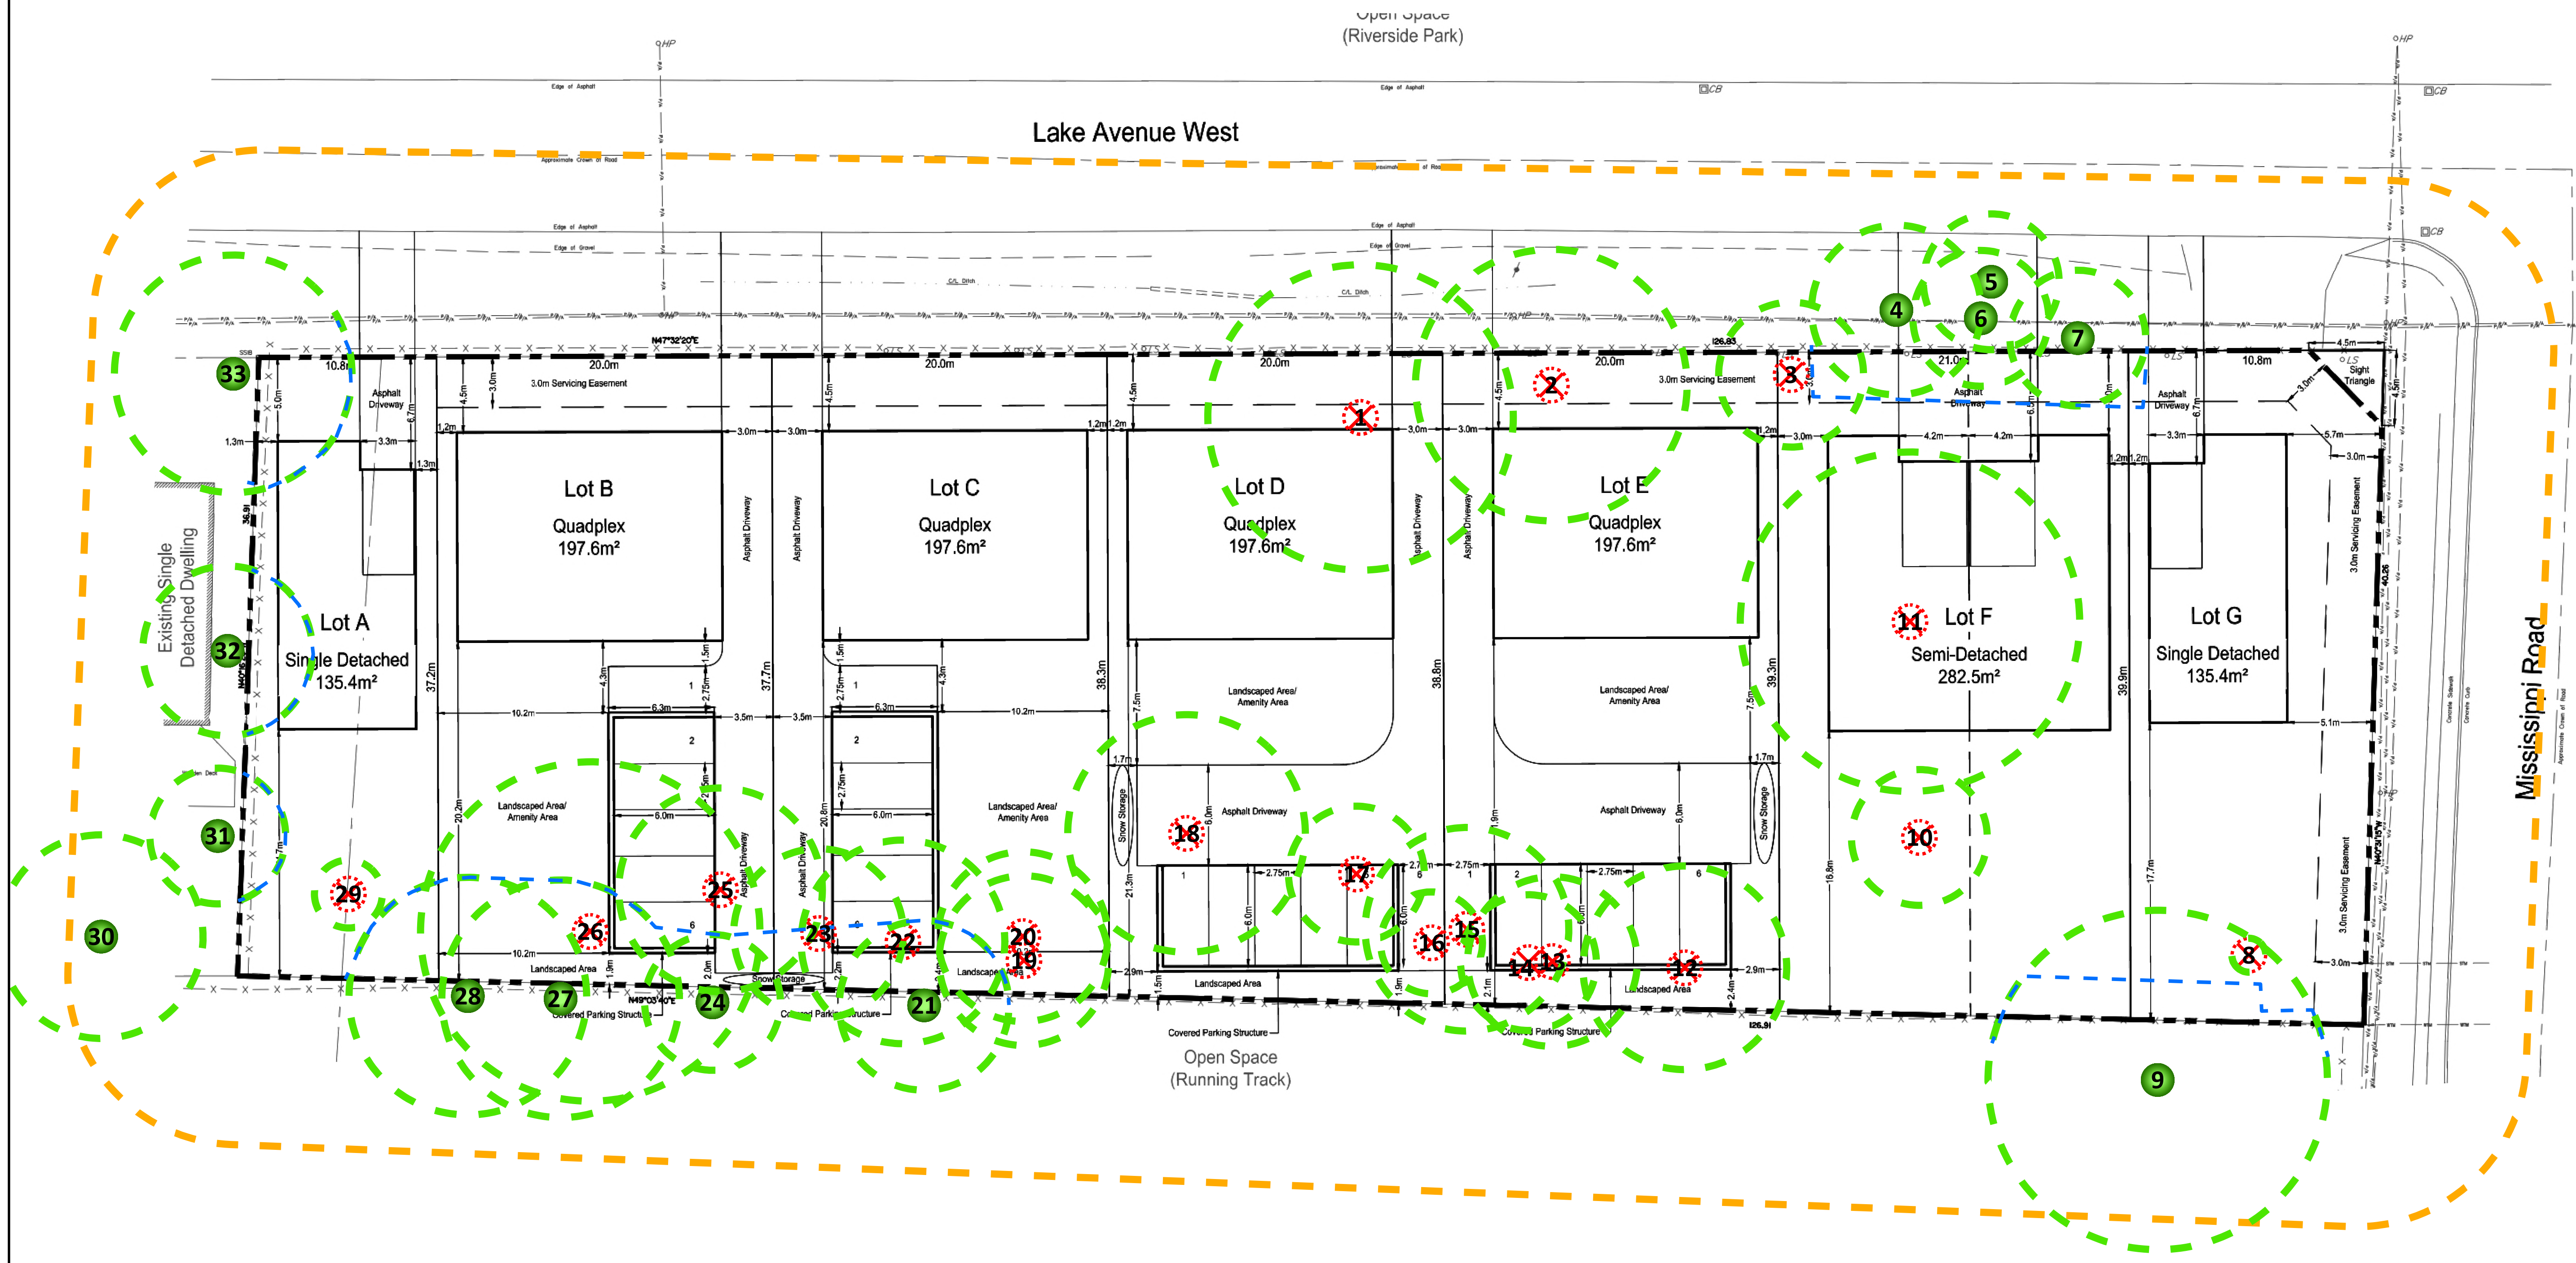
The size and location of the proposed construction, driveways and parking will result in the removal of all vegetation on the subject property (see plan on page 5). All trees fully on or shared with adjacent private and town property will be retained.

A total of thirty-three trees which meet the TPP minimum diameter threshold were found within and in proximity to the development zone. Most of these trees are privately owned. Four were found on town property and nine on private land adjacent to the subject property (including a single endangered butternut tree). Tables 1 and 2 on pages 3 and 4 detail the species, size, canopy and ownership of each tree.

Preservation and protection measures intended to mitigate damage during construction will be applied for the trees to be retained on properties adjacent to the proposed development. The following measures are the minimum recommended to ensure tree survival during and following construction:

1. Erect a fence at the critical root zone (CRZ<sup>1</sup>) of trees.
2. Do not place any material or equipment within the CRZ of the tree.
3. Do not attach any signs, notices or posters to any tree.
4. Do not raise or lower the existing grade within the CRZ without approval.
5. Tunnel or bore when digging within the CRZ of a tree.
6. Do not damage the root system, trunk or branches of any tree.
7. Ensure that exhaust fumes from all equipment are NOT directed towards any tree's canopy.

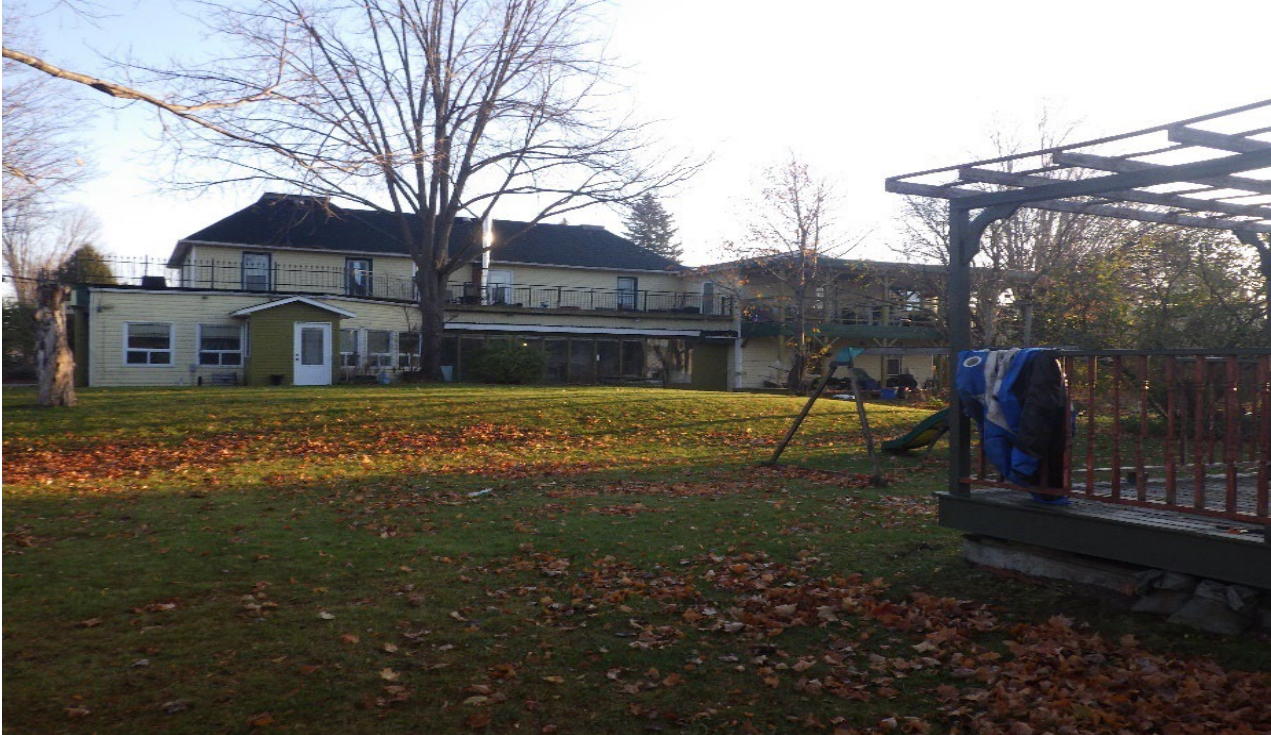
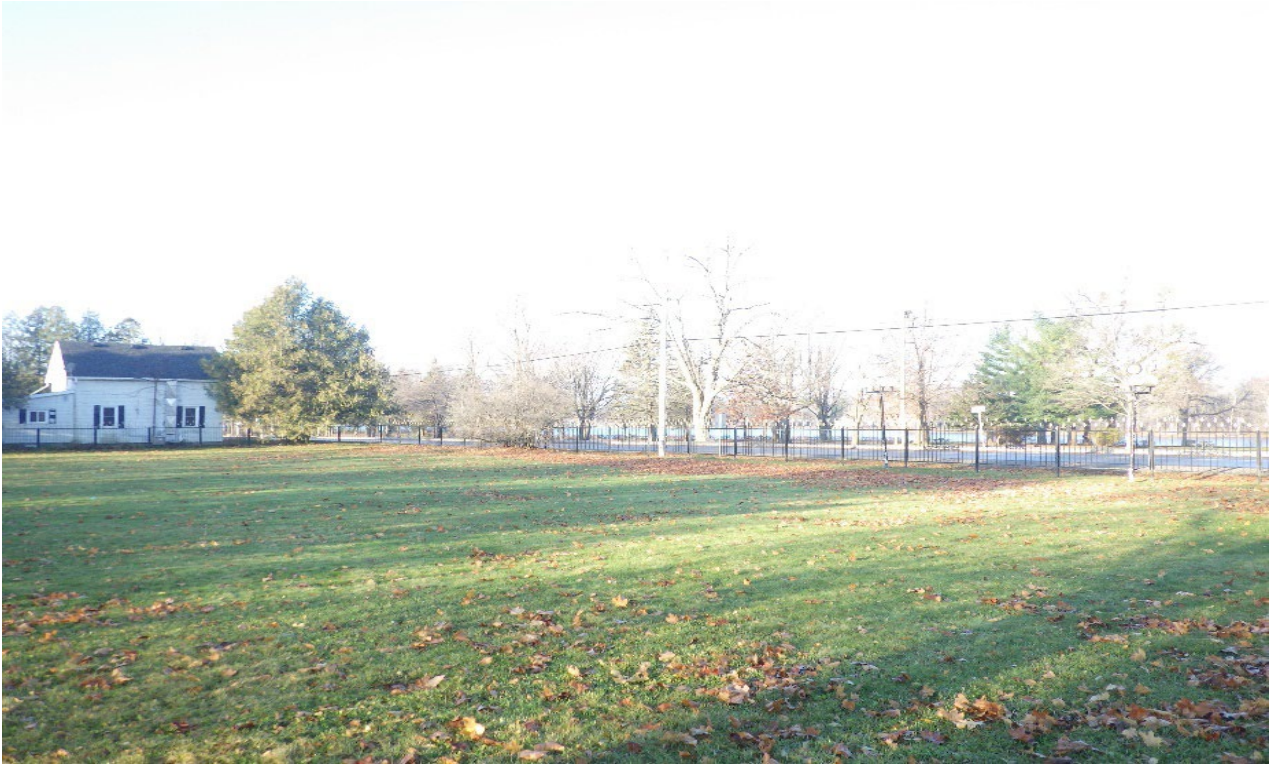
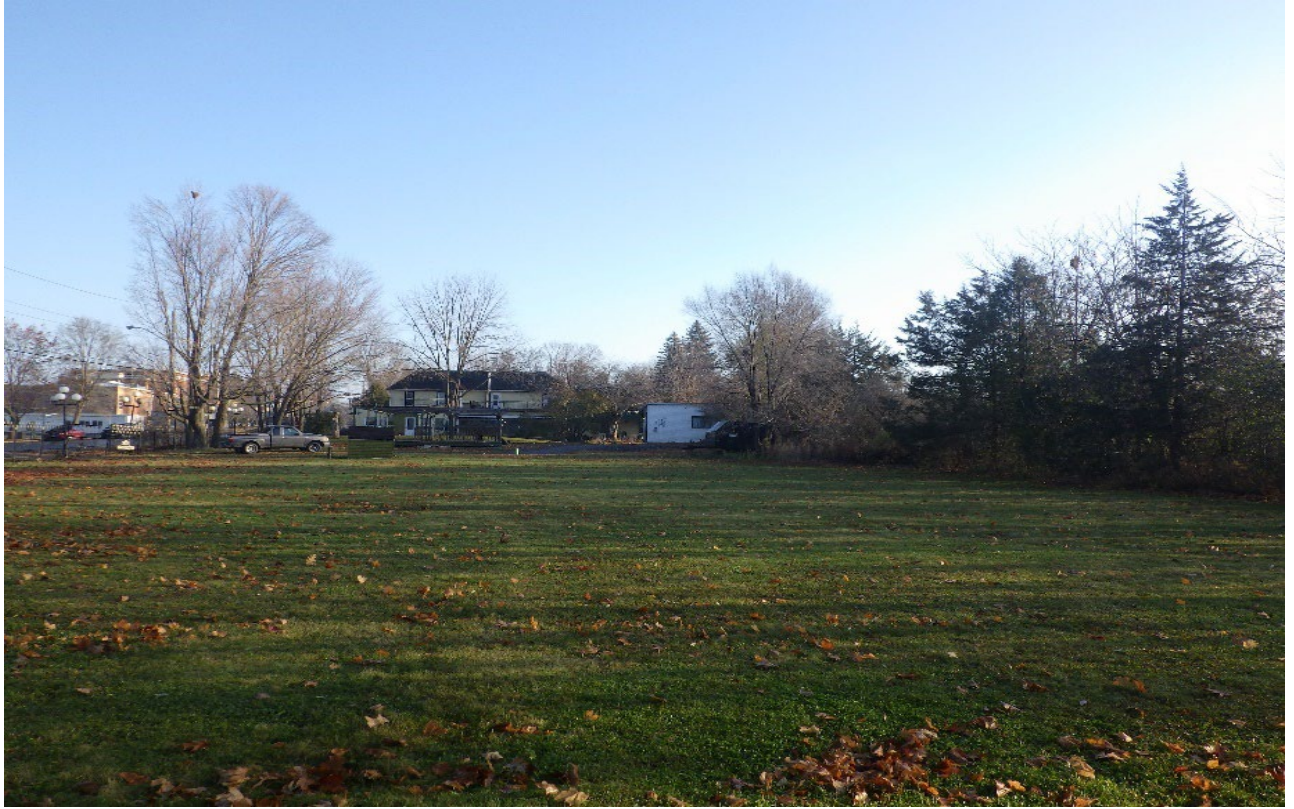
APPENDIX A: PHOTOS OF THE GENERAL SITE CONDITIONS

Field work for this report was completed in November 2024. Site conditions at that time are shown in the photos included in Appendix A.
