Subject: 355 Franktown – Addendum to Environmental Impact Study

Bowfin Environmental Consulting (Bowfin) prepared an Environmental Impact Study (EIS) for the proposed residential development at 355 Franktown Road on behalf of 11309455 Canada Inc. Since that time, Bowfin has merged its services with those of CIMA+. As such, the mandate of addressing comments has been transferred to CIMA+. Following our review of the consolidated comments provided by the Lanark County Planning Department on March 27, 2023, CIMA+ offers the following input on the comment concerning the EIS. Note that portions of the Bowfin report are included appended to this memo.

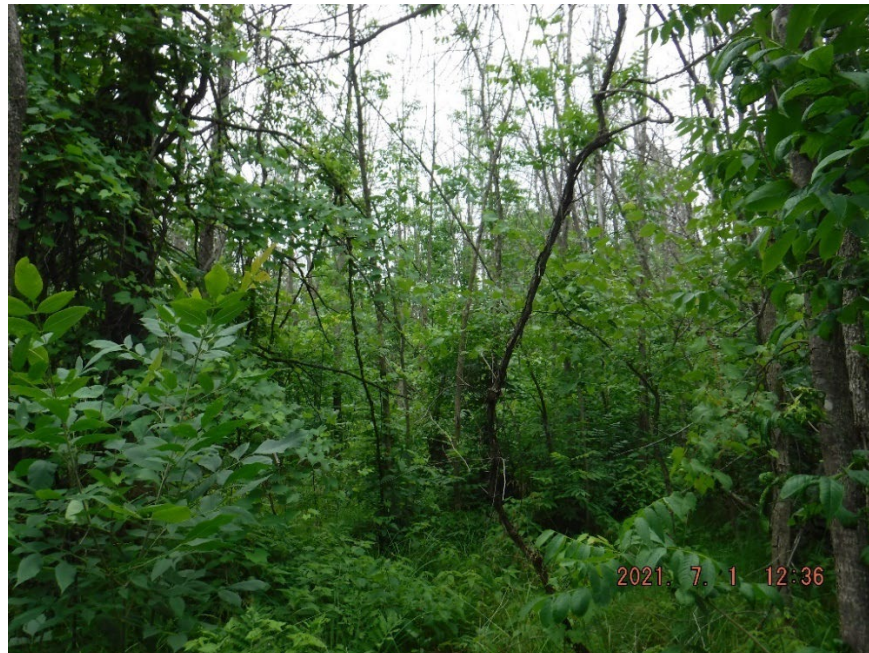
“It was fairly disturbed with several brush piles and stumps as well as emerald ash borer, and glossy buckthorn. In some areas the glossy buckthorn was the only species present. The soil was sampled to a depth of 58 cm. The upper layer was a silty clay loam (0-32 cm) with a silty sand underneath (32-58 cm). The water table was 47 cm below the surface. The wetland was a tall shrub swamp with three forms. These were: dead deciduous trees (mostly dead ash), tall shrub (glossy buckthorn, green ash, white ash, black ash, slender willow, and nanny berry (note that these individual trees were <6 m tall), and ground cover (purple loosestrife, spotted joe-pyeweed, sensitive fern, river grape, Virginia creeper, swamp milkweed, bittersweet nightshade, boneset and spotted jewelweed.). Other species encountered were reed canary grass, broad-leafed cattail, silver maple, Freeman’s maple, scouring rush, and sedges.” (Bowfin, 2022)

Photo 1: Looking north from center of Tall Shrub Swamp (July 1, 2021)

Vegetation Description of the Tall Shrub Swamp Community

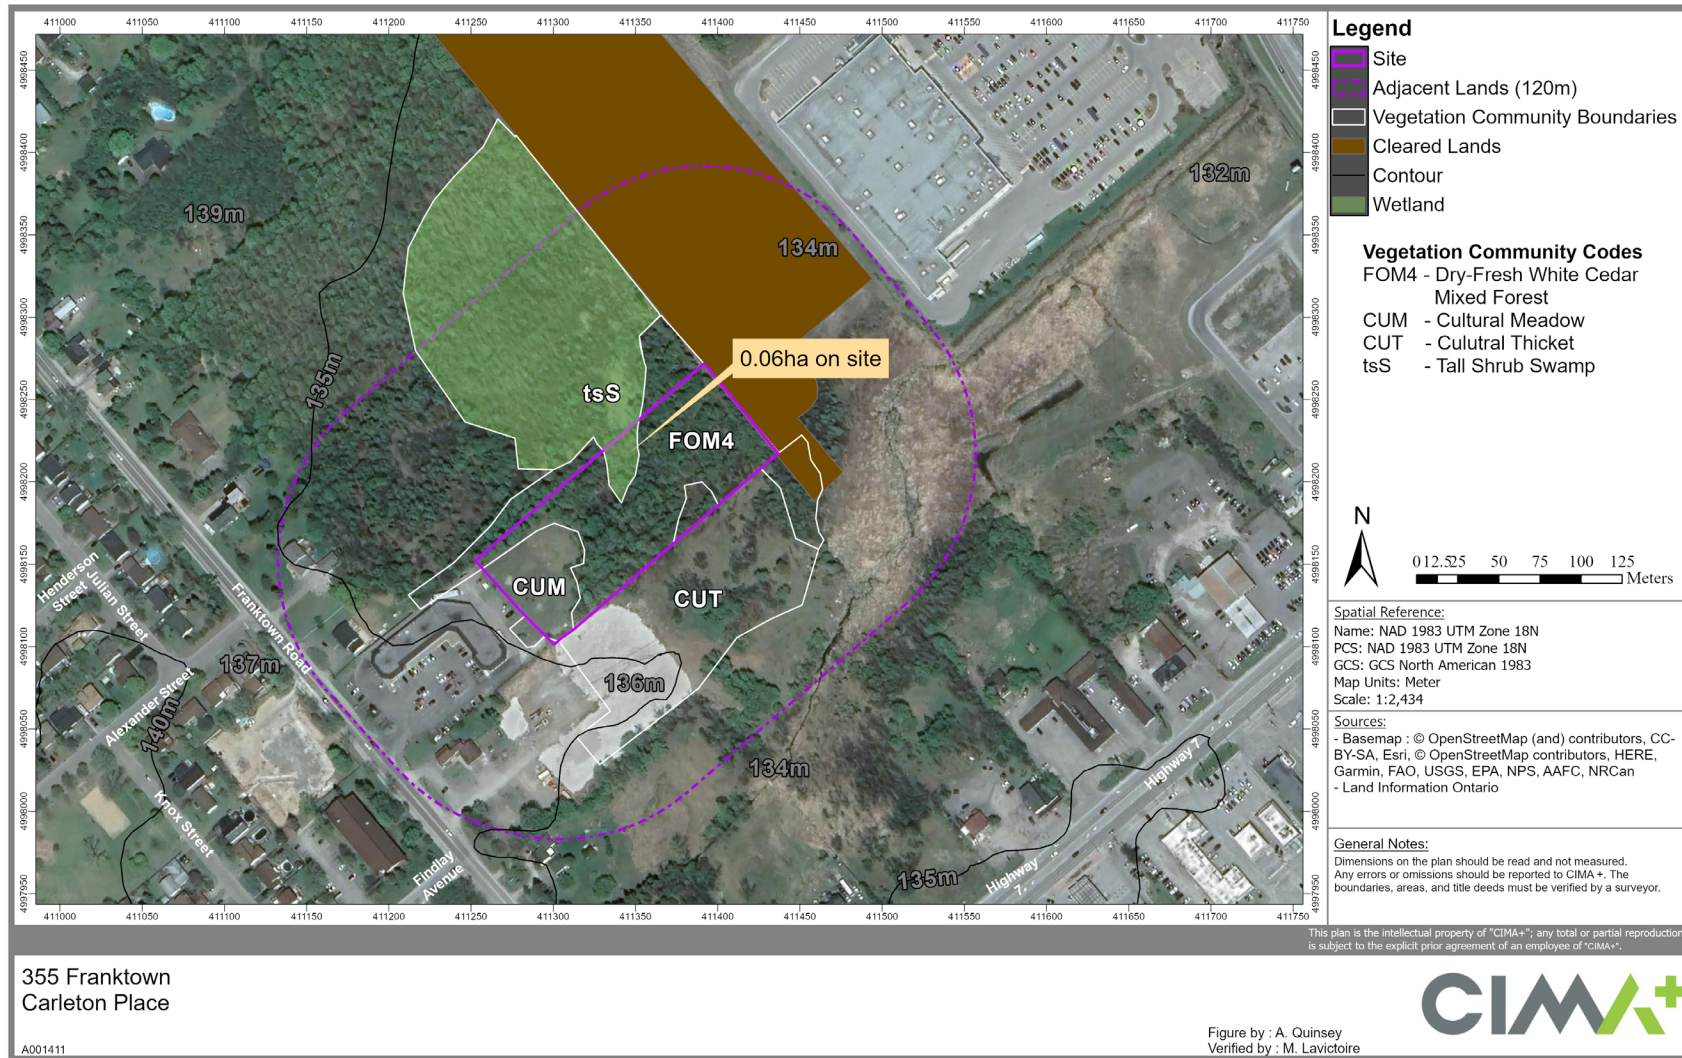
Figure 1: Location of Wetland and Vegetation Description from EIS (Bowfin, 2022)

As per the Bowfin report, the vegetation communities included a tall shrub swamp in the centre, on the north side of the property that continued further offsite, to the north (figure and community description appended). Overall, only 0.06 ha of wetland was present within the 355 Franktown site. Based on Bowfin's interpretation of available satellite information, this wetland had a size of 1.9 ha (both on and off site). As such, the 355 Franktown Road project would require the removal of ±3% of the northern wetland.
