# Updated Geotechnical Investigation Proposed Residential Development 355 Franktown Road Carleton Place, Ontario

**Final Report**

OTT-21002179-B0

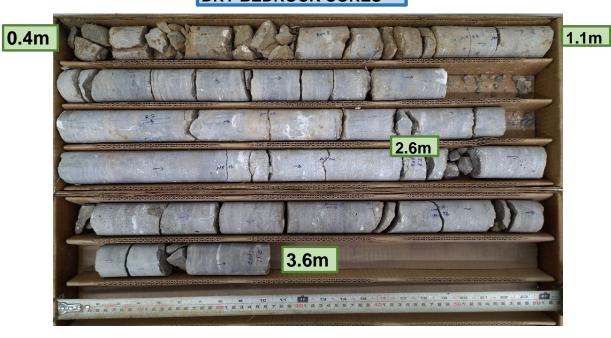
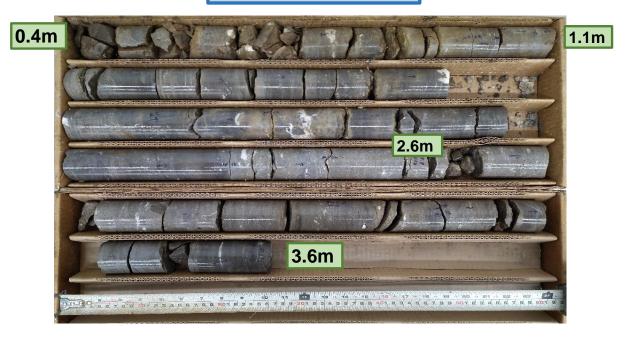
I BH-02	Run 1: 0.4m - 1.0m Run 2: 1.0m - 2.5m	PROPOSED RESIDENTIAL DEVELOPMENT	OTT-21002179-B0
	Run 3: 2.5m - 3.4m End of Borehole	ROCK CORE PHOTOGRAPHS	FIG 49

#### DRY BEDROCK CORES

#### **WET BEDROCK CORES**

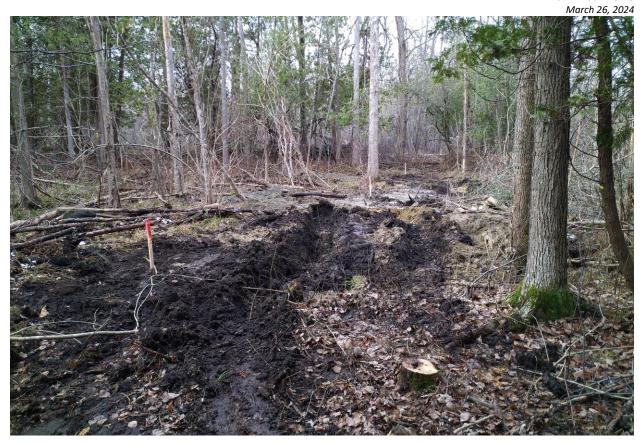
Photo 21: Location of Test Pit No. TP-20 to TP-22, Facing North from TP-22
