HYDROGEOLOGICAL ASSESSMENT AND TERRAIN ANALYSIS

GRIZZLY HOMES SUBDIVISION, BECKWITH, ON

Project No.: CCO-22-0256

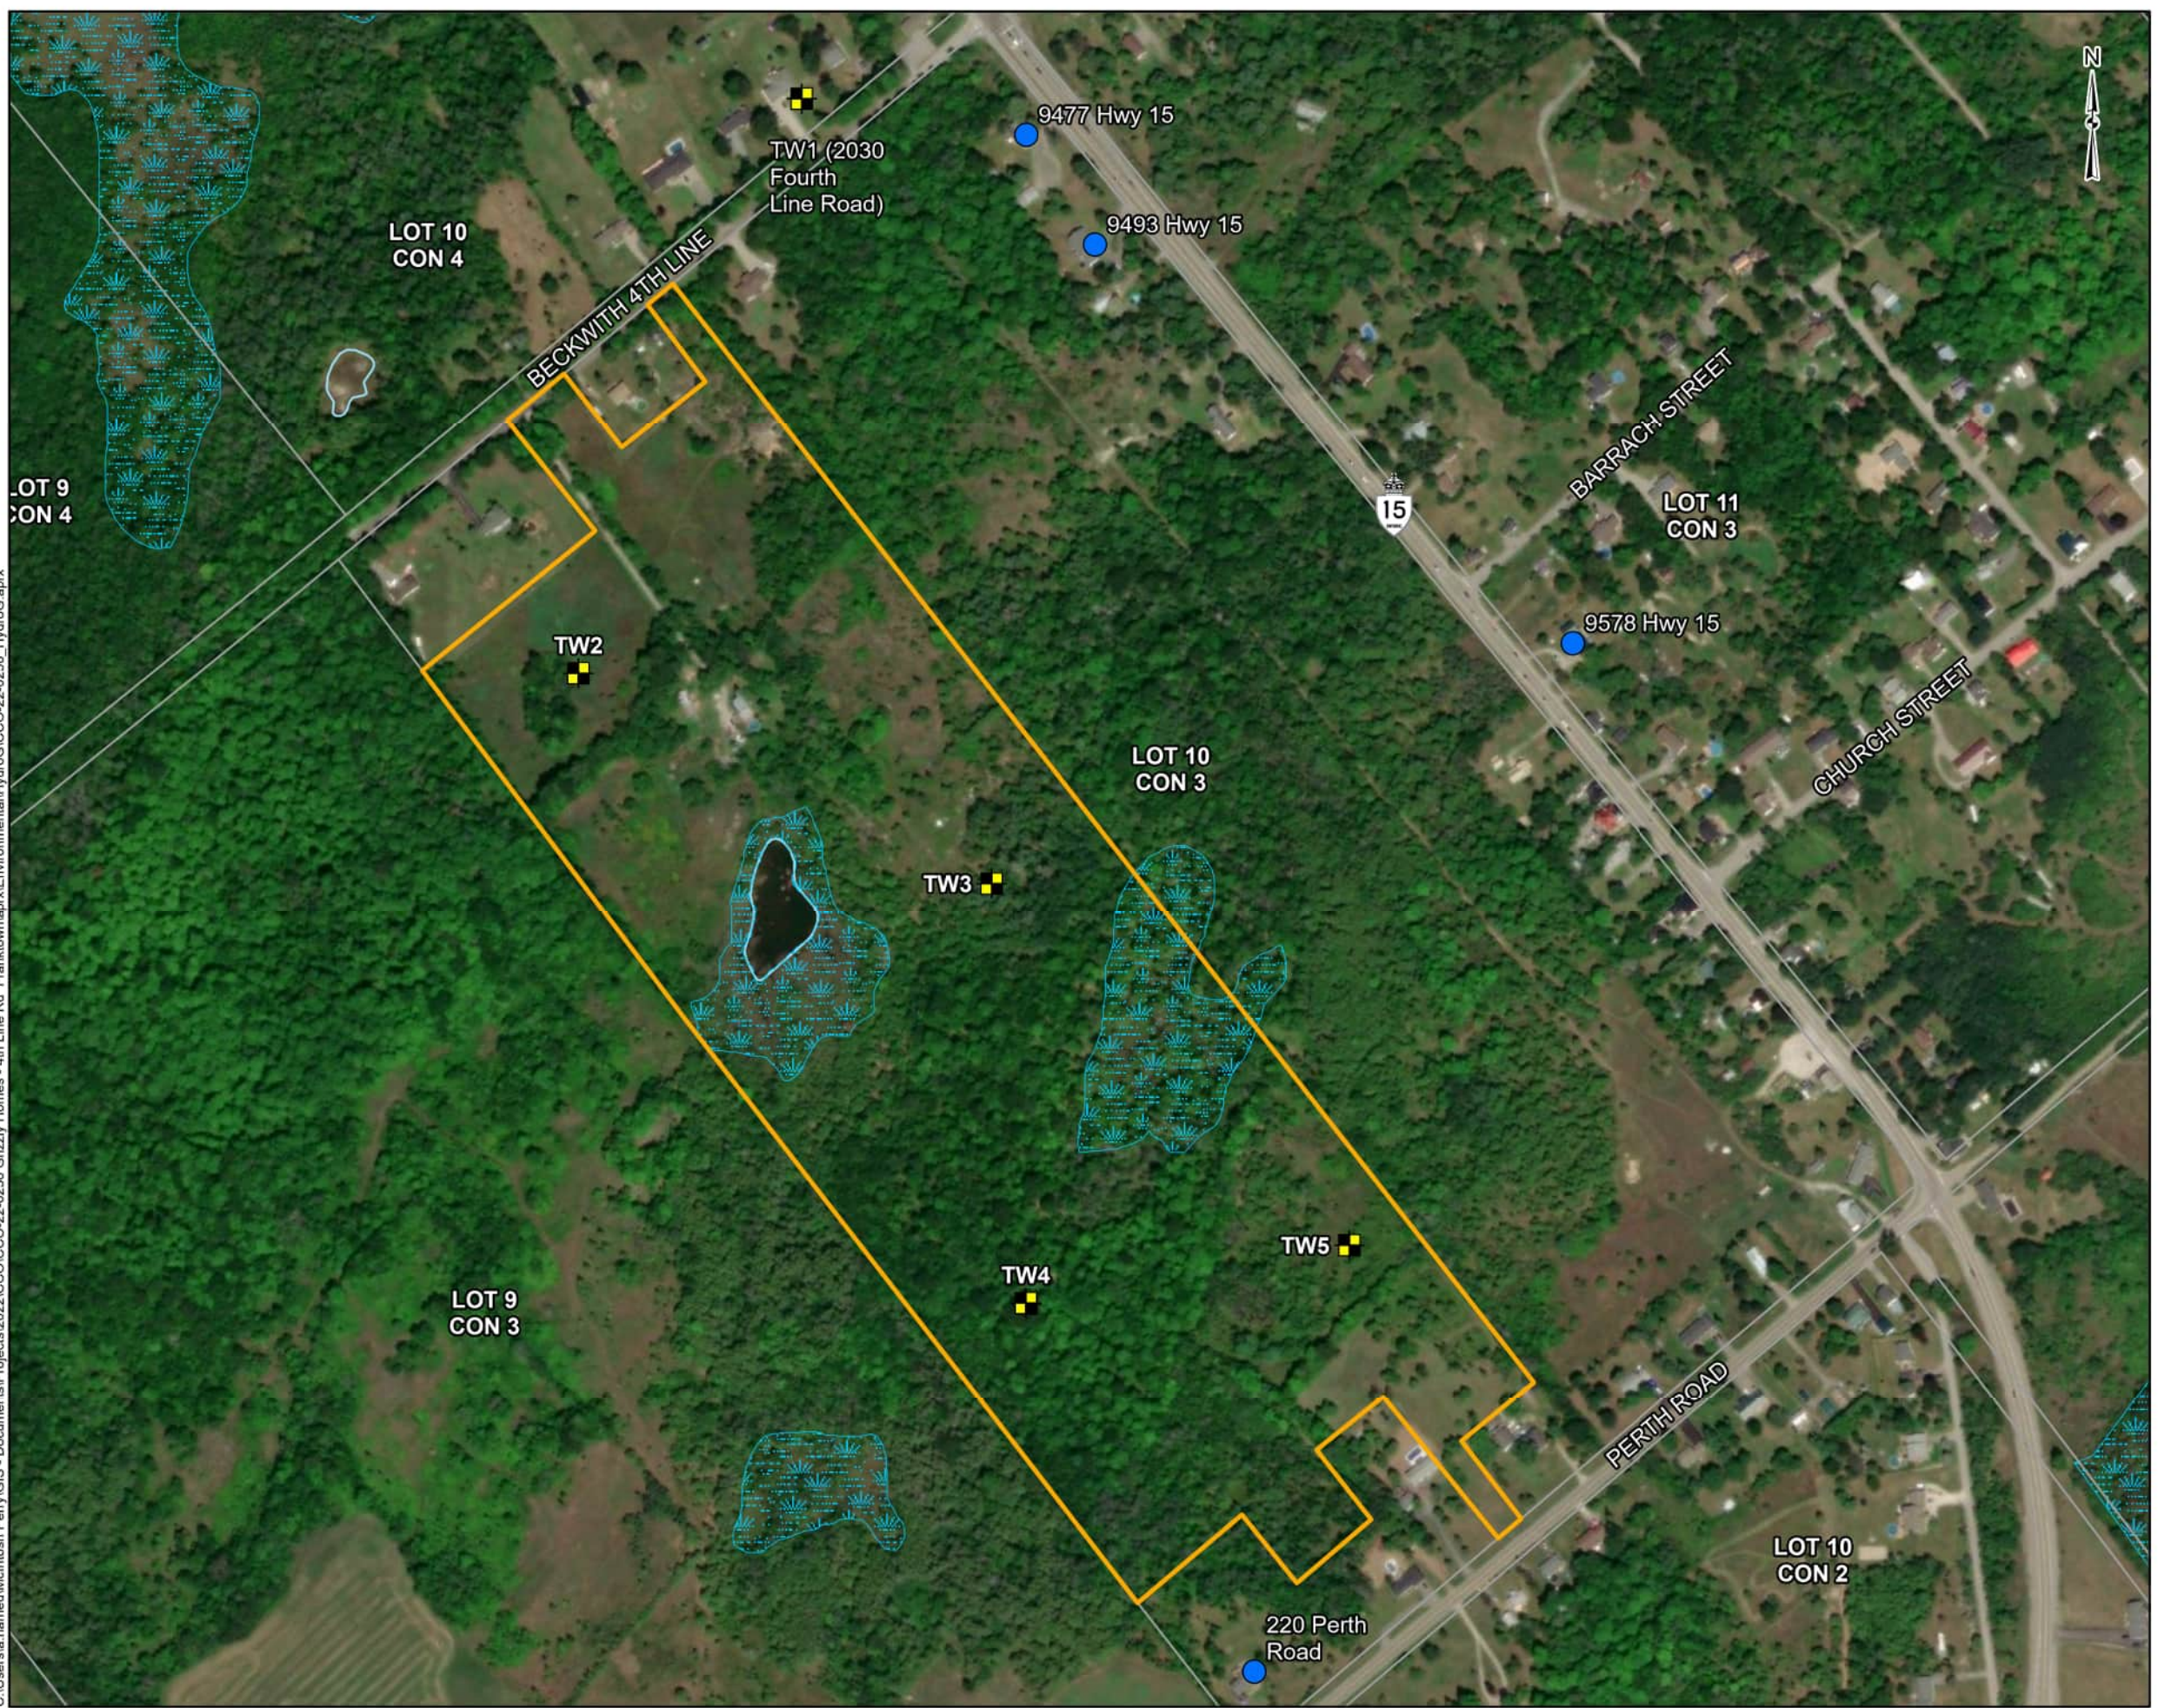
- Private well location
- Test Well Location
- Approximate Site Boundary
- Lot & Concession
- ~ Watercourse
- Unevaluated Wetland
- Waterbody

McIntosh Perry supervised the installation of four on-site water wells, as well as the excavation of fifteen on-site test pits. Wells were used for groundwater quality and quantity testing, and all test well locations were selected for eventual domestic use when the Site is developed. Test pit data were collected for purposes of soil classification and overburden thickness. A summary of the test wells and test pit locations is illustrated on Figure 2.

Air Rock Drilling Ltd. (Air Rock; Well Contractor’s Licence No.1119) was retained by Grizzly Homes to drill four water wells at the Site for testing purposes and eventual domestic use when the property is developed. The drilling was conducted by licensed employees of Air Rock, and McIntosh Perry personnel observed the grouting of each well per O. Reg. 903 (Wells), as amended. The driller also provided and installed a pump for the pumping test activities at the drilled test wells (TW2, TW3, TW4, TW5). A summary of the test well construction based on driller-provided well records is presented in Table 1. The location of all on-site wells is noted on Figure 2.

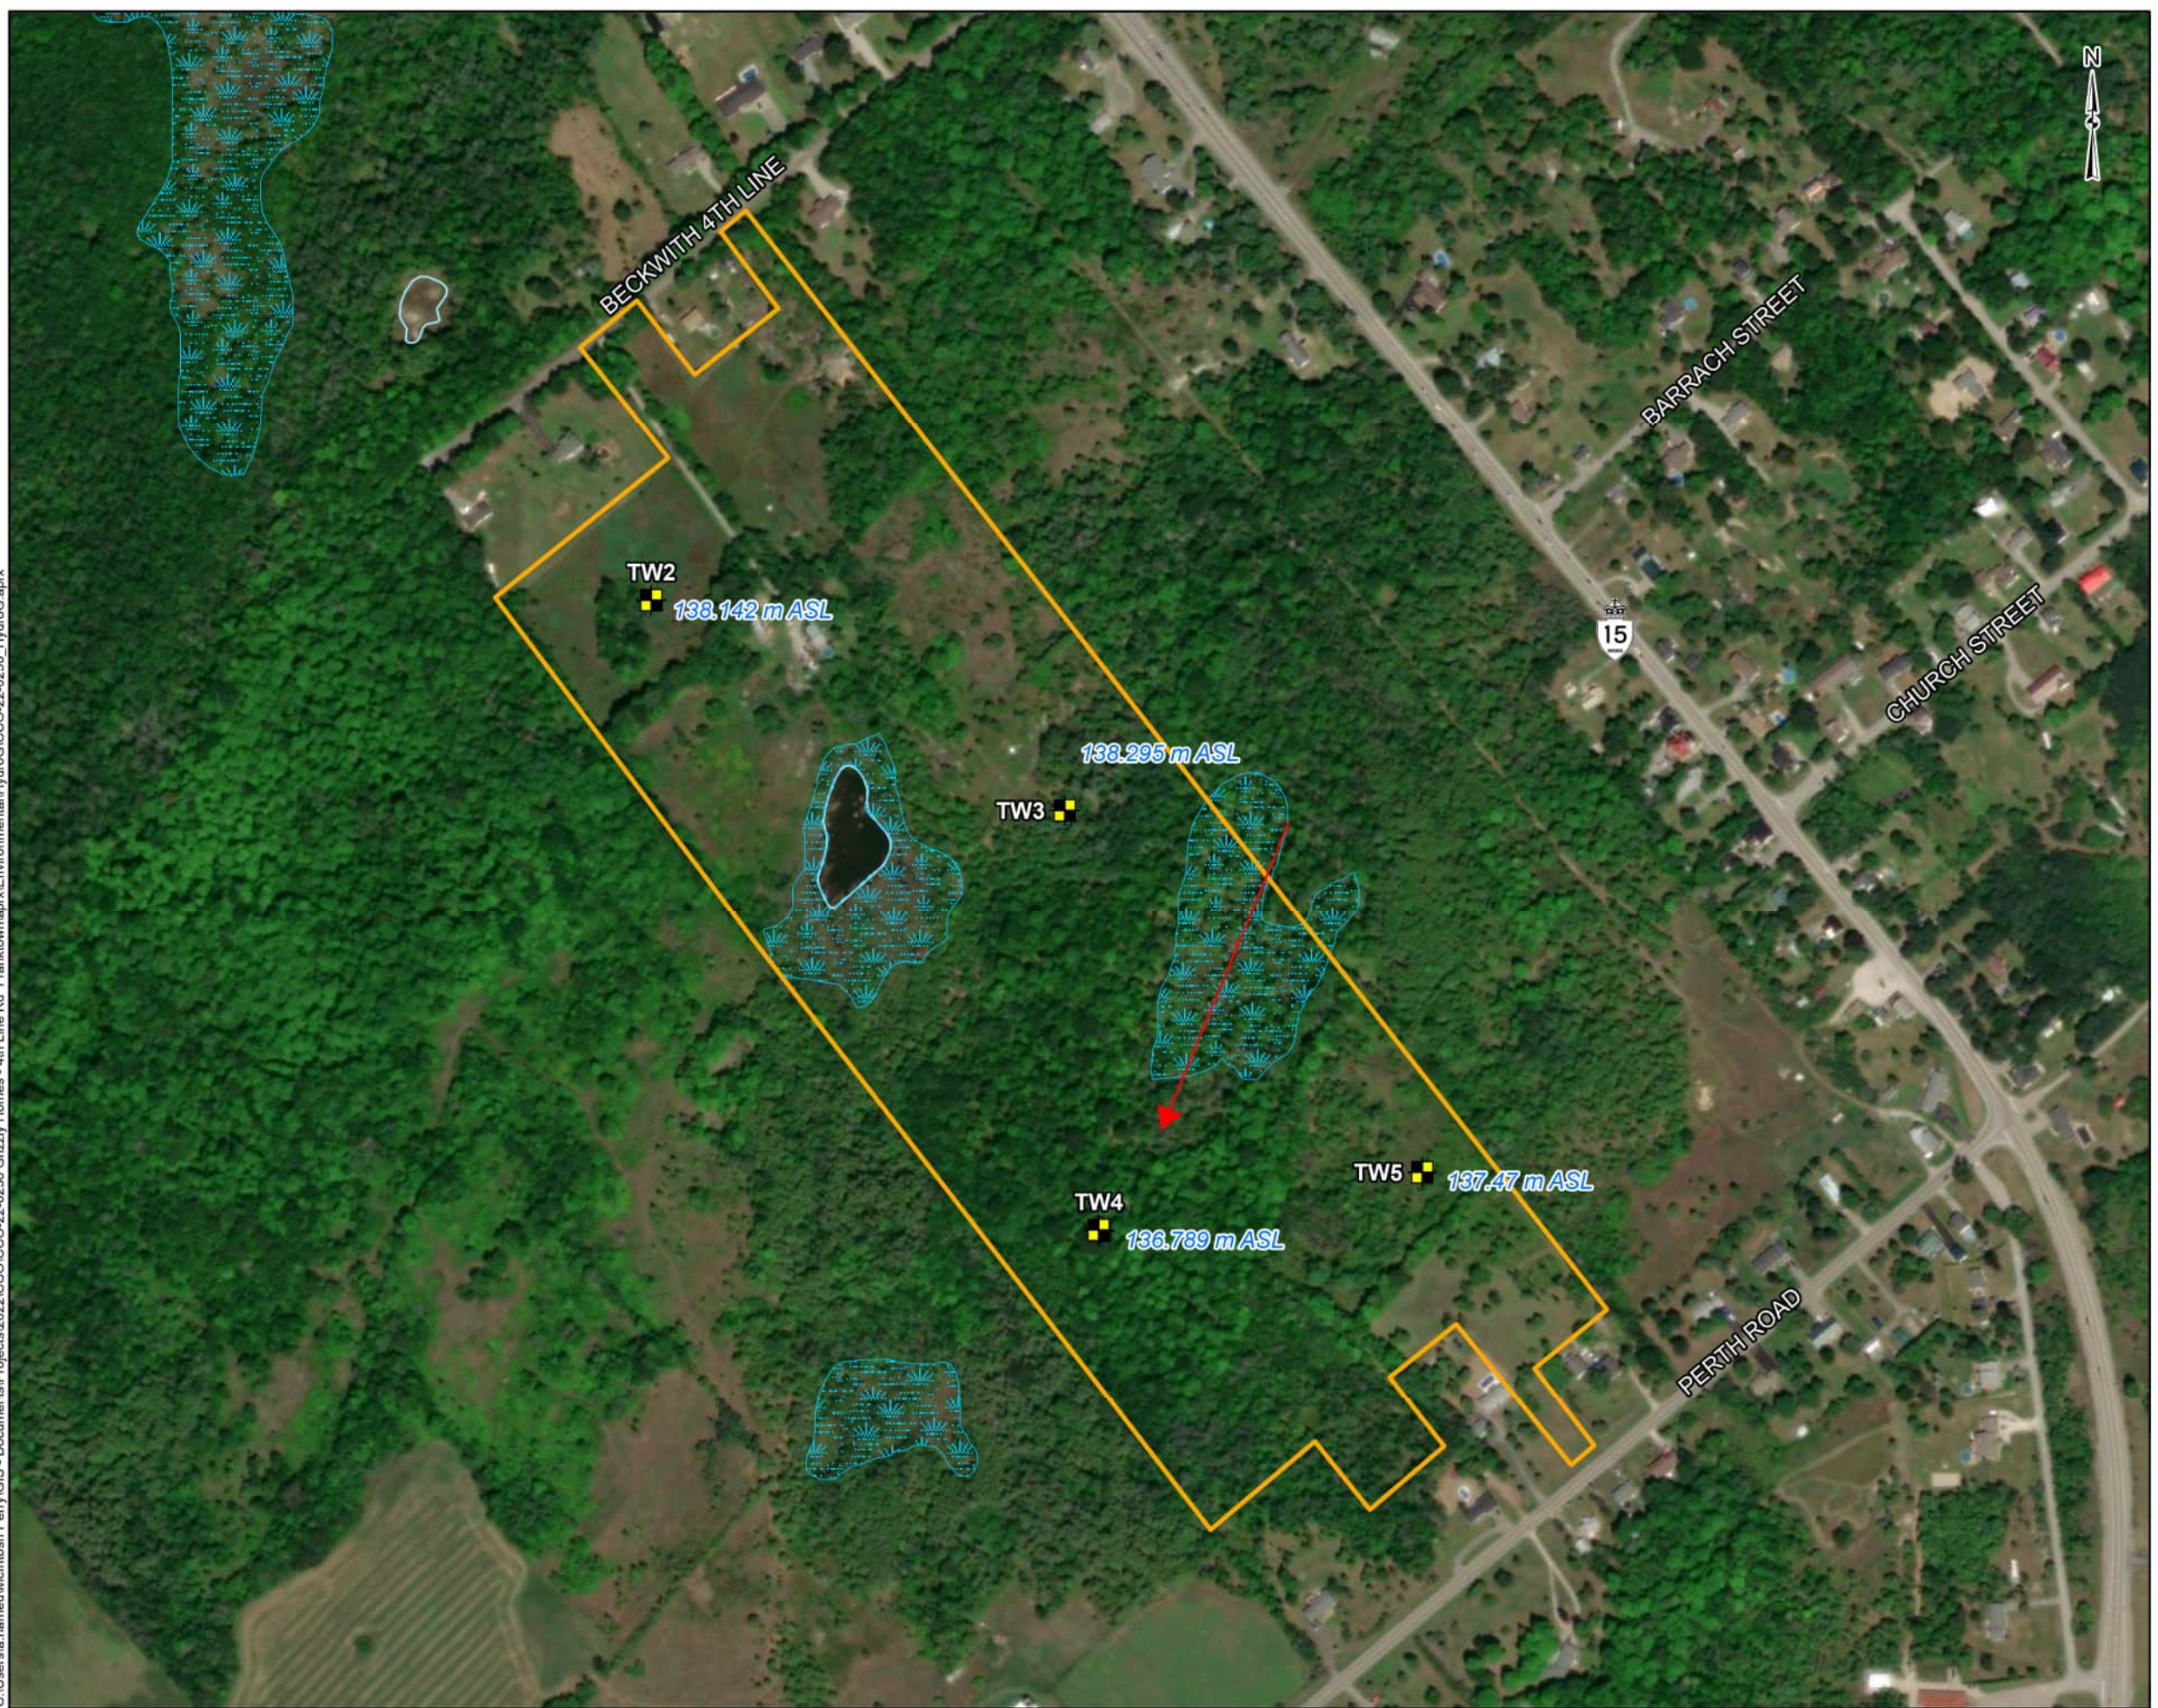
- Approximate Site Boundary
- Waterbody
- Unevaluated Wetland
- Test Well Location
- ← Groundwater direction
- 136.1 Static water elevation

Prior to the initiation of pumping, water levels were measured in the five test wells (Table 2, below). The static groundwater elevation ranged between 142.904 – 148.916 m asl at the time of the pumping tests (Figure 4). Static groundwater elevations suggest that on-site bedrock groundwater flow has a southwestern flow component. On-site wells were completed in a similar geologic unit (listed by the driller as “sandstone”). Well depths are noted in Table 2, below.

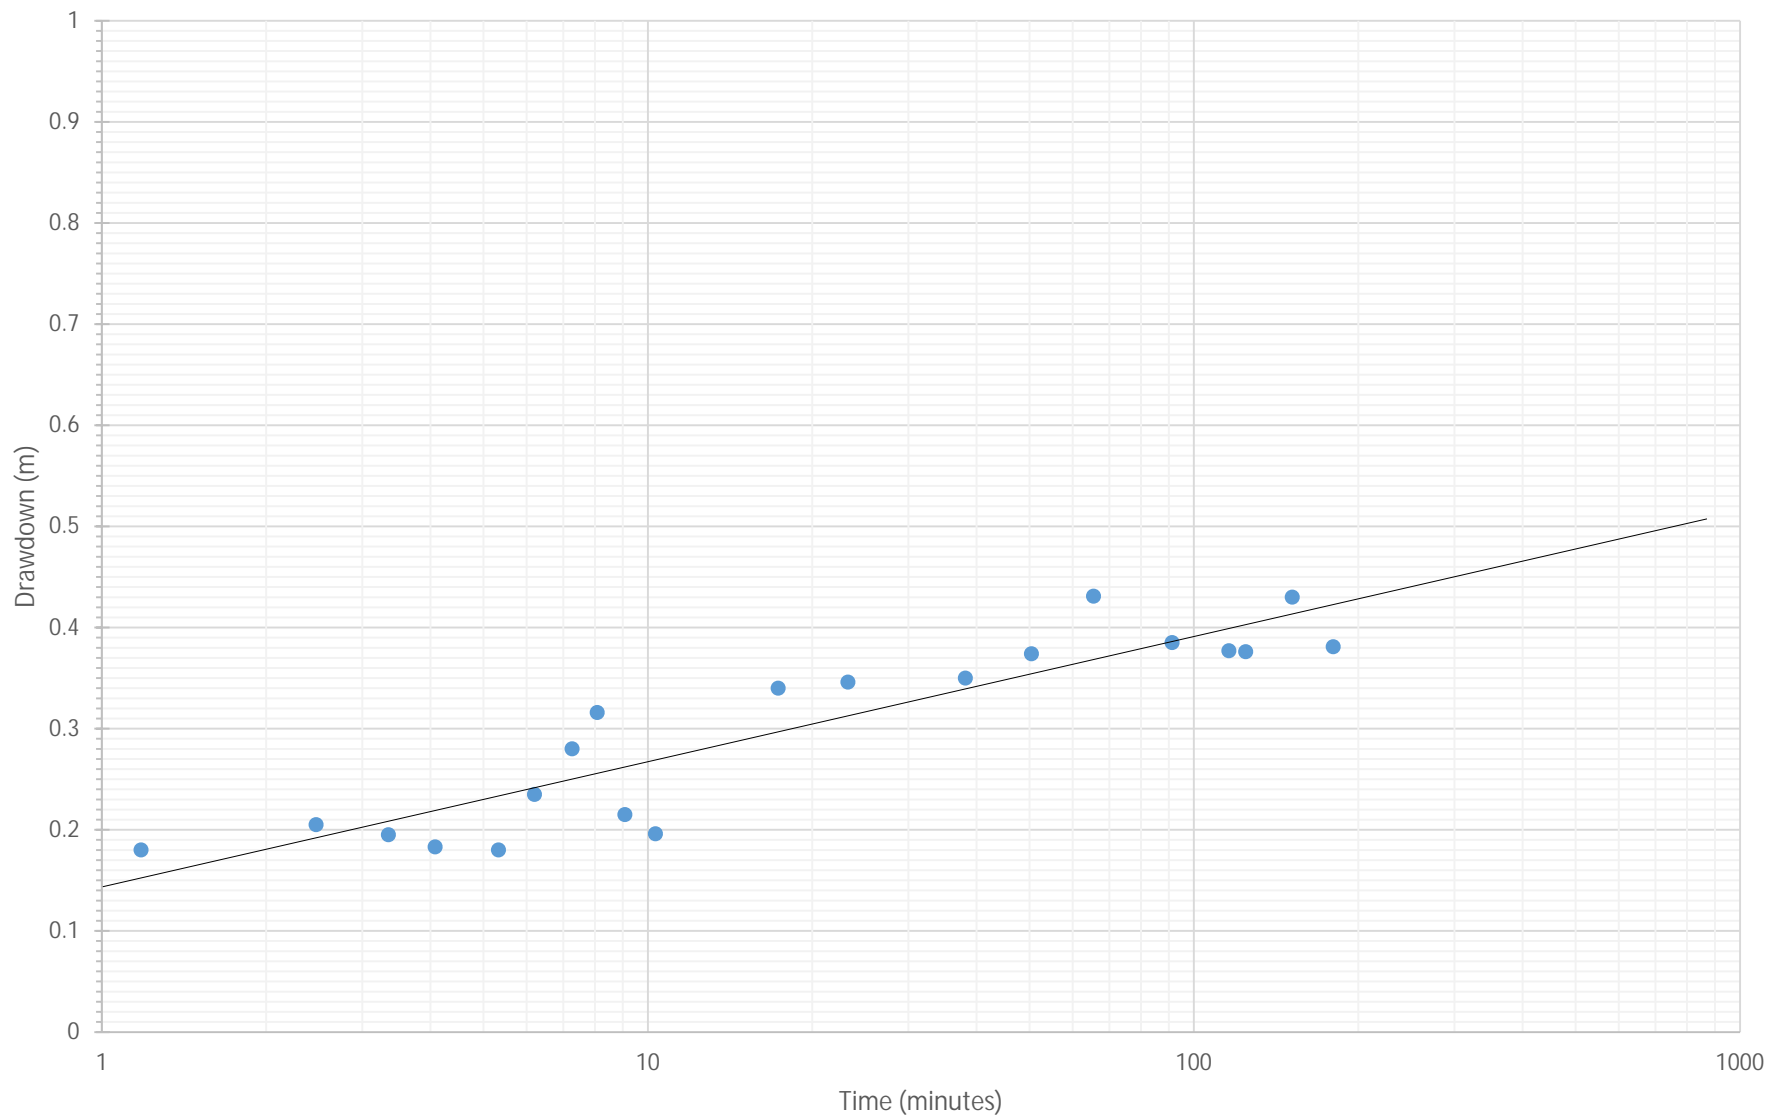
Drawdown vs Log Time
TW1 Pumping Test (Drawdown), January 18, 2022
2030 Fourth Line Road, FranktownON

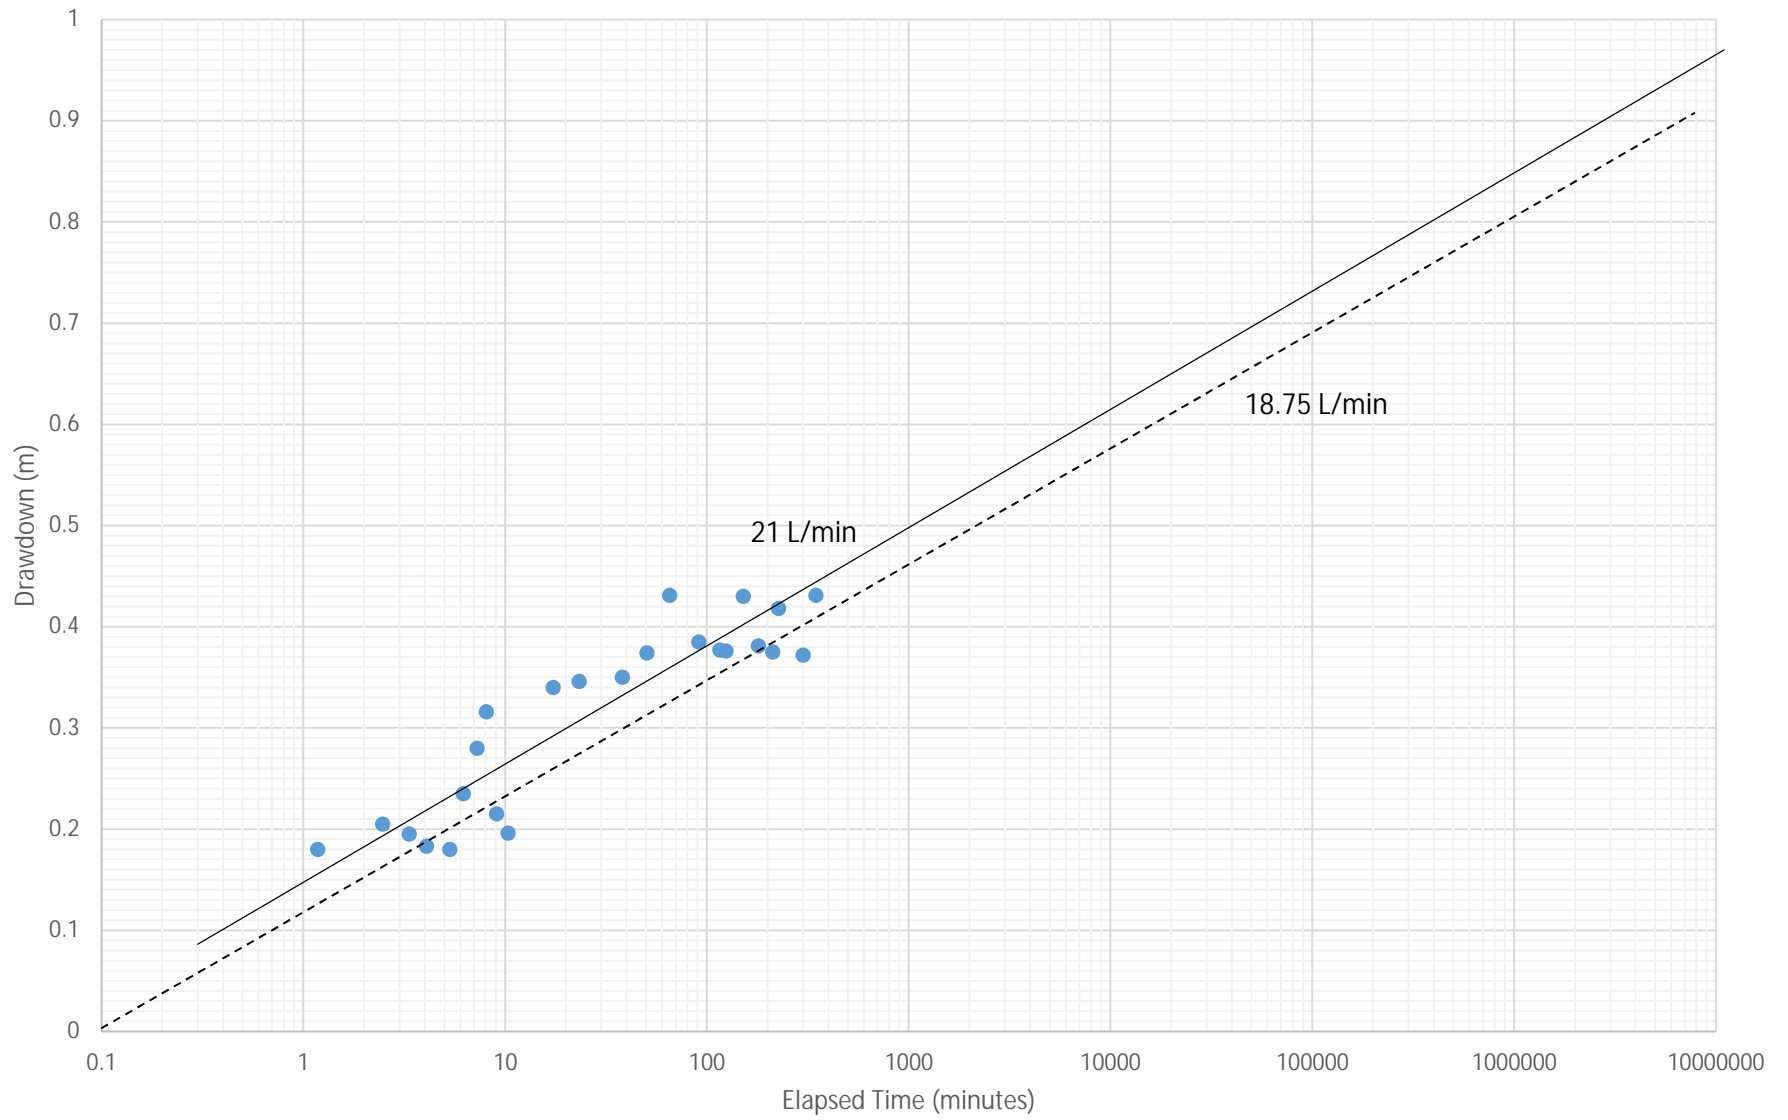
Drawdown vs Log Time
TW1 Pumping Test (Long-Term), January 18, 2022
2030 Fourth Line Road, Franktown ON

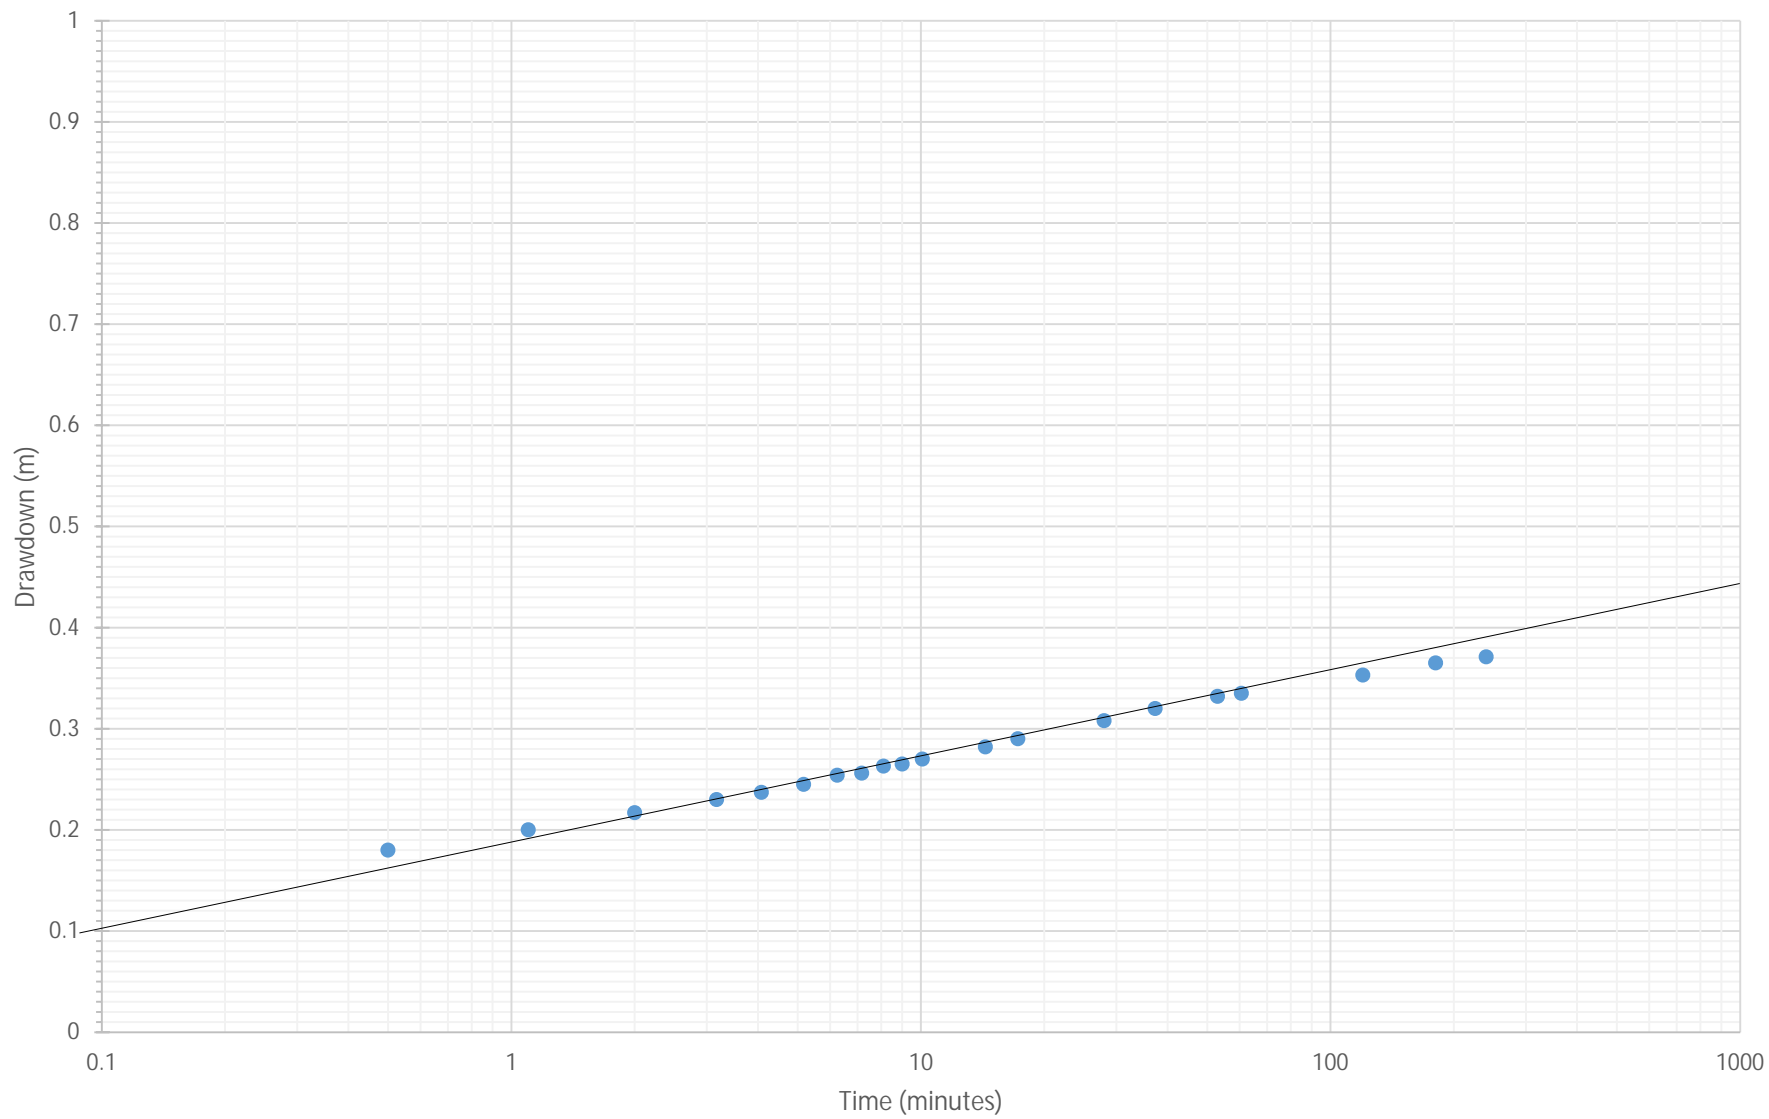
Drawdown vs Log Time
TW4 Pumping Test (Drawdown), September 9, 2021
Grizzly Homes, FranktownON

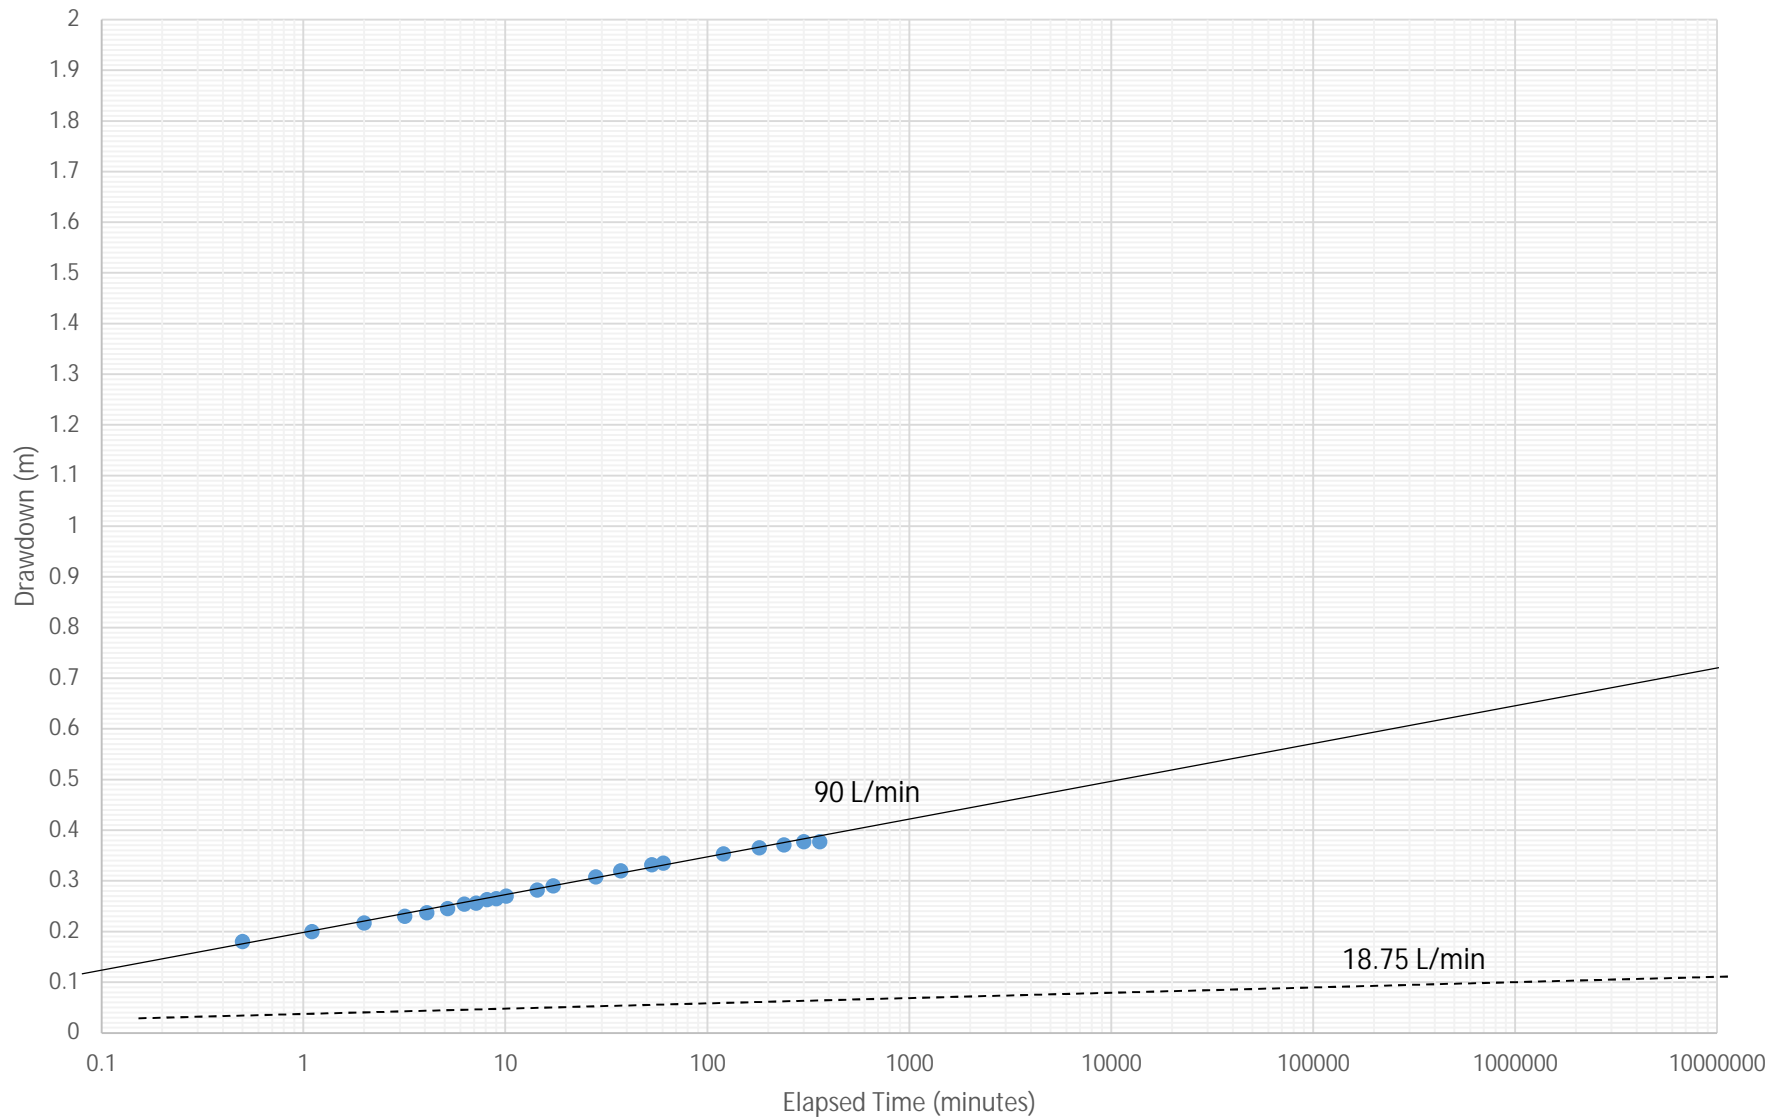
Drawdown vs Log Time
TW4 Pumping Test (Long-Term), September 9, 2021
Grizzly Homes, Franktown ON
