HYDROGEOLOGICAL ASSESSMENT AND TERRAIN ANALYSIS

GRIZZLY HOMES SUBDIVISION, BECKWITH, ON

Project No.: CCO-22-0256

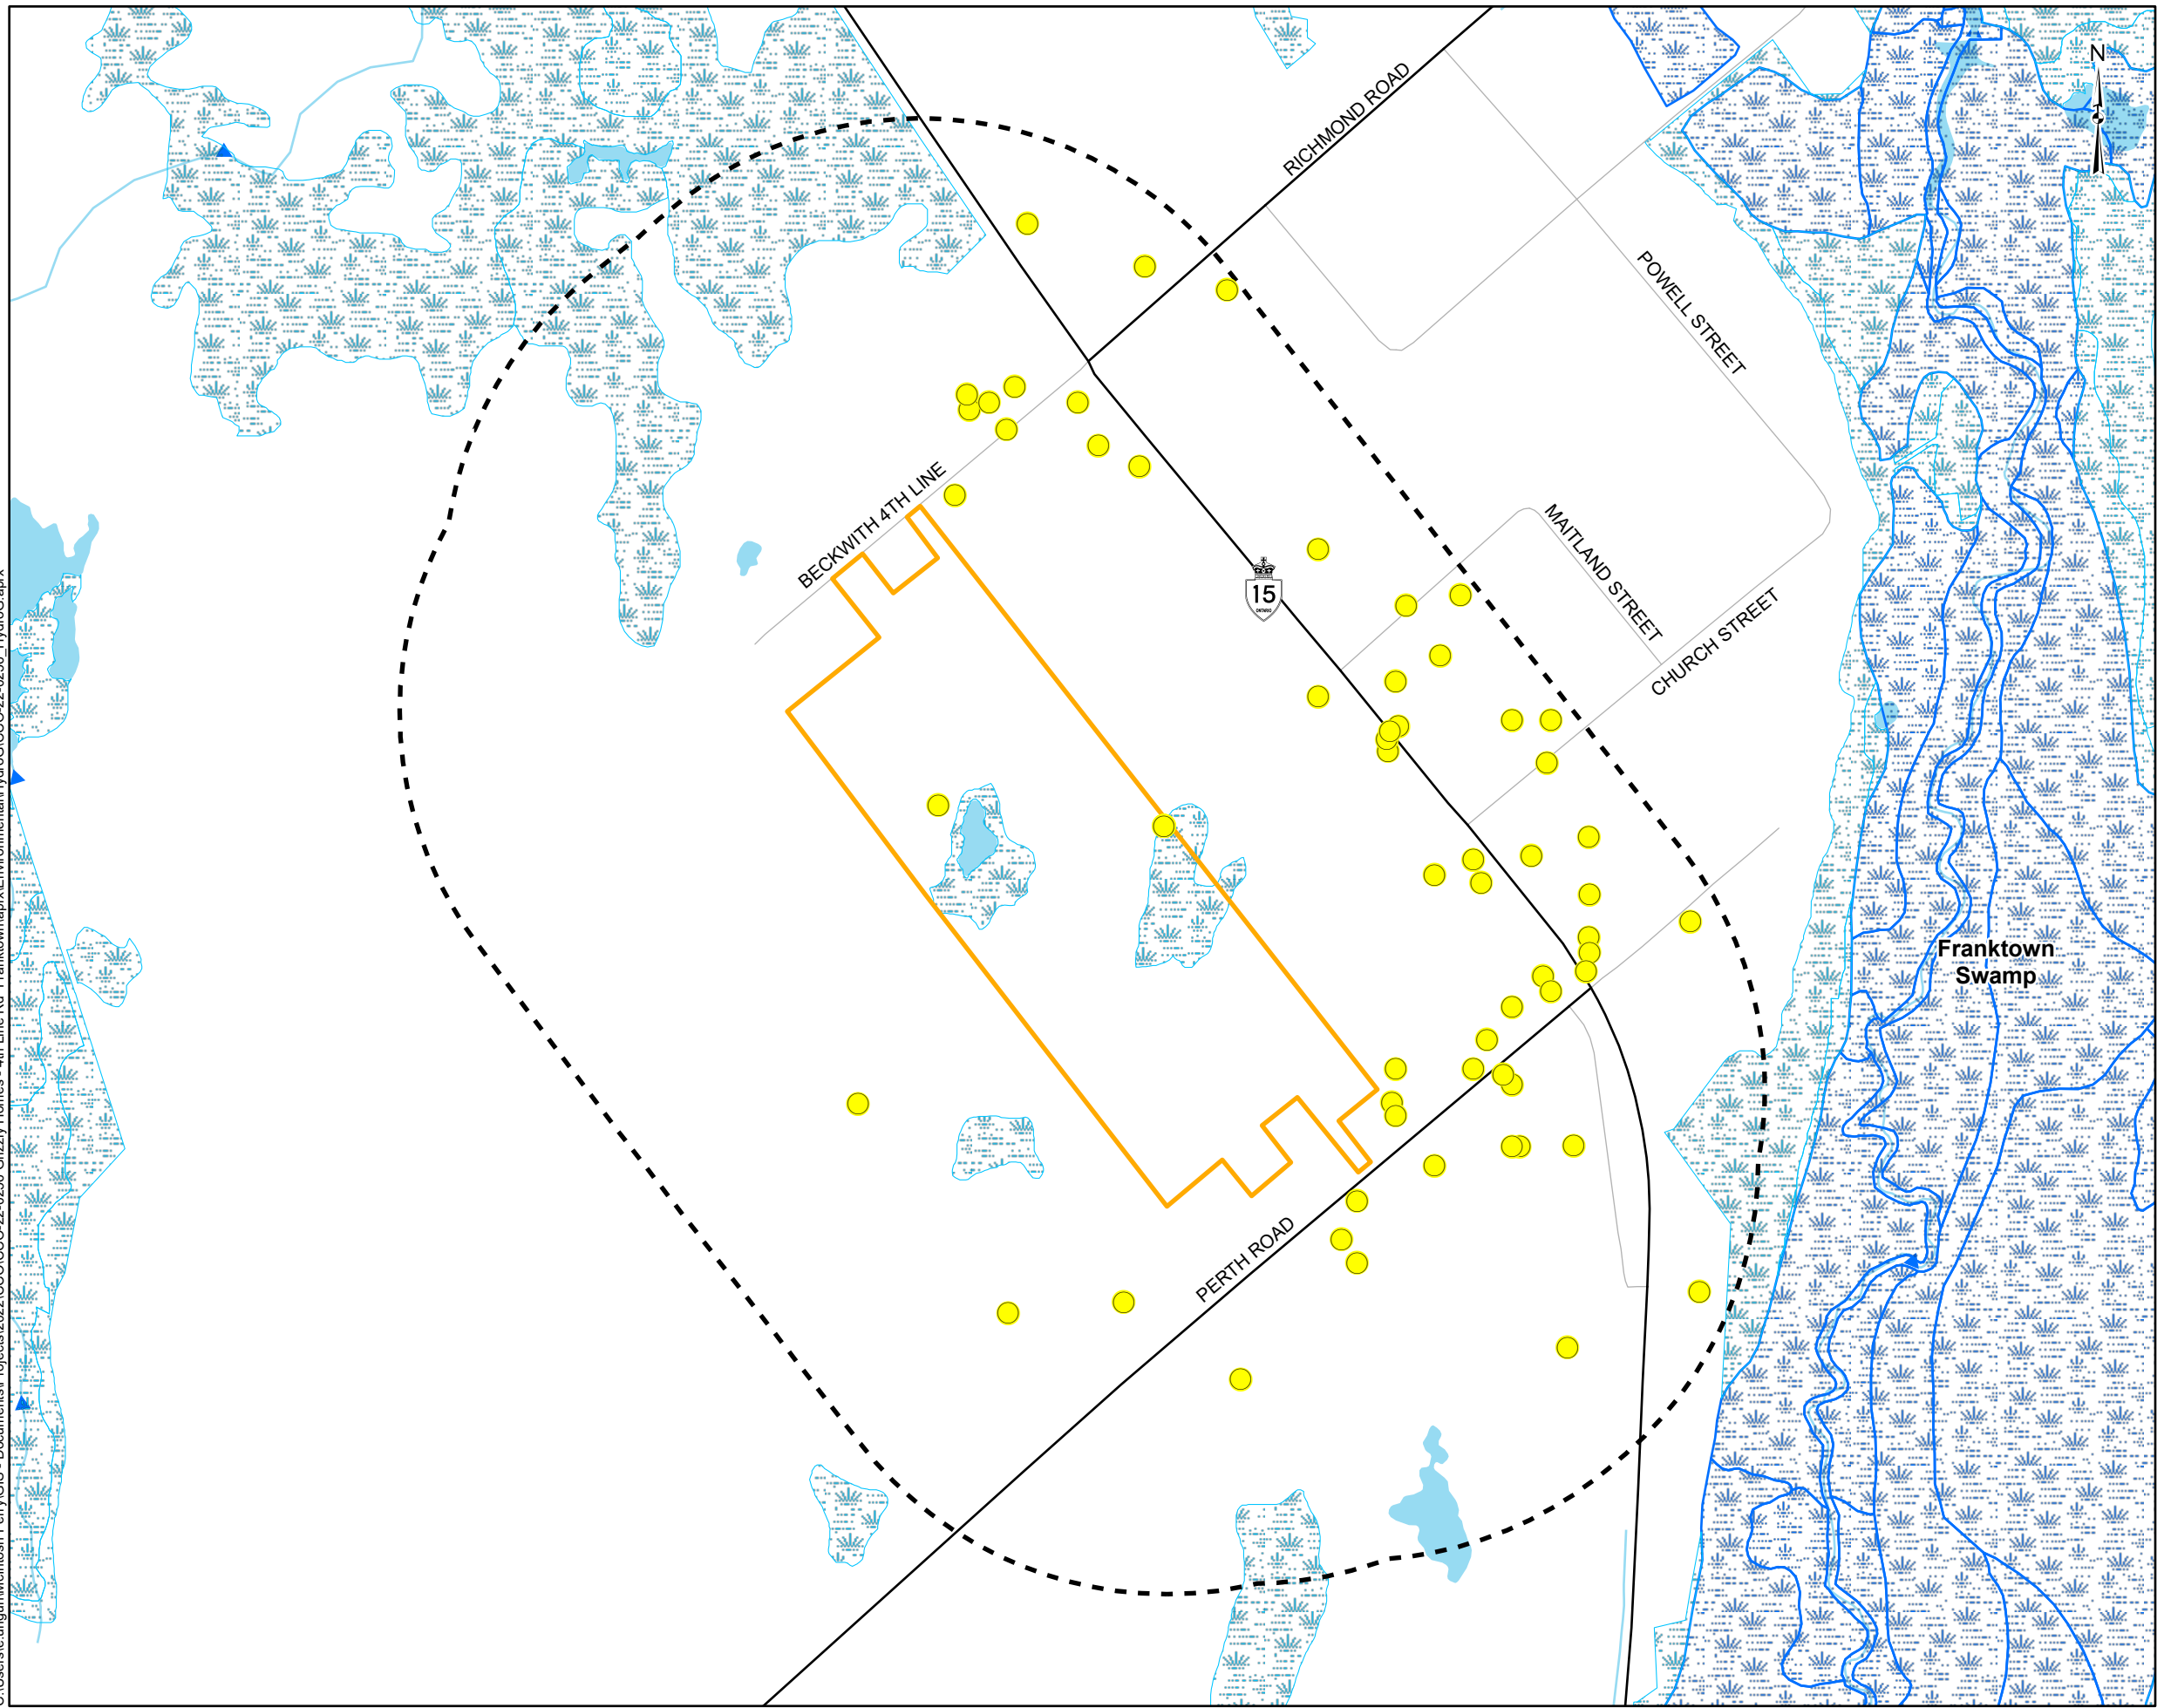
- LEGEND**
- Approximate Site Boundary
 - MECP Well Location
 - 500m Buffer
 - Local Road
 - Major Road
 - Watercourse
 - Waterbody
 - Unevaluated Wetland
 - Provincially Significant Wetland

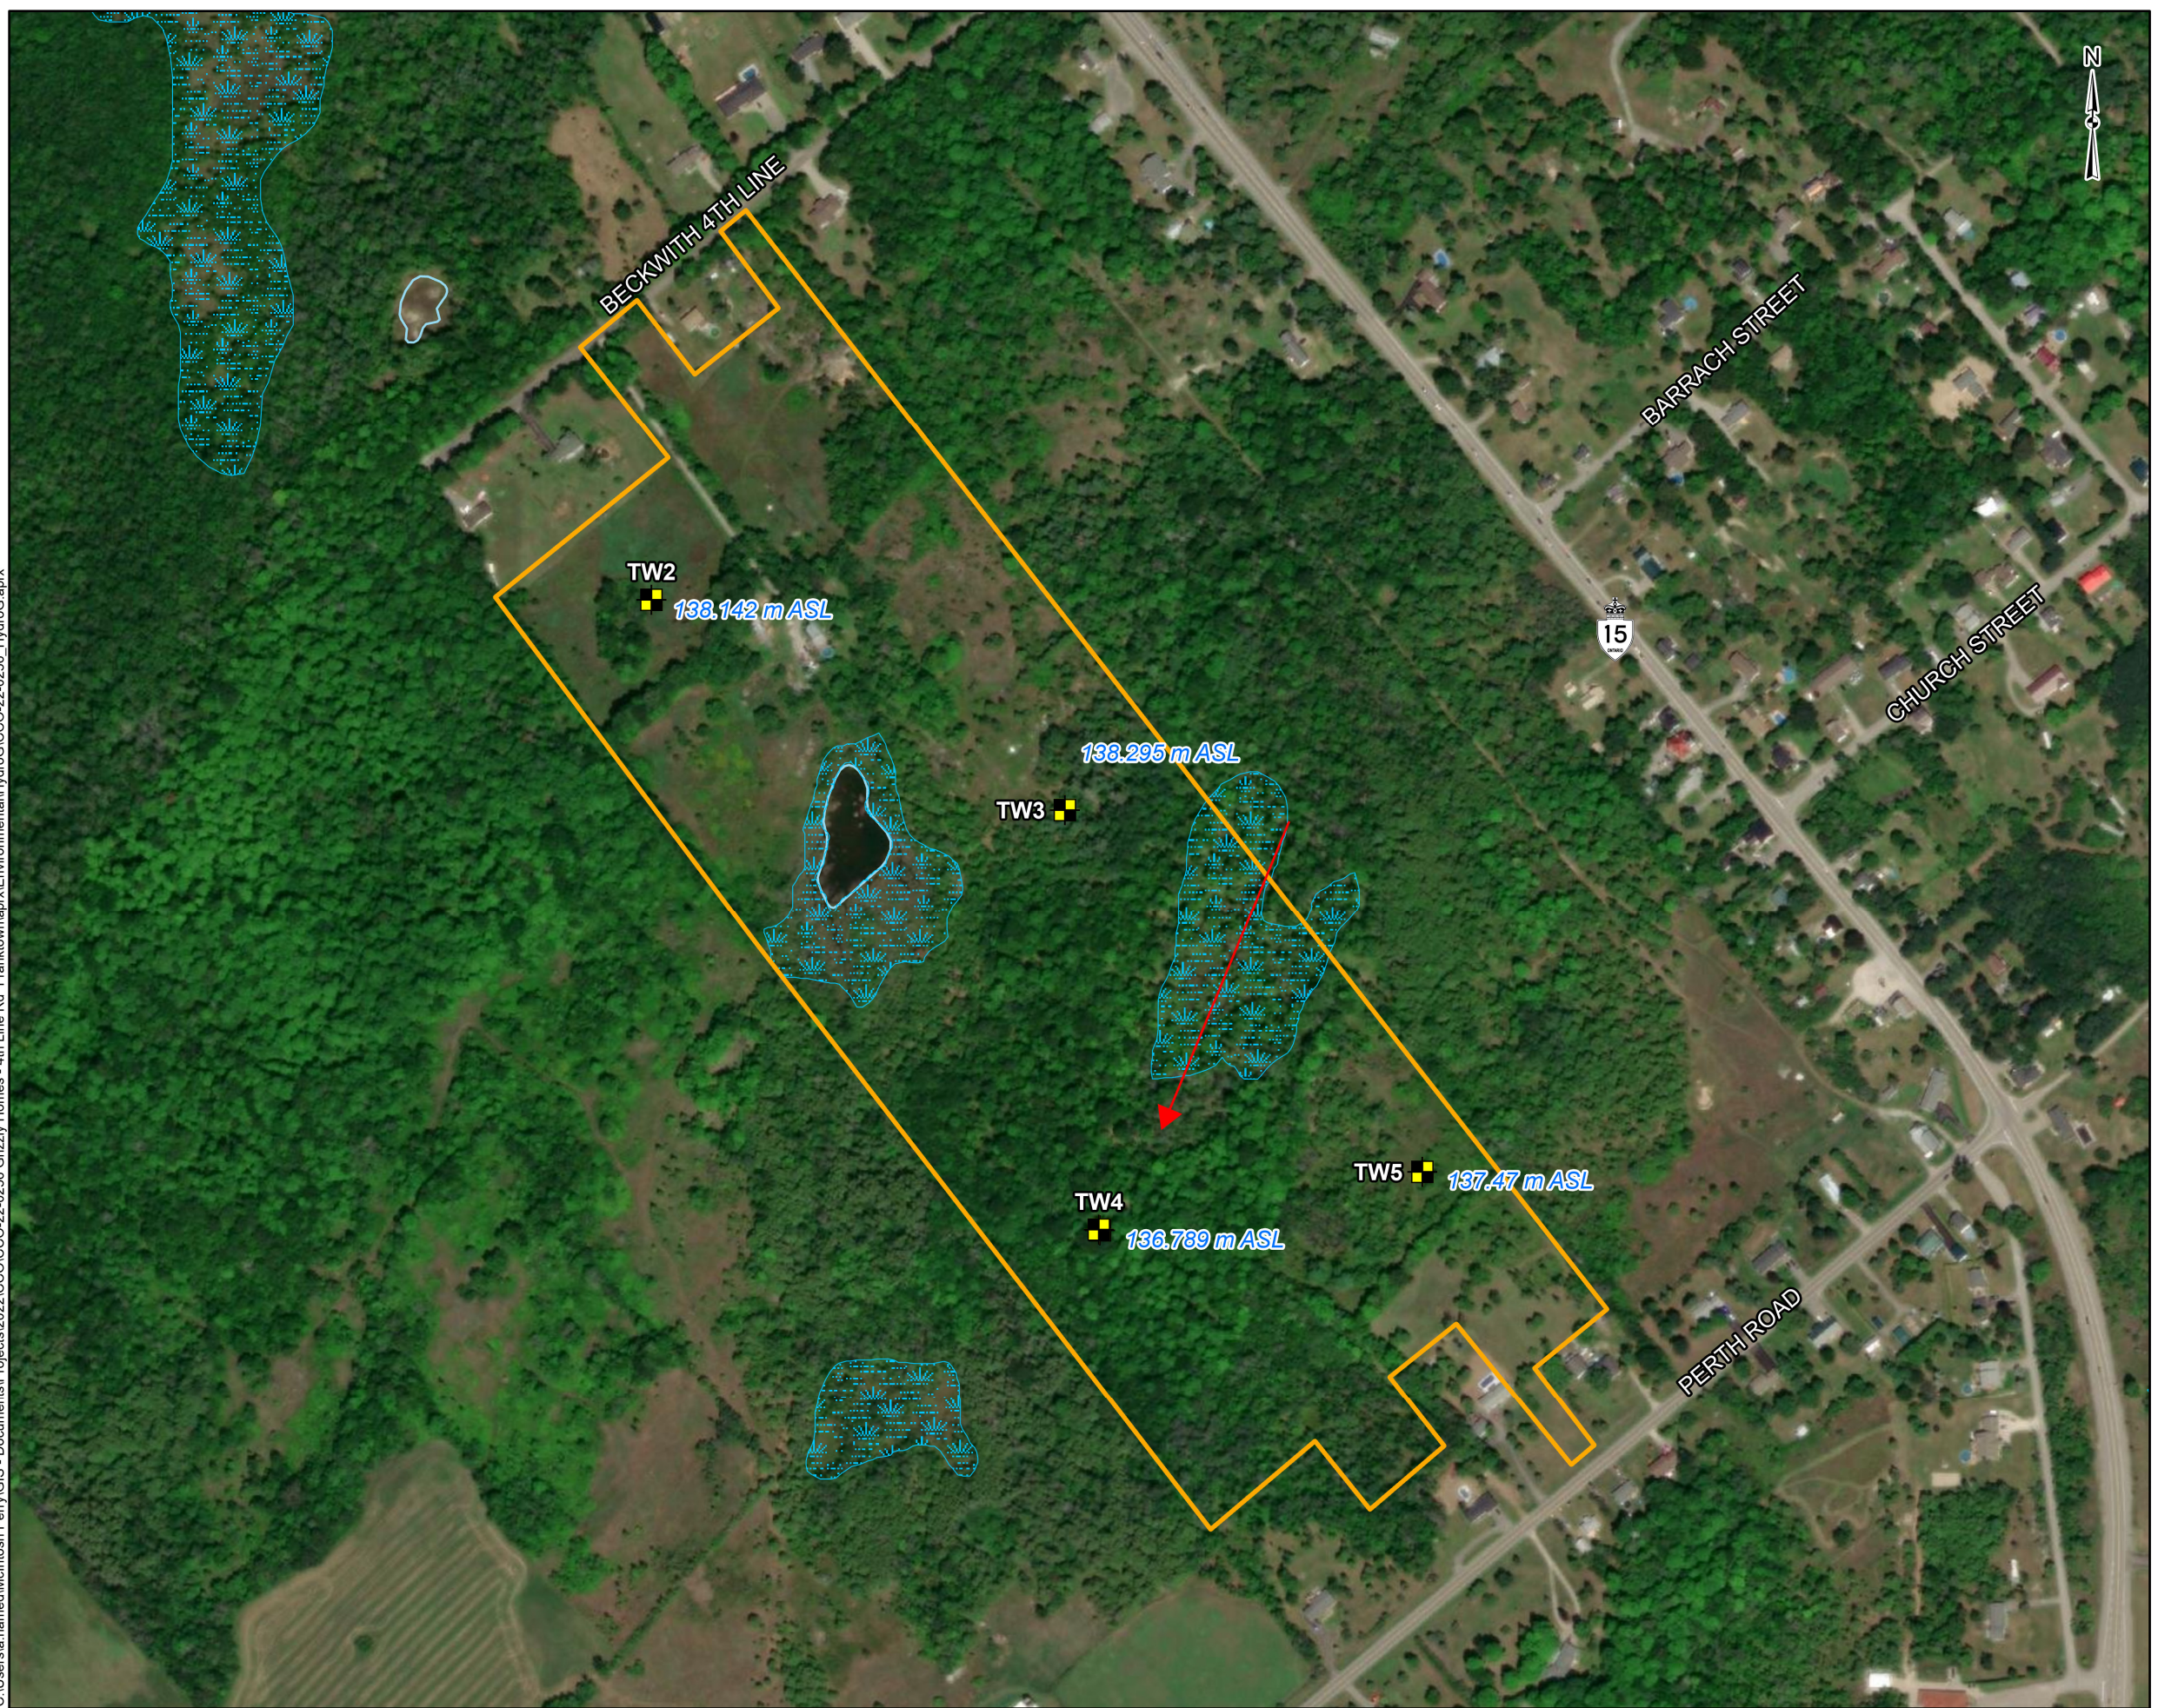
- LEGEND**
- Approximate Site Boundary
 - Waterbody
 - Unevaluated Wetland
 - Test Well Location
 - ← Groundwater direction
 - 136.1 Static water elevation

Prior to the initiation of pumping, water levels were measured in the five test wells (Table 2, below) by the drillers. The static groundwater elevation ranged between 142.904 – 148.916 m asl at the time of the pumping tests (Figure 4). Static groundwater elevations suggest that on-site bedrock groundwater flow has a southwestern flow component. On-site wells were completed in a similar geologic unit (listed by the driller as “sandstone”). Well depths are noted in Table 2, below.
