Cultural Heritage Report and Heritage Impact Assessment
January 03, 2023

CULTURAL HERITAGE EVALUATION REPORT AND HERITAGE IMPACT ASSESSMENT

BLAKENEY BRIDGE, MISSISSIPPI MILLS, ONTARIO

Client: Lanark County

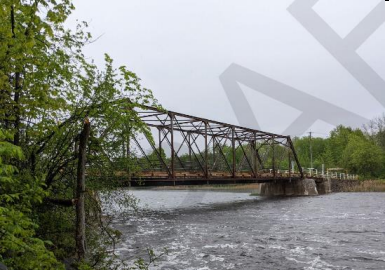
Bridge Name	Location	Summary	Photo
Andrewsville Bridge	Pakenham (over the Mississippi River)	Built in 1904, the Andrewsville Bridge has been evaluated as having historical, cultural and cultural value, including its Pratt-truss design, Dominion Bridge engineering, design by architect George T.

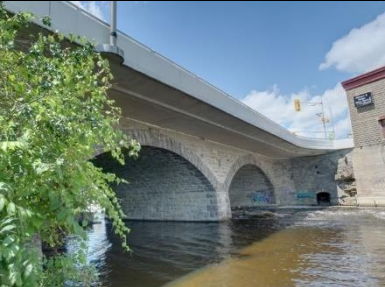
Martin, rural context, Rideau Canal context, and landmark status.	
Beckwith Street Bridge	Smiths Falls	The date of the stone-arch bridge structure is not determined. It sits below a wider modern deck.

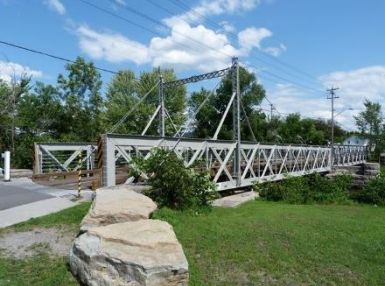
<p>Source: Historicbridges.org</p>
Beckwith Street Swing Bridge	Perth	Built in 1889; rivet-connected truss bridge, that may be among the oldest metal bridges in Ontario.

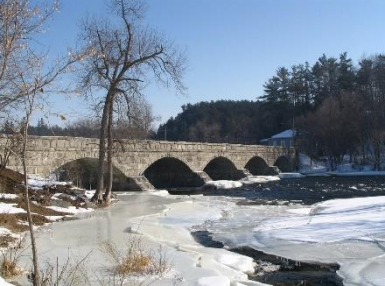
<p>Source: Historicbridges.org</p>
Pakenham Bridge	Pakenham (over the Mississippi River)	The five-arch stone bridge at Pakenham was built in 1903 and rebuilt in 1984 as a reinforced concrete bridge clad in the same stones as the original bridge. The County of Lanark designated the bridge as a municipal heritage property in 1984 (By-law 84-36).

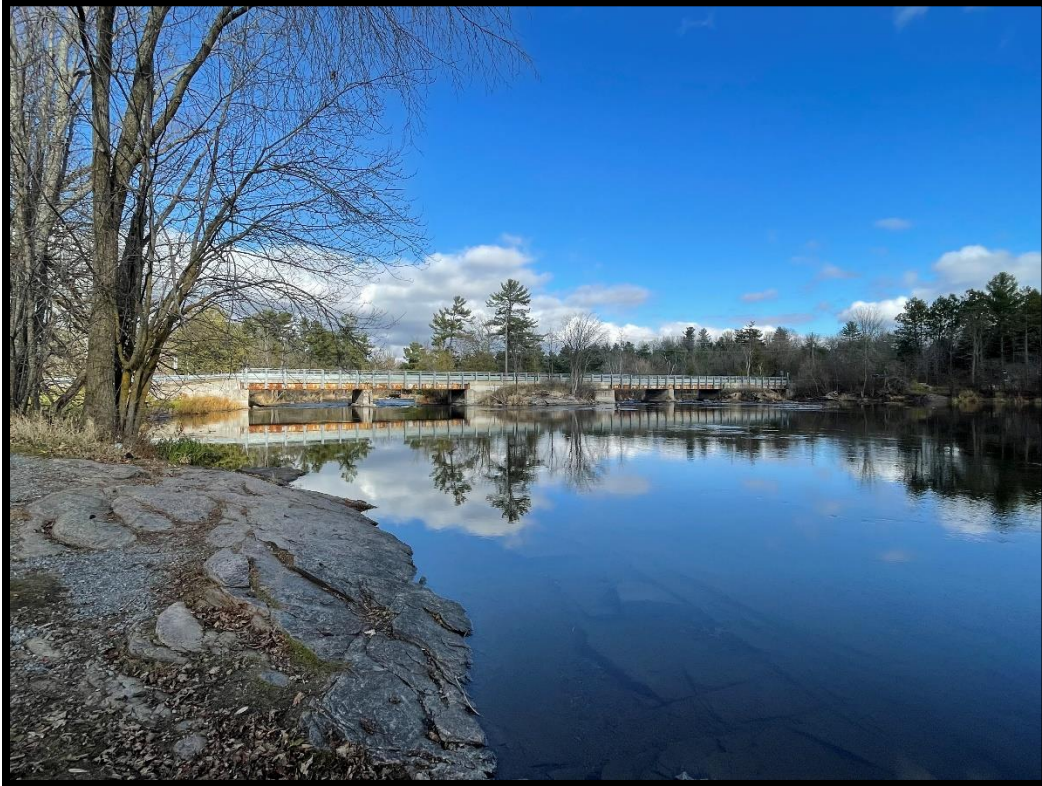
Figure 1: Looking northeast from the shore of the Mississippi River to Blakeney Bridge. Source: Contentworks, 1 November 2022.

Blakeney Bridge (Figure 1 and Figure 2) is a one-lane bridge crossing the Mississippi River near the village of Blakeney in the amalgamated municipal of Mississippi Mills (Figure 3). The bridge was constructed in 1915 to replace an older bridge erected in the 1830s (Figure 4). The current bridge has a concrete substructure (piers and abutment walls), rigid frame steel and concrete superstructure, and plain steel barrier walls/railings.

The CHER evaluates the heritage value of Blakeney Bridge (Figure 1 and Figure 2) by considering evidence and opinions pertinent for applying criteria outlined in *Regulation 9/06: Criteria for Determining Cultural Heritage Value or Interest* under the *Ontario Heritage Act* (as amended to 2022). Regulation 9/06 is to be used by municipalities to assess whether a property is of sufficient heritage value or interest and eligible for full designation. The process of writing a CHER requires the collection and analysis of information about the property itself – history, design and context – and comparative information that can be used to measure value against the criteria. The research and analysis work for this CHER follows guidance from the *Ontario Heritage Tool Kit* by the Ontario Ministry of Heritage, Sport, Tourism and Culture Industries.

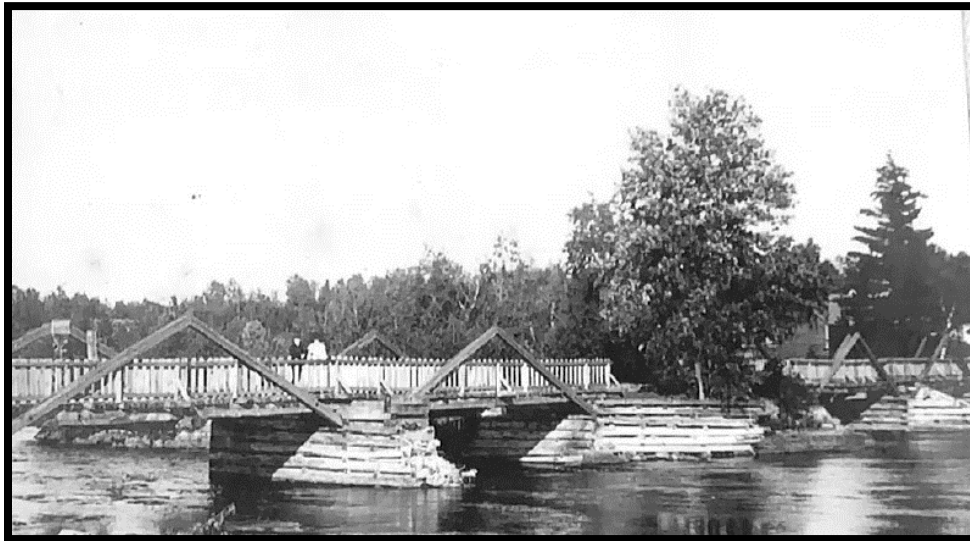
Figure 4: Timber bridge at Blakeney, [1900], looking towards the south (upstream) side of the bridge. Source: Ramsay Women's Institute, *Tweedsmuir History Book 7*, accessed online at http://images.ourontario.ca/Partners/FWIO/FWIO003203526_0040p.pdf.

Blakeney Bridge is located on the Mississippi River near the former village of Blakeney that is now part of the Municipality of Mississippi Mills (Figure 3). The existing bridge was constructed in 1915 to replace an 1830s timber bridge (Figure 4). The current bridge uses a plain concrete substructure (piers, retaining walls and abutment walls), a steel and concrete superstructure, and steel barrier walls/railings (Figure 5, Figure 8, Figure 9 and Figure 10). Blakeney Bridge has not been identified previously by the municipality or any other community or level of government as being of potential cultural heritage value or interest.

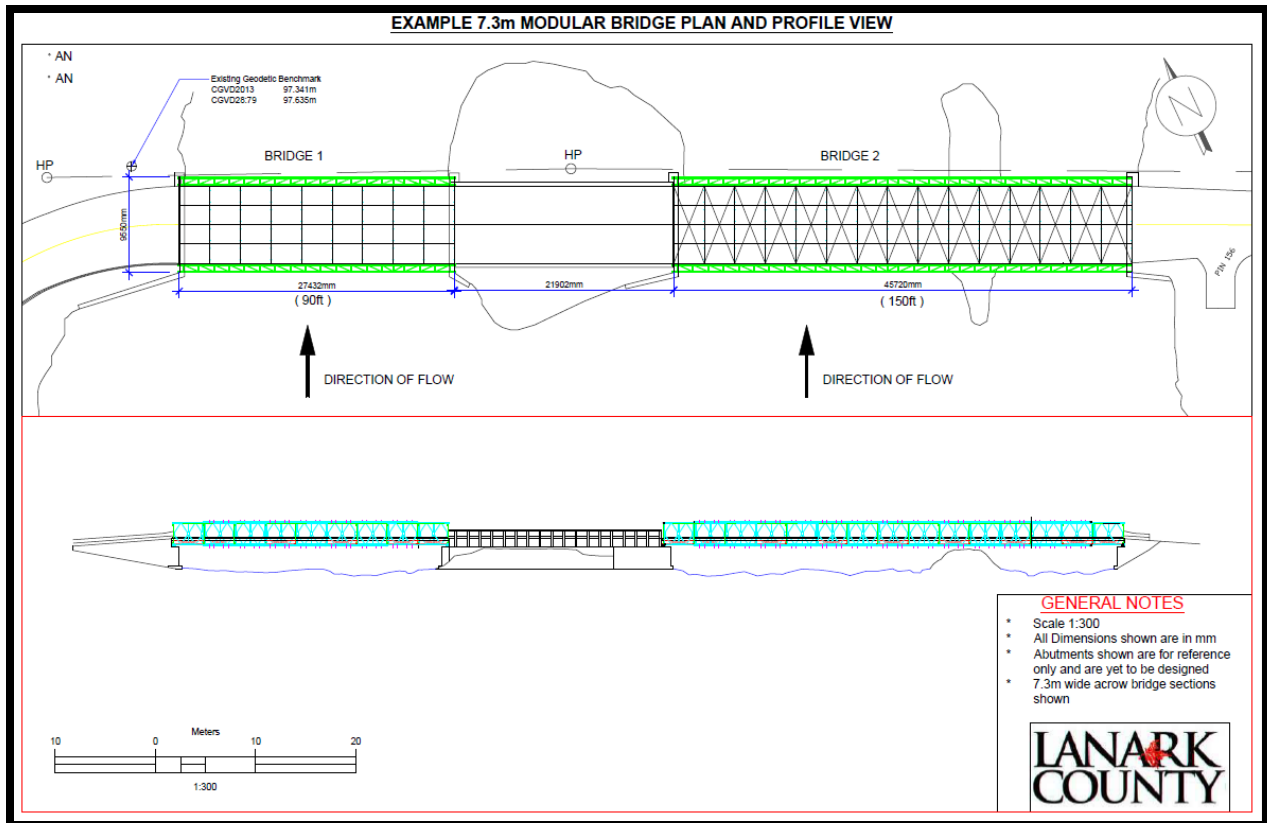
Figure 5: Plan and profile views for the double-lane modular steel bridge proposed. Source: Lanark County. 2022. Blakeney Bridge Replacement Options.

Lanark County plans to replace Blakeney Bridge two-lane modular steel bridge configured for one-way traffic using a traffic control system that will provide space for active transportation modes during normal operation (Figure 5 and Figure 6). The HIA, which is integrated into this report as **Appendix C**, considers the impact of the proposed option on the heritage values and attributes of the current Blakeney Bridge and suggests mitigation measures that can help conserve the bridge's heritage value.

All options under consideration by Lanark County involve replacement of the bridge. The preferred option is a two-lane, modular, steel bridge in the same location of the 1915 bridge, but with two single-span sections, rather than two double-span and one single-span configuration (Figure 5 and Figure 6). This option allows for wider farm machinery to cross the bridge.

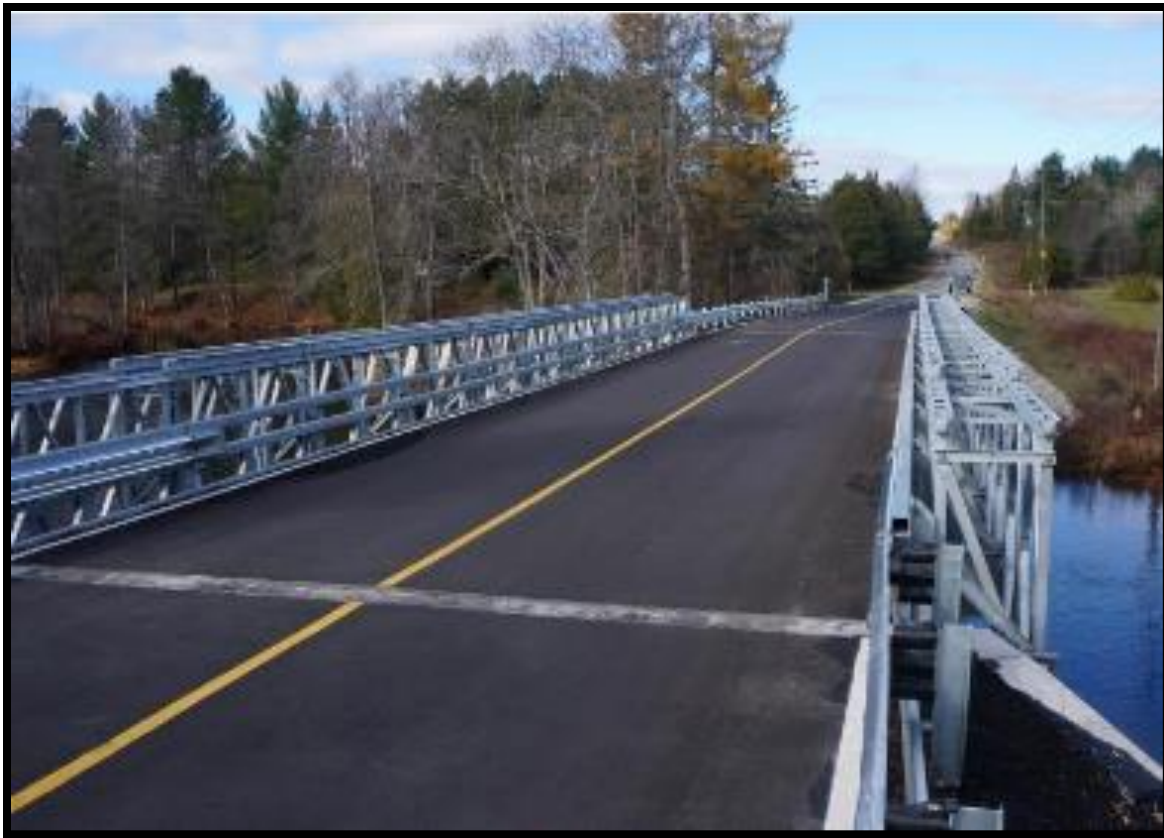
Figure 6: Lanark Highlands modular bridge. This bridge is the same design as the replacement bridge proposed for the Blakeney crossing. Source: [Acrow], n.d.

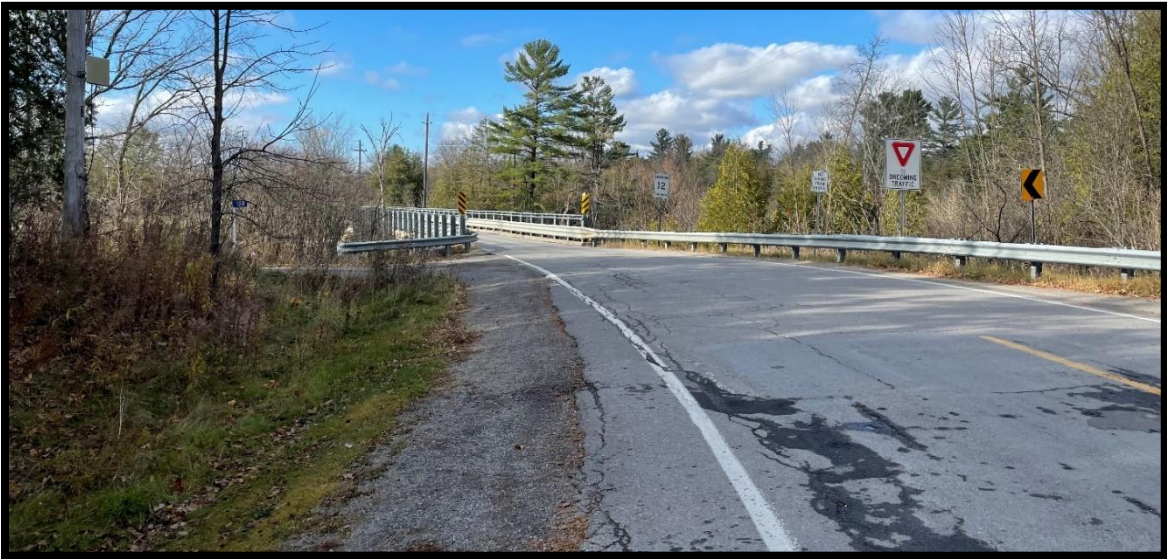
Figure 8: East approach to Blakeney Bridge, November 2022. Source: Contentworks.

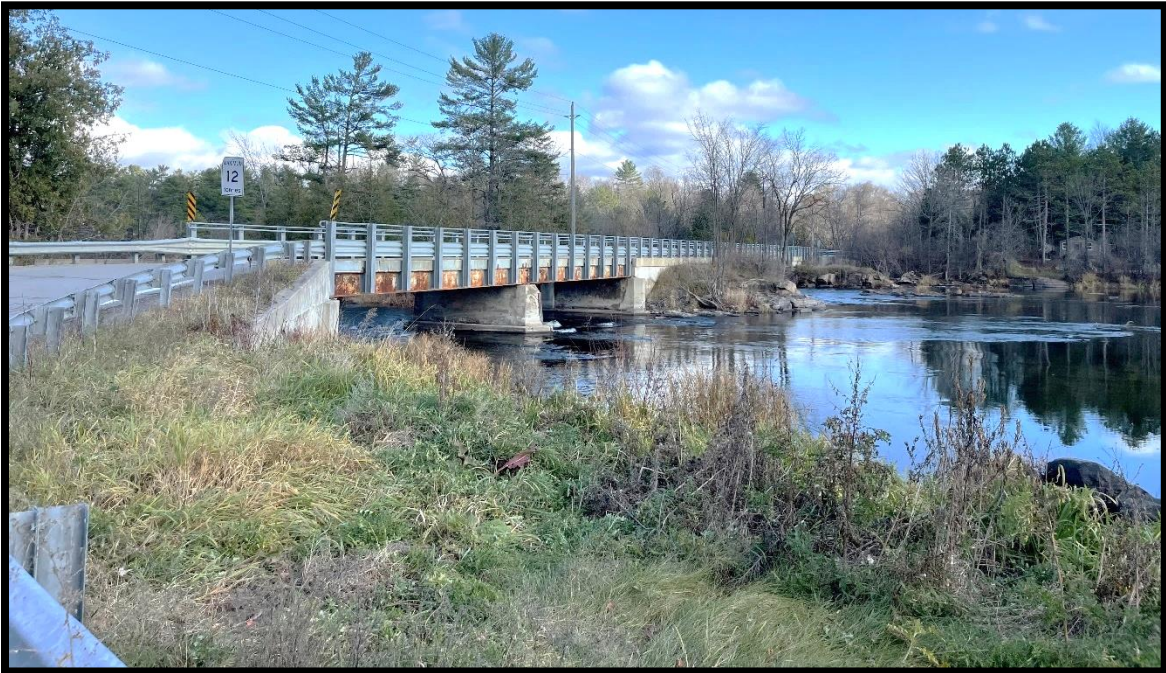
Figure 9: View of the upstream (south) side of the Blakeney Bridge looking from the west side. Source: Contentworks, November 2022.

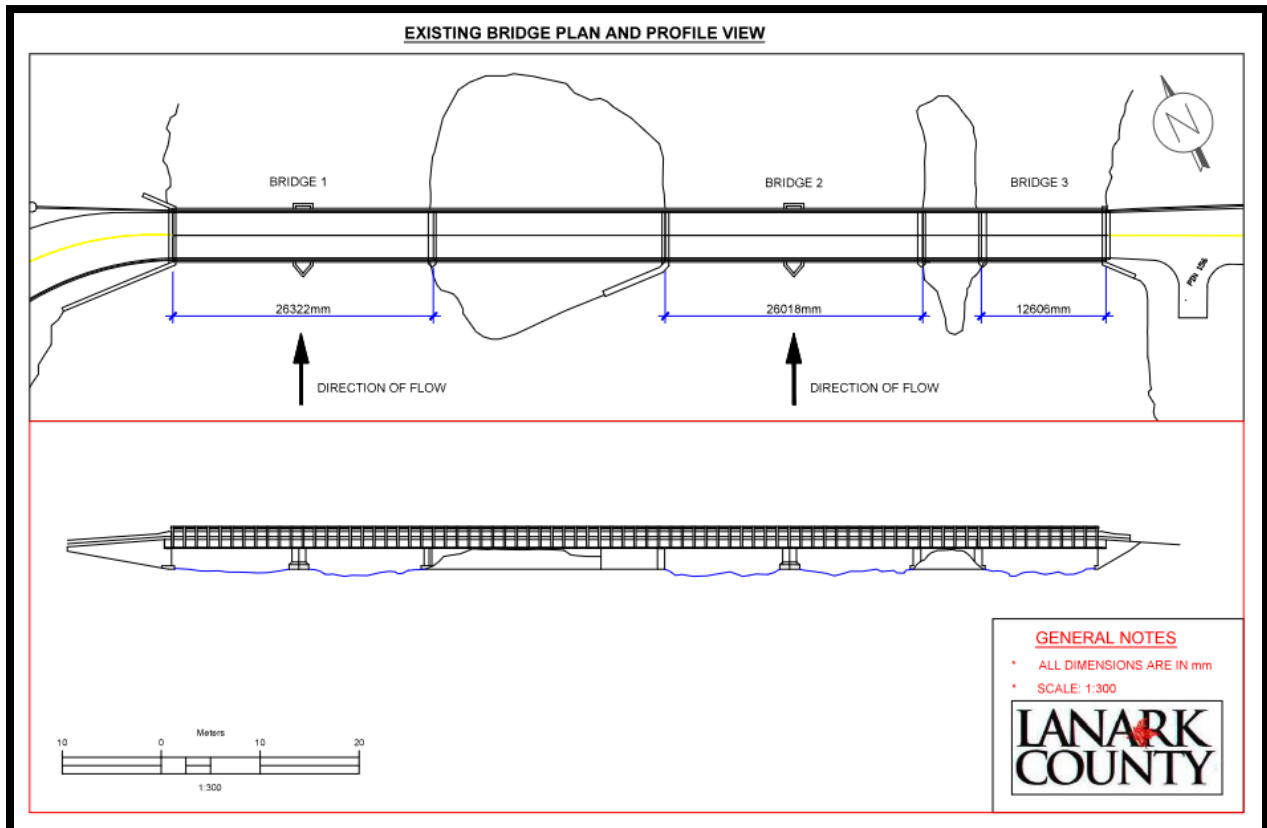
Figure 11: Current plan and profile views of the Blakeney Bridge. Source: Lanark County. 2022. Blakeney Bridge Replacement Options.

The extant crossing was constructed in 1915 and is on a straight alignment that consists of three separate structures spanning the Mississippi River via two islands using the same configuration as the original 1830s bridge (Figure 11 and Figure 12). One single span and two two-span bridges make up the crossing with a single-lane-wide deck. The east bridge has a single span of 13.1 m. The west bridge has two spans totalling 26.8 m. The middle bridge has two spans totalling 26.5 m. The superstructure is made up of twin steel girders with steel floor beams and stringers.

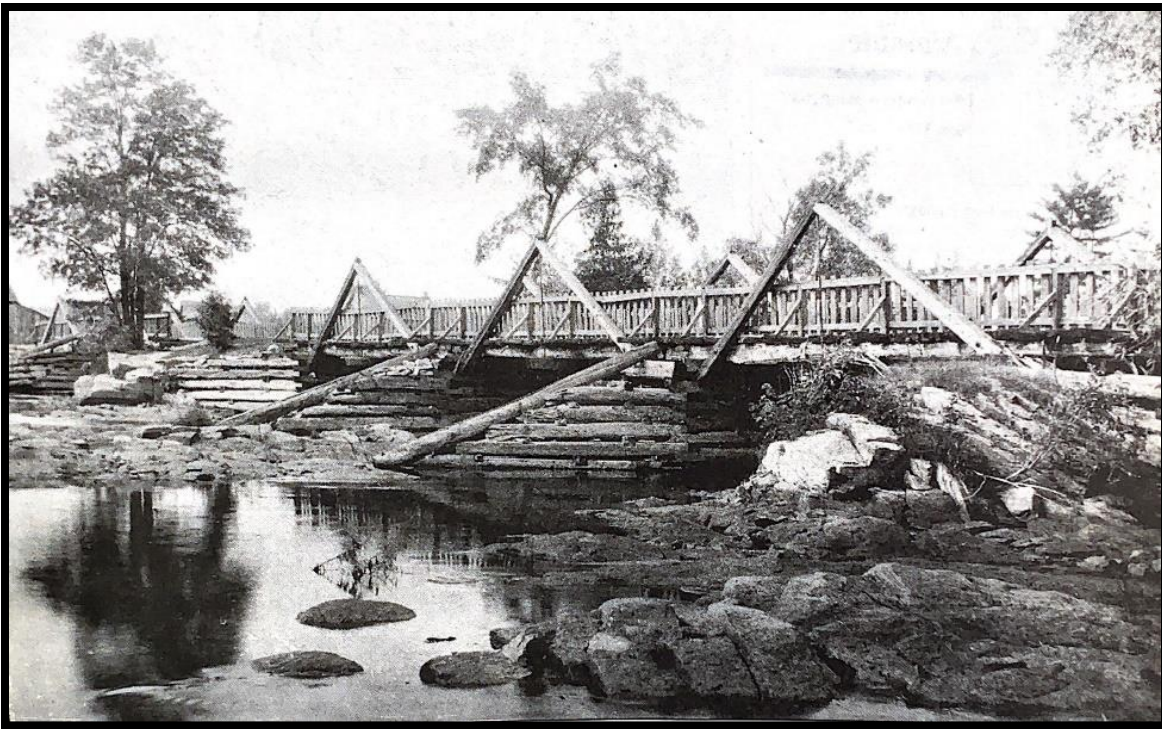
Figure 12: Timber bridge at Blakeney, [1910]. Source: "Pic of the Past," in Hilda Geddes, *The Canadian Mississippi River*, General Store Publishing House, p. 249. Courtesy of Archives Lanark.

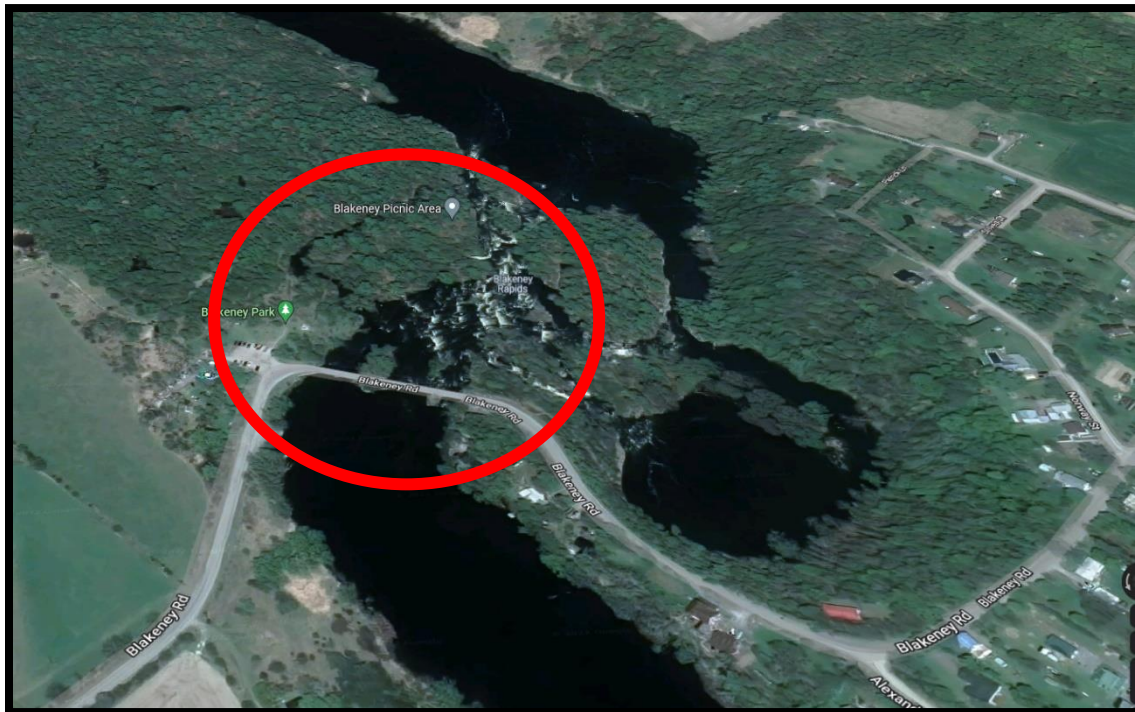
Figure 13: Blakeney Bridge Study Area. The study area extends approximately 150 m from the centre bridge towards the shore and islands to the north and about 100 m upstream to the south. Source: Google maps, 2022, annotation by Contentworks.

The study area is centred on Blakeney Bridge and extends about 150 m to the north from the bridge towards Blakeney Park and islands in the Mississippi River and 50 m to the south along the Mississippi River's west shore. The area covers the bridge and views to the bridge from public spaces (Figure 13).

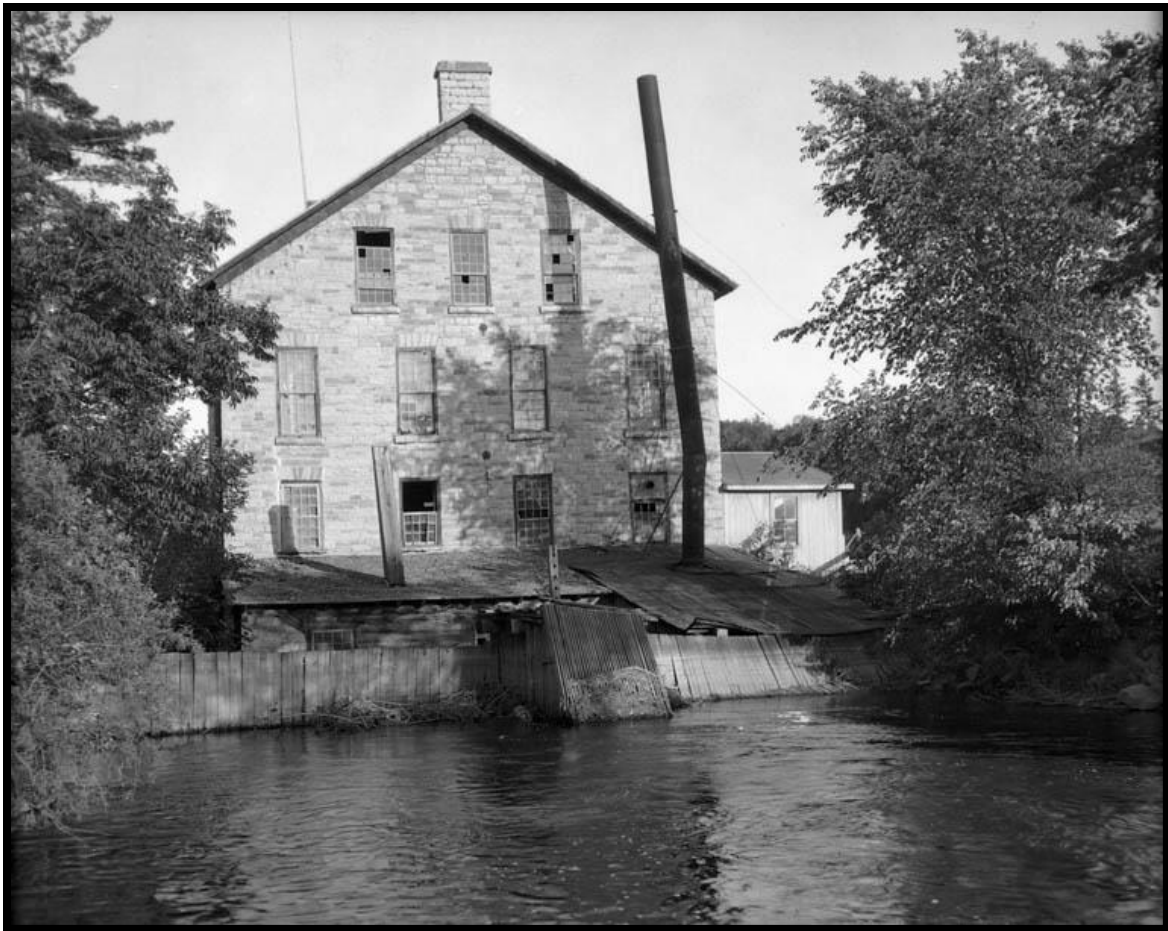
Figure 18: Former Blakeney Woolen Mill, on the pond above the bridge near town. Source: Library and Archives Canada, Colborne Powell Meredith, aO26959.

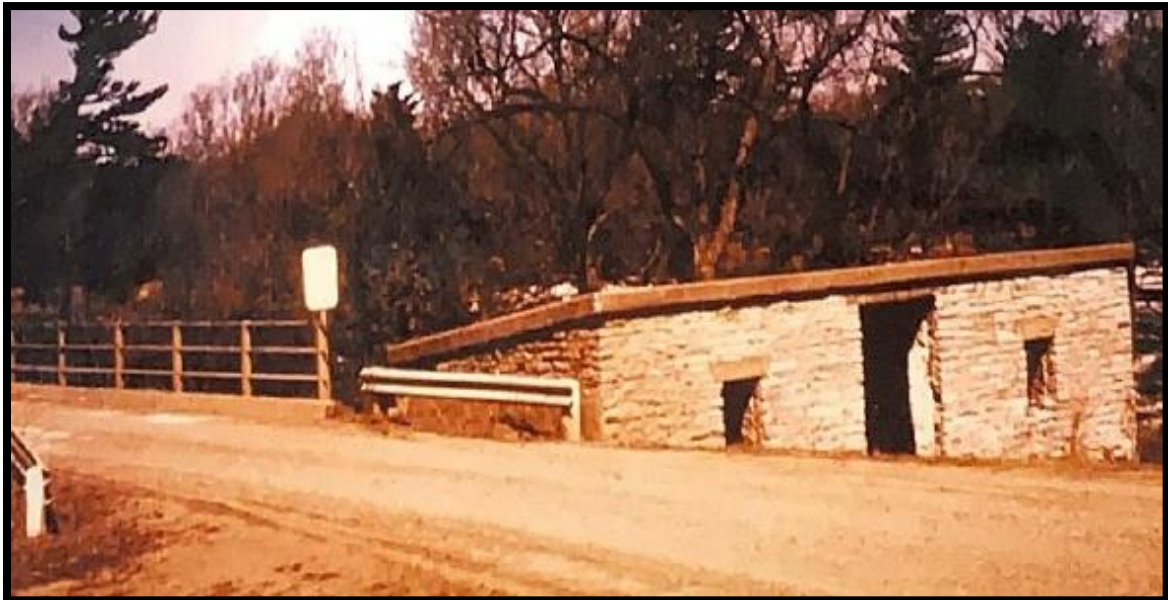
Figure 19: Storage shed from the woolen mill on the east end of the Blakeney Bridge on Blakeney Road. The shed was demolished in 1991. Source: Ramsay Women's Institute, *Tweedsmuir History Book 7*, accessed online at http://images.ourontario.ca/Partners/FWIO/FWIO003203526_0040p.pdf.

In the 19th century, Blakeney's position on the Mississippi River provided waterpower and commerce to support sawmills, a gristmill, an inn, a tannery, brewery, flour mill, cheese factory, woollen mill, blacksmith shop, general store, post office and Presbyterian church (Figure 16, Figure 17 and Figure 18). None of these buildings are extant. One of the last buildings, a storage shed for the woolen mill, was located very close to the east abutment of the bridge until the shed was demolished in 1991 (Figure 19).

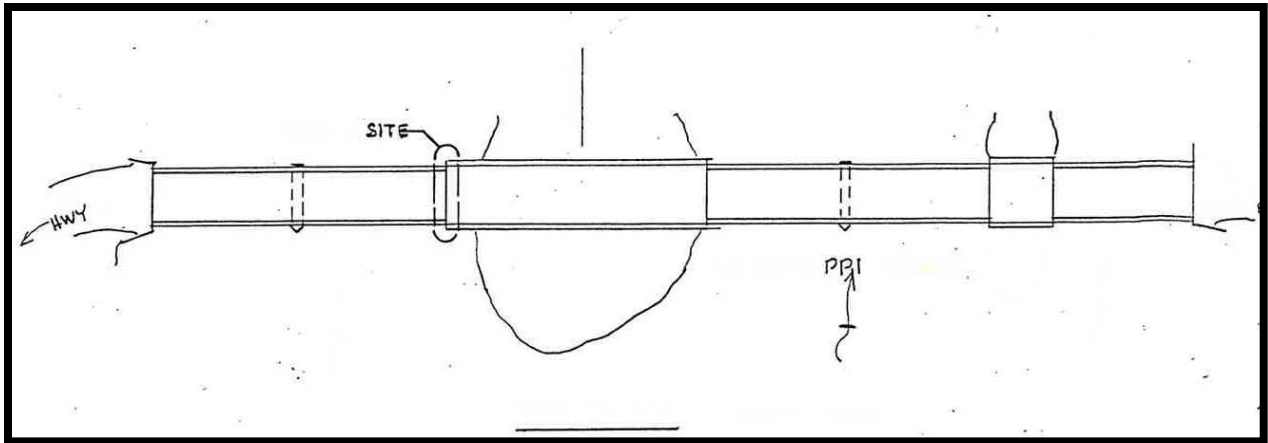
Figure 22: Drawing showing the location of the repair to the abutment on the island at the end of bridge 1 of the Blakeney Bridge. Source: County of Lanark/Moller Engineering Services Ltd., Blakeney Bridge, Con. IX, Lot 26, Ramsay Township, Repairs to Abutment, 13 September 1993.

- 1993 - remedial work in 1993 on a collapsing abutment (Figure 22 and Figure 23)
- 1995 - repairs to the south abutment on the north island by removing old abutment concrete and replacing abutments¹⁵
- 2000 - major refurbishment
- 2007 - emergency repairs

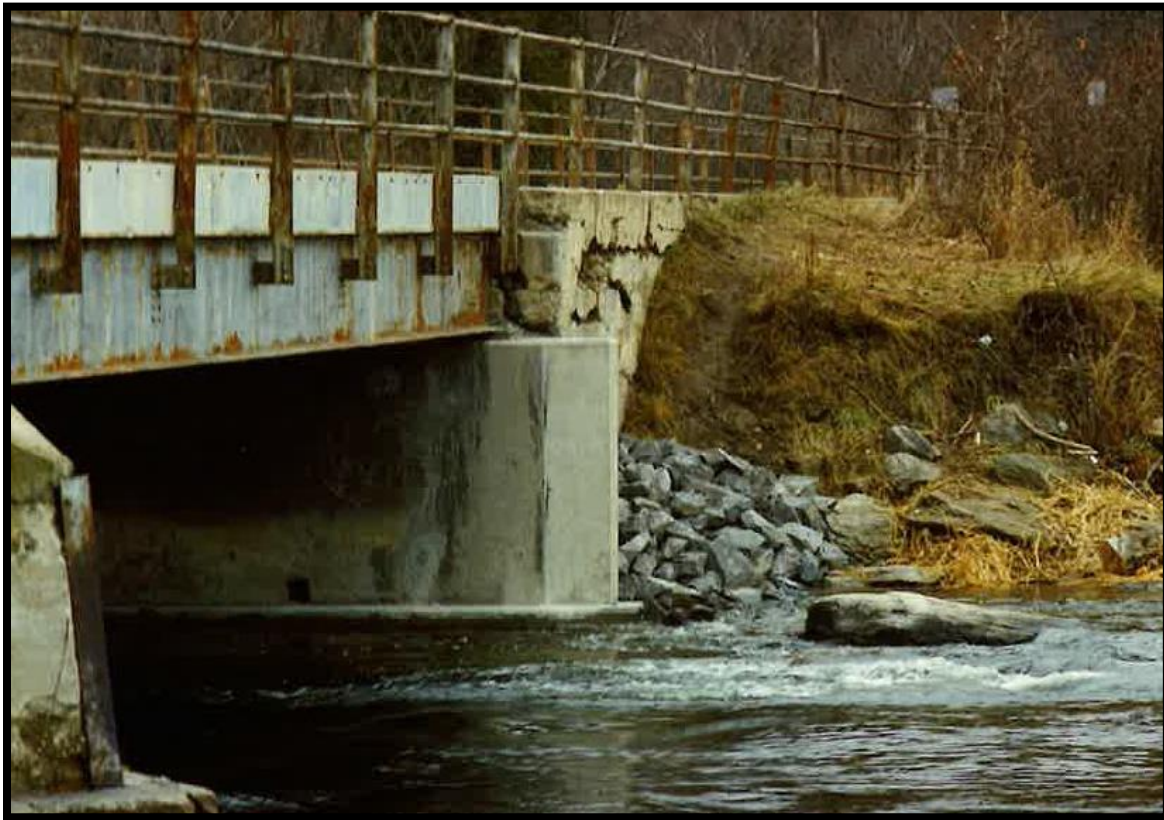
Figure 23: Photograph of the abutment requiring repair, 1993. The original railing, composed of riveted steel posts and steel piping is visible in this photograph. The railing system was replaced in 2000 with the current guardrails with handrails. Source: County of Lanark, Repair Photos 1992, Blakeney Bridge

Blakeney Bridge's abutments, piers and wing walls/retaining walls were constructed of concrete cast directly on bedrock.²⁰ The original railing of the 1915 bridge, composed of riveted steel posts and steel piping (Figure 23), was replaced in 2000 with the current system of guiderails and handrails (Figure 9). In 2000, major repairs were also made to the concrete work to stabilize sections by replacing and reinforcing sections of the piers, wing walls, retaining walls and abutments.
