**Replacement of Blakeney Bridge, on Blakeney Rd -
approx. 6km downstream of Almonte, County of Lanark**

**Species at Risk Impact Assessment and
Mitigation Plan**

Prepared for County of Lanark

**Stringer's
Environmental
Services**

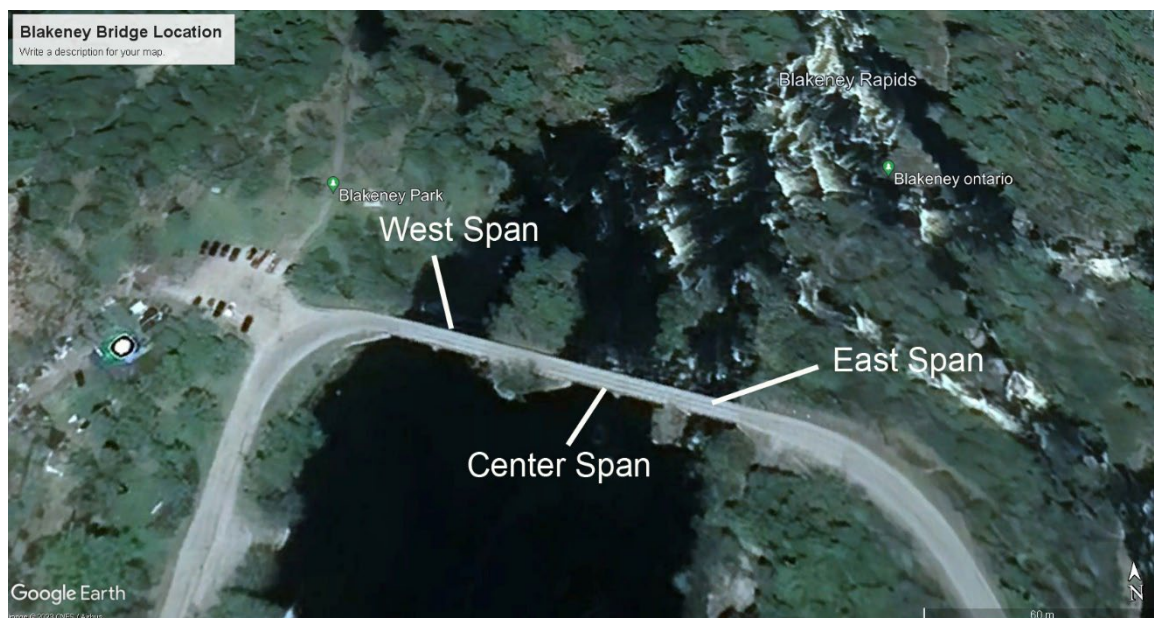
Figure 1: Blakeney Bridge

Lanark County is planning to replace the Blakeney Bridge over the Mississippi River located approx. 6.2 km downstream from Almonte (UTM: 18T 401926 5013436). The existing bridge is a 3 span single lane structure consisting of steel girders resting on concrete abutments at the ends of each span. It is located at a point in the river immediately upstream of Blakeney Rapids where two small bedrock islands divide the river's flow into 3 channels (Figure 1). The running surface is concrete placed over sheet steel supported by the girders and abutments. It has the appearance of a straight, single span bordered by steel beam guiderails when viewed from above.

The westernmost span is the longest of the three (approx. 26.32m) and has a single concrete pier centrally located in the span. The west abutment is on the west bank of the river and the east abutment is on a rocky island located part way across the river. The pier is located near mid channel and rests on footings placed on the bedrock. The rocky island is approx. 20m in width with concrete abutments and wingwalls placed on each side of the island.

The central span is slightly shorter (26.02m) and bridges the central channel of the river. It also has a center pier similar to the west span. The west end of this span rests on the east abutment on the westernmost island and its east end rests on a concrete abutment on the eastern, smaller (approx. 7m wide) island. This abutment and the one supporting the west end of the east span are an integral concrete unit.

The east span is the shortest (12.61m) and has no central pier. Its east end rests on an abutment and wingwalls on the east bank.

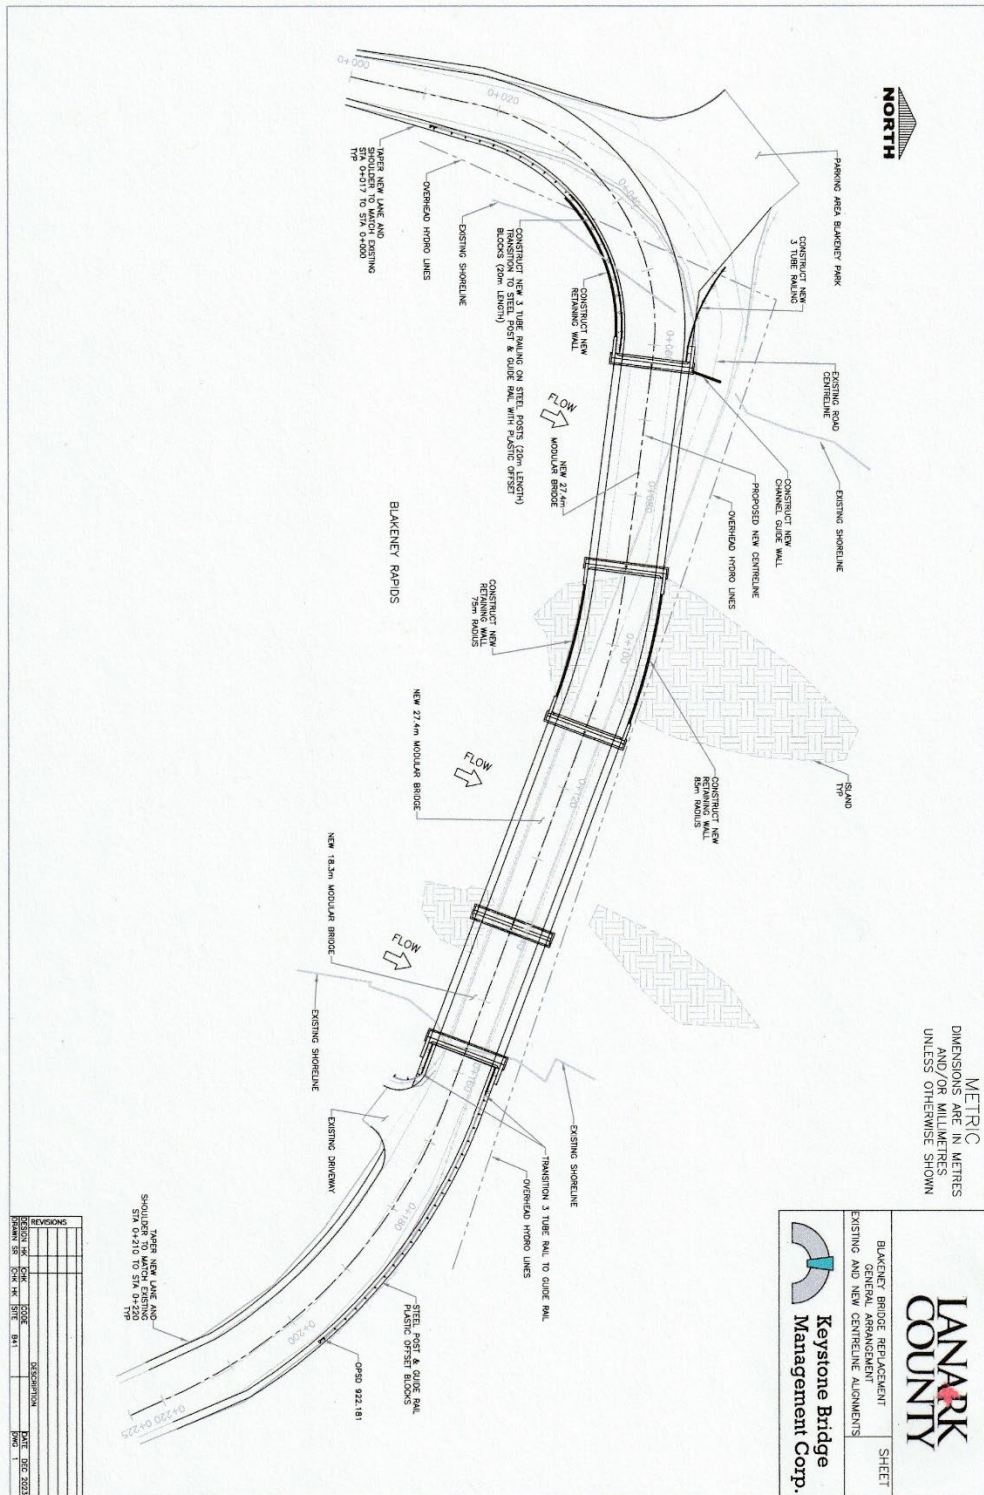
Appendix A – General Arrangement – New Bridge

The new structure has been designed to be a 3 span, 2 lane bridge but the spans will be modular in structure and will not require center piers for the two longer spans (Appendix 1). The alignment will be adjusted to incorporate a slight curve over the larger island necessitating slight changes to the positioning of the abutments. There will also be a significant reduction in the angle of the curve at the west end of the bridge. This will require significant adjustments to the wingwalls and abutment at this location resulting in encroachment on the watercourse and a reduction in the area of naturalized riverbank between the roadway and the river.

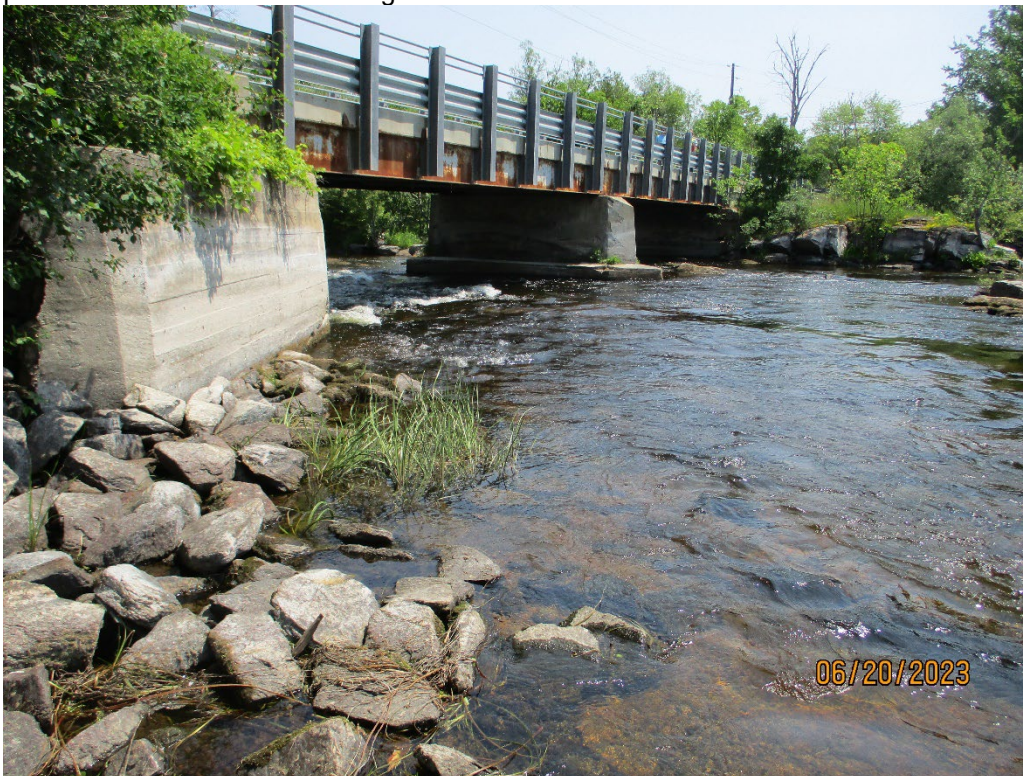
Photo 2 - Looking easterly at the southerly side of the bridge. The west span is visible showing the pier and the abutment on the larger of the two Islands.

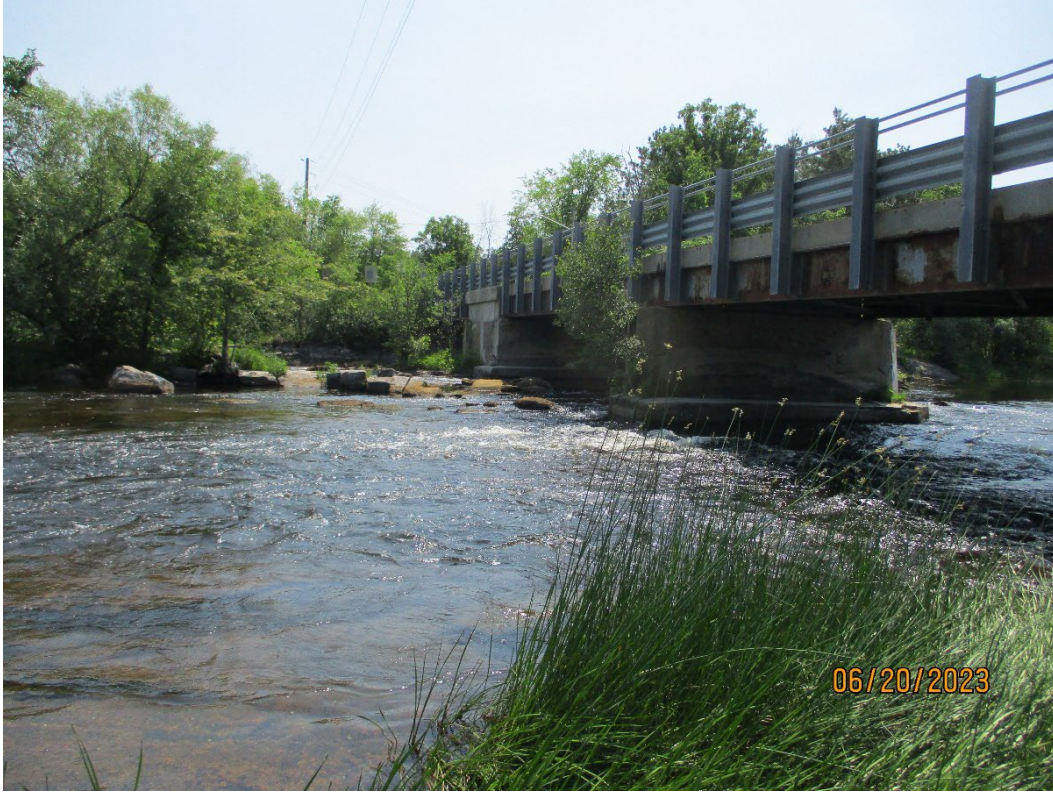
Photo 3 – Looking easterly at the northerly side of the center span showing the central pier and the concrete abutment on the small island.

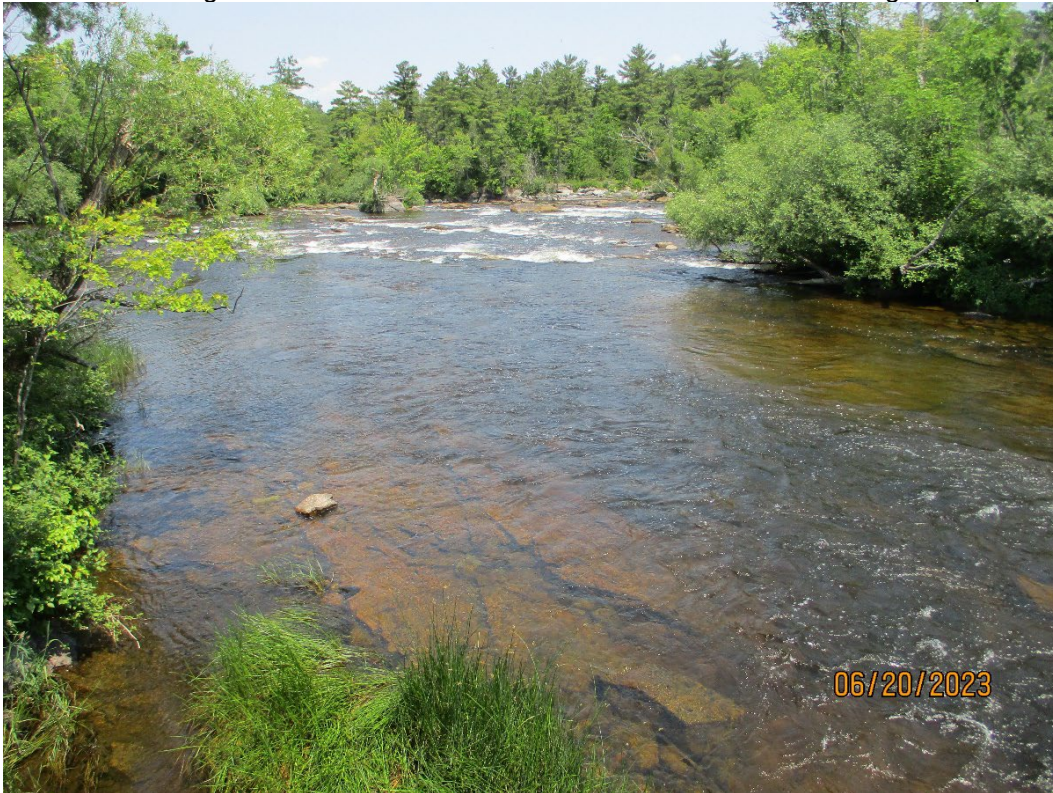
Photo 5 – Looking downstream from the deck at the central channel showing the top of the rapids.

The bridge is located at the upstream end of Blakeney Rapids where the Mississippi River jogs northeasterly for 300 meters and descends approx. 15m in numerous channels over a series of limestone bedrock ledges. The rapids have a rich history of use by early settlers for waterpower with numerous mills having operated in the area up to the early 1900's. Little evidence of that era remains and the banks along the rapids have largely re-naturalized. Almonte Fish and Game Club has developed a network of trails and small bridges that provide public access to much of the area along the west bank downstream of the bridge. The community of Blakeney is located on the east side of the river.

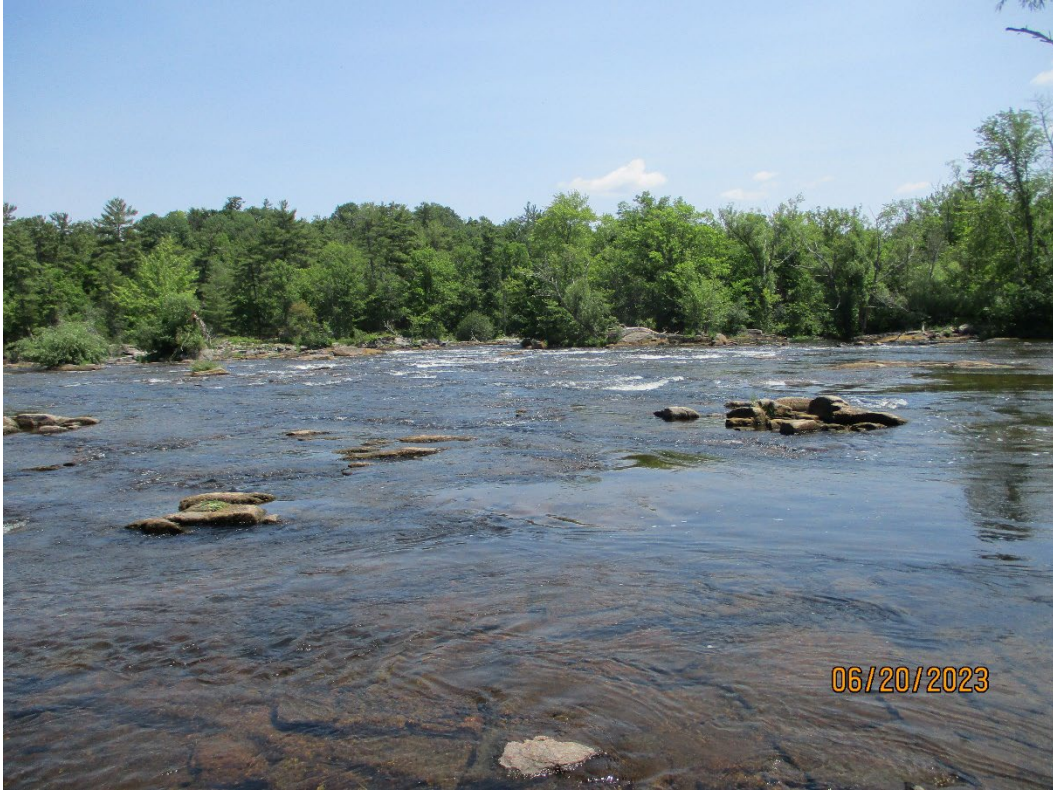
Photo 7 Looking at the top of the main rapids from the westerly bank 50m downstream of the bridge

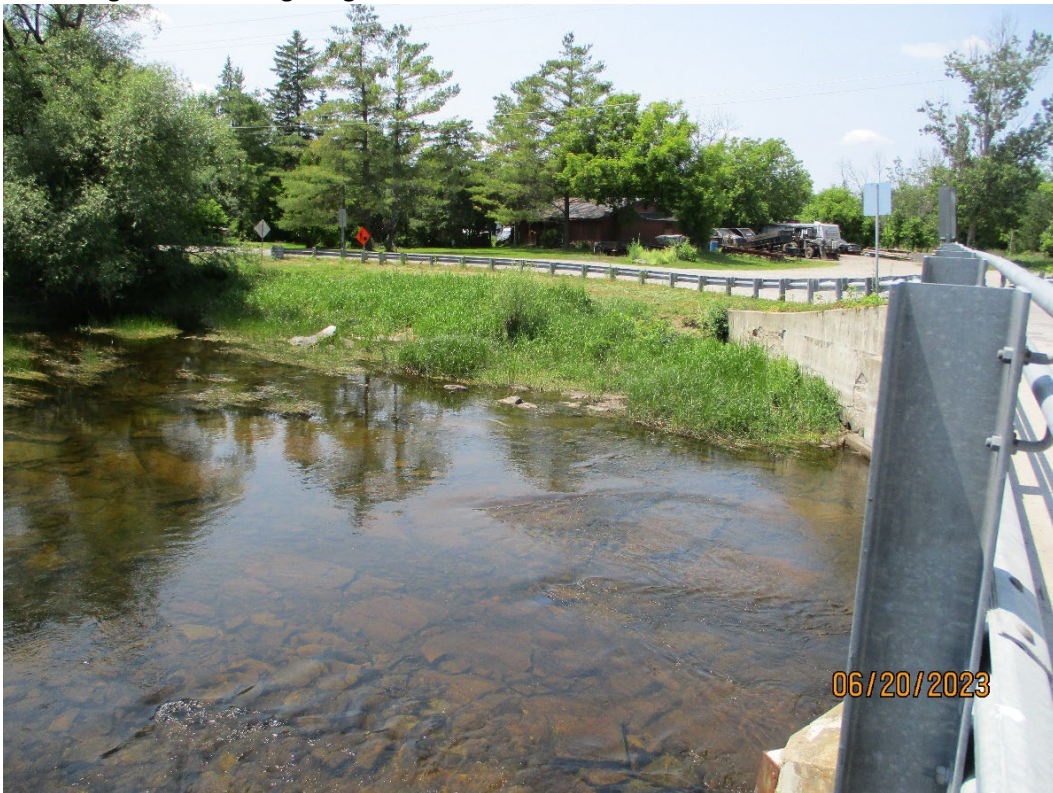
Photo 8 – Looking westerly at the SW corner of the current bridge. It is in this area that most of the changes to the bridge alignment will occur.
