Geotechnical
Investigation Report
March 21, 2023

**Geotechnical Investigation and
Preliminary Soil Quality Screening
New Bridge Crossing Design
Blakeney Road, 0.5 Kilometers West
of the Town of Blakeney**

GEMTEC Project: 100156.017

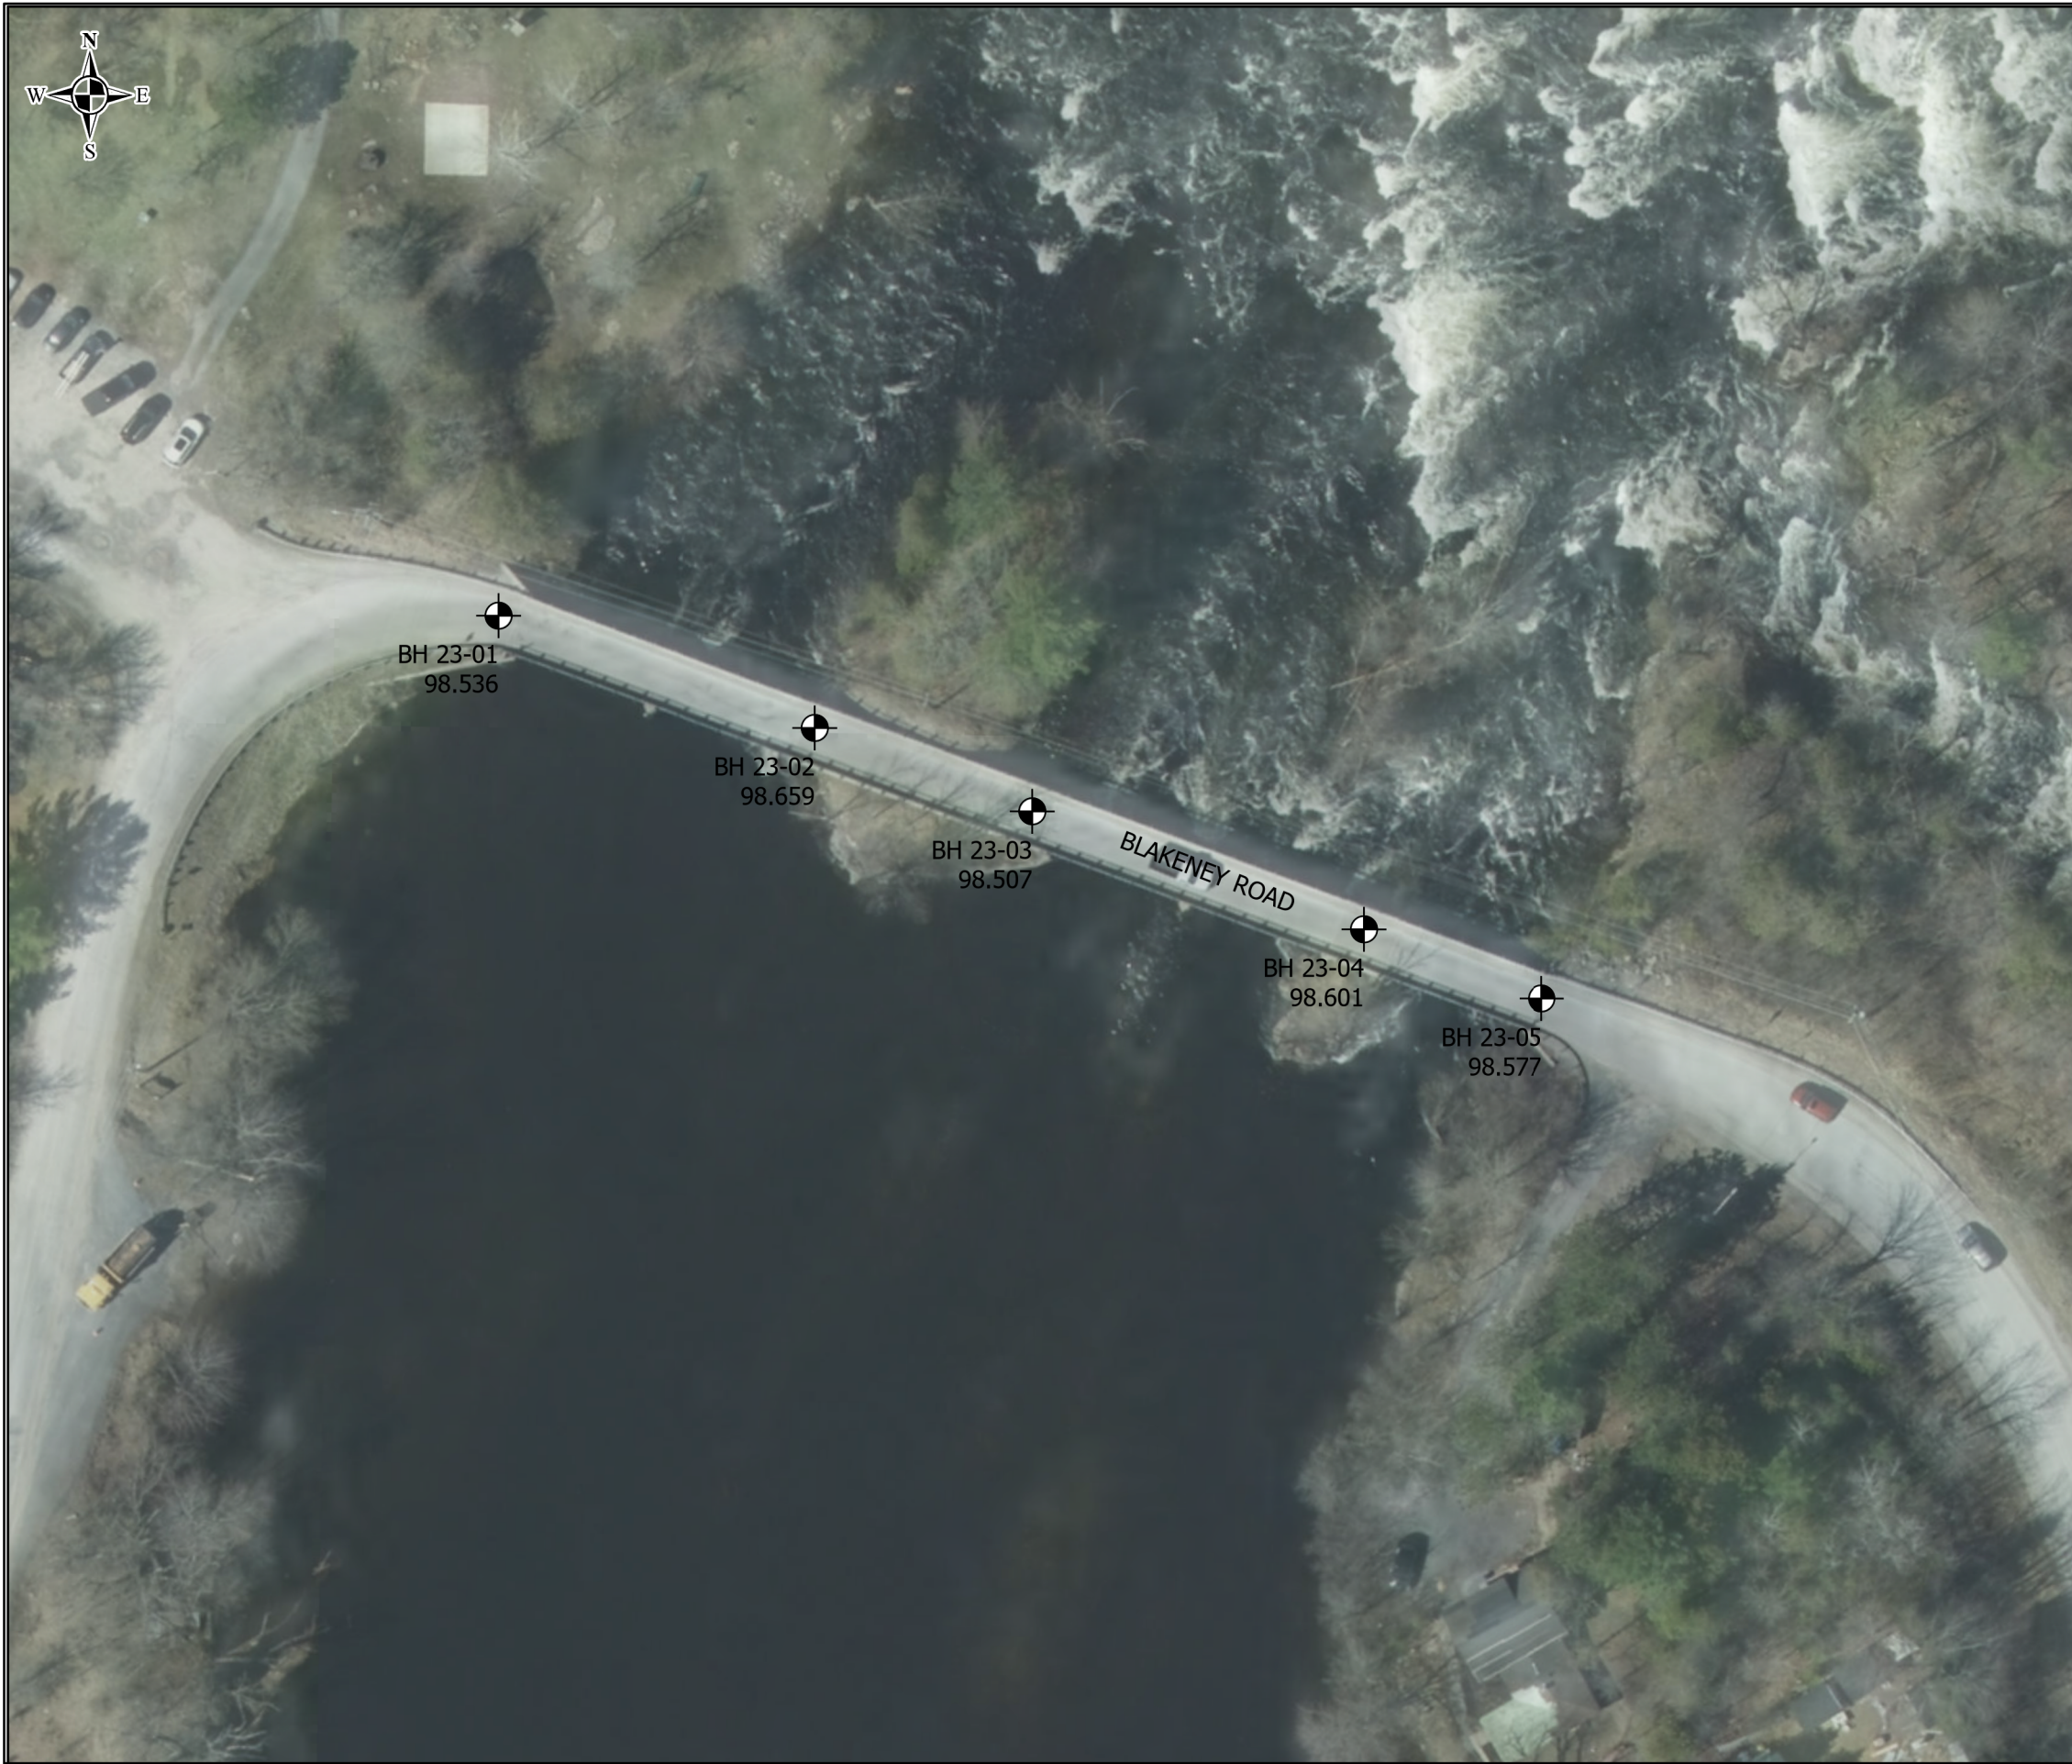
Site Plan

The geotechnical field investigation included five (5) boreholes, numbered 23-01 to 23-05 inclusive, at the locations shown on the borehole location plan (see Figure 1 in Appendix A). A complete description of the stratigraphy encountered at each borehole location is presented on the Record of Borehole sheets in Appendix B.
