BLAKENEY BRIDGE REPORT #PW-26-2022

Public Works Committee
October 26, 2022

BLAKENEY BRIDGE ENHANCED INSPECTION REPORT

Lanark County – October 2022

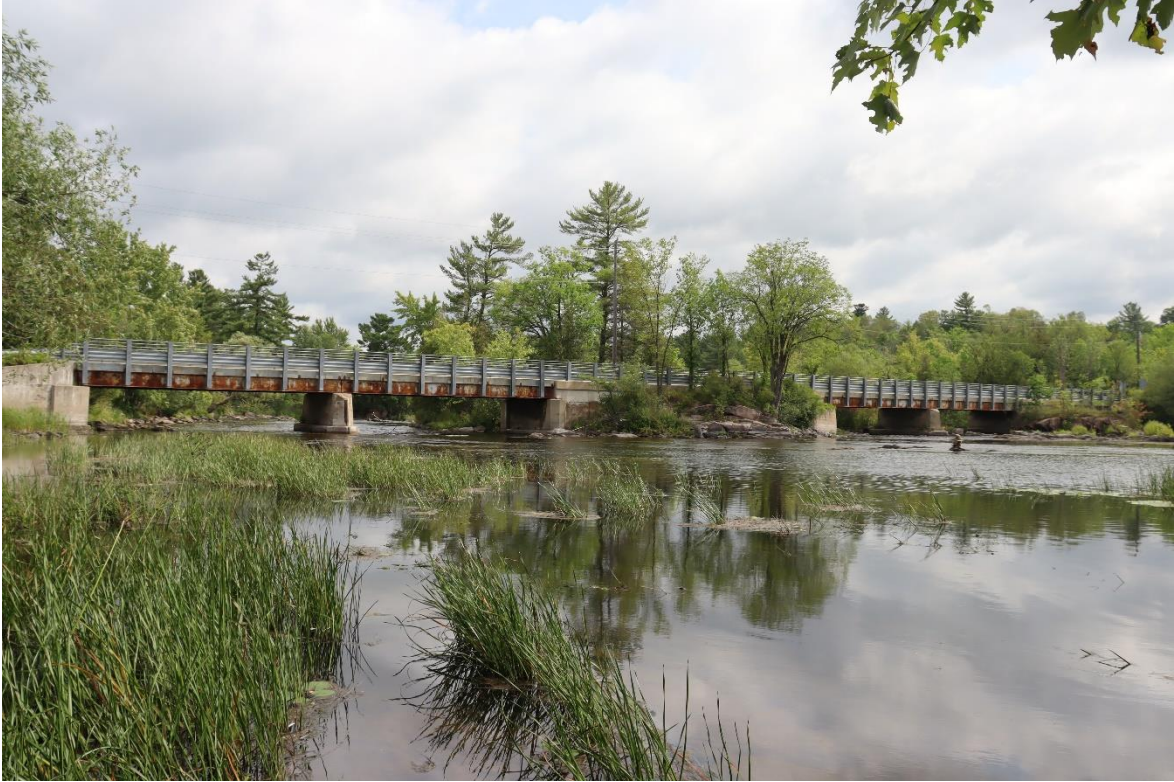
Image 1 Upstream view of Blakeney Bridge

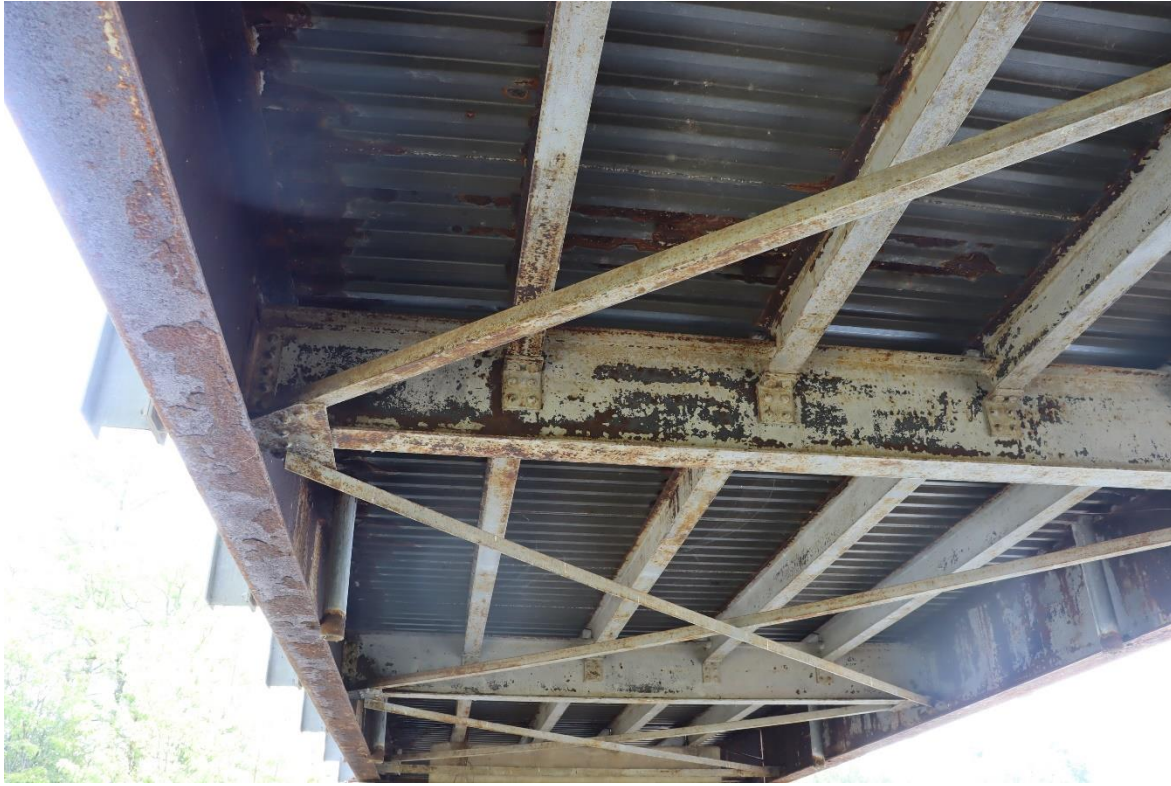
Image 7 Typical steel floor system with exterior main girders, transverse floor beams, and longitudinal internal stringers

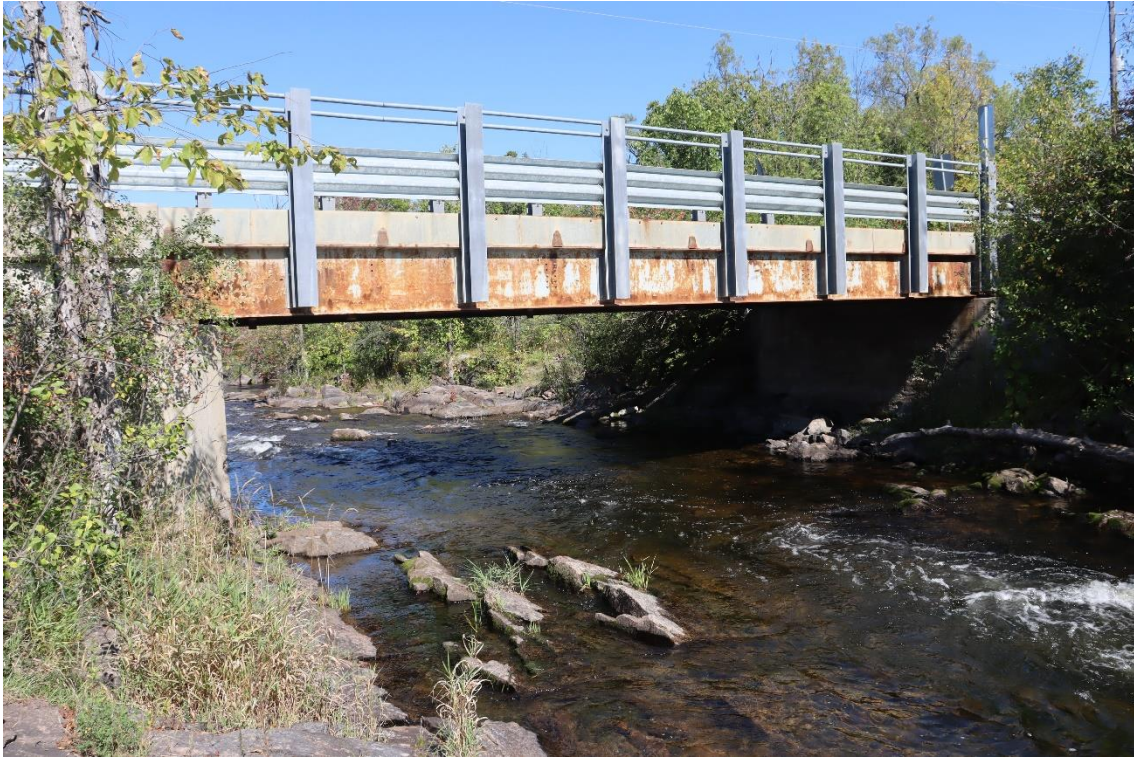
Image 1. South elevation of east bridge

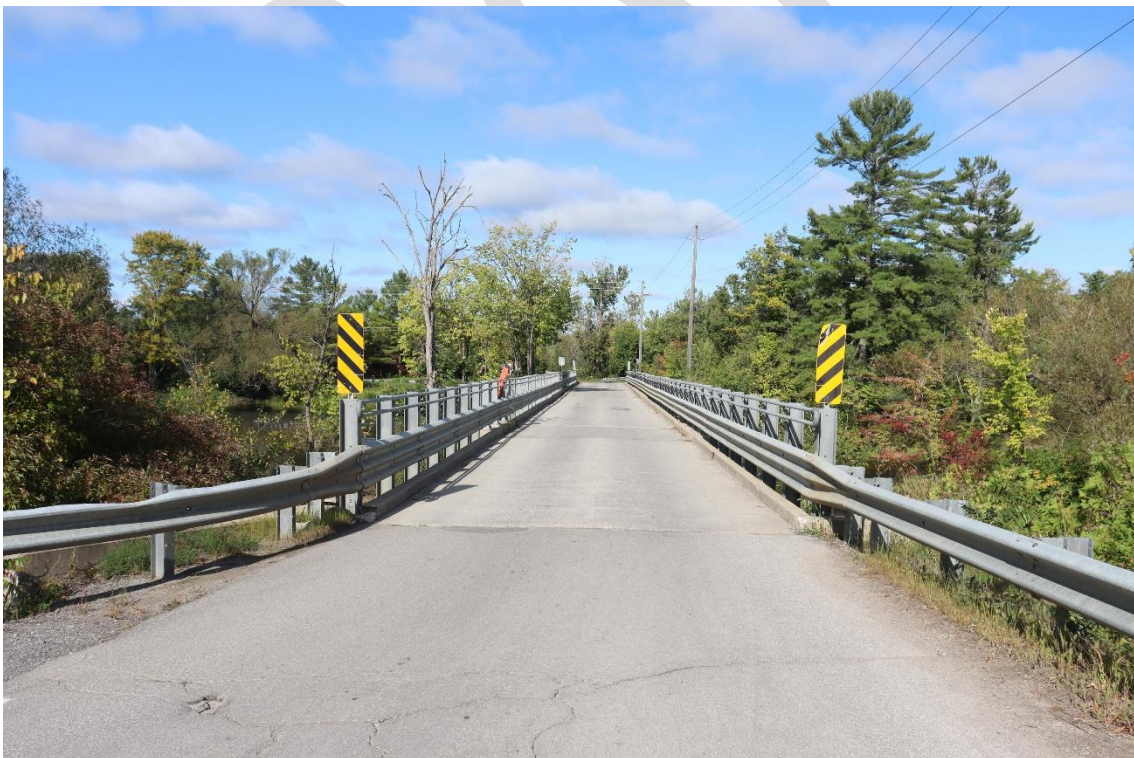
Image 2. East approach of east bridge

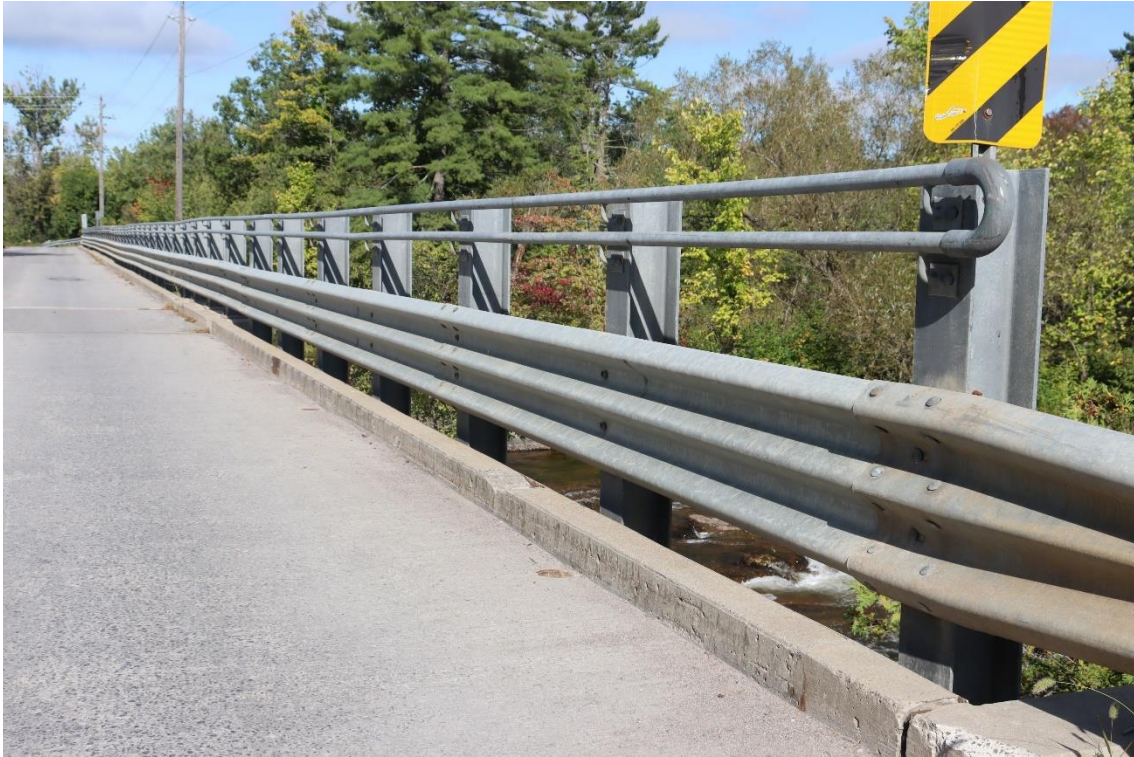
Image 3. Typ. railing system on east bridge

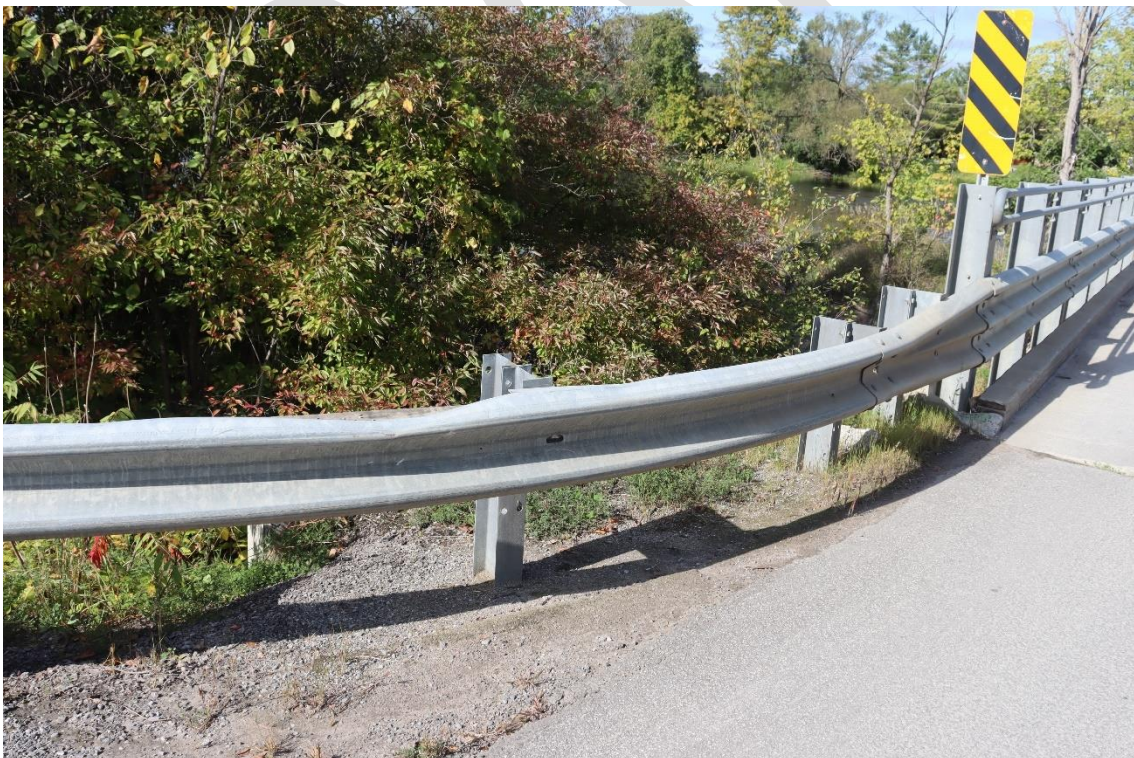
Image 4. South guide rail on east bridge

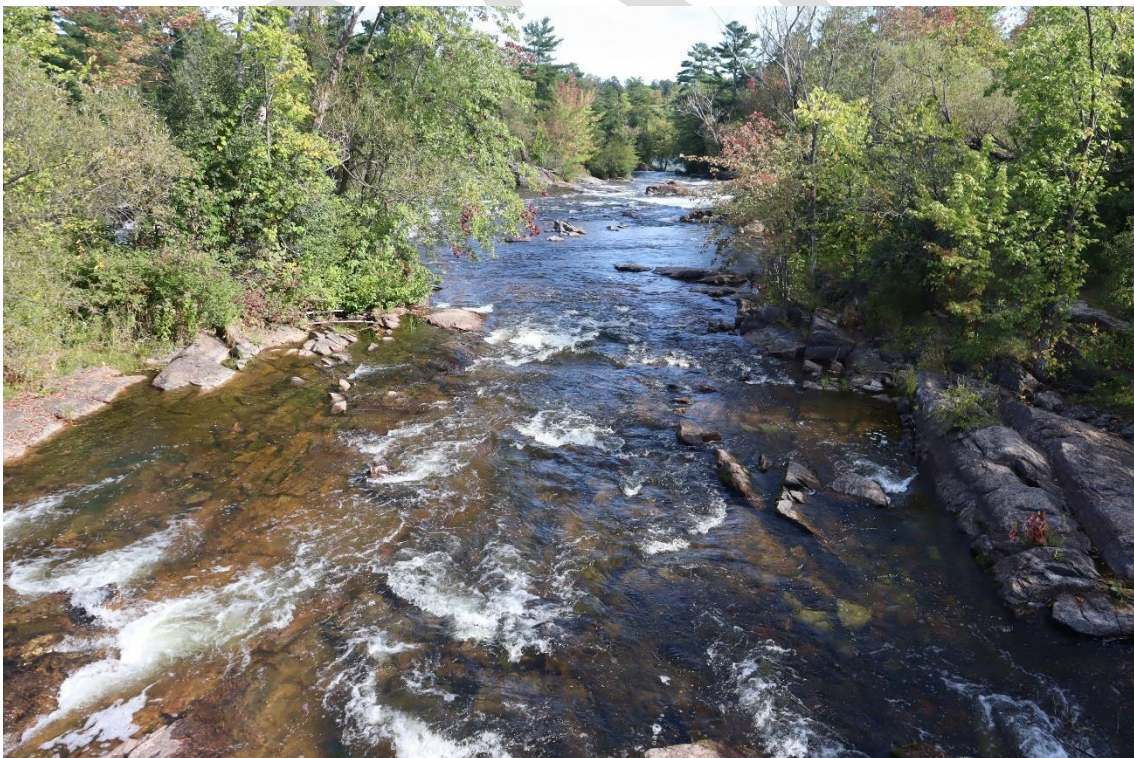
Image 6. South downstream channel of east bridge

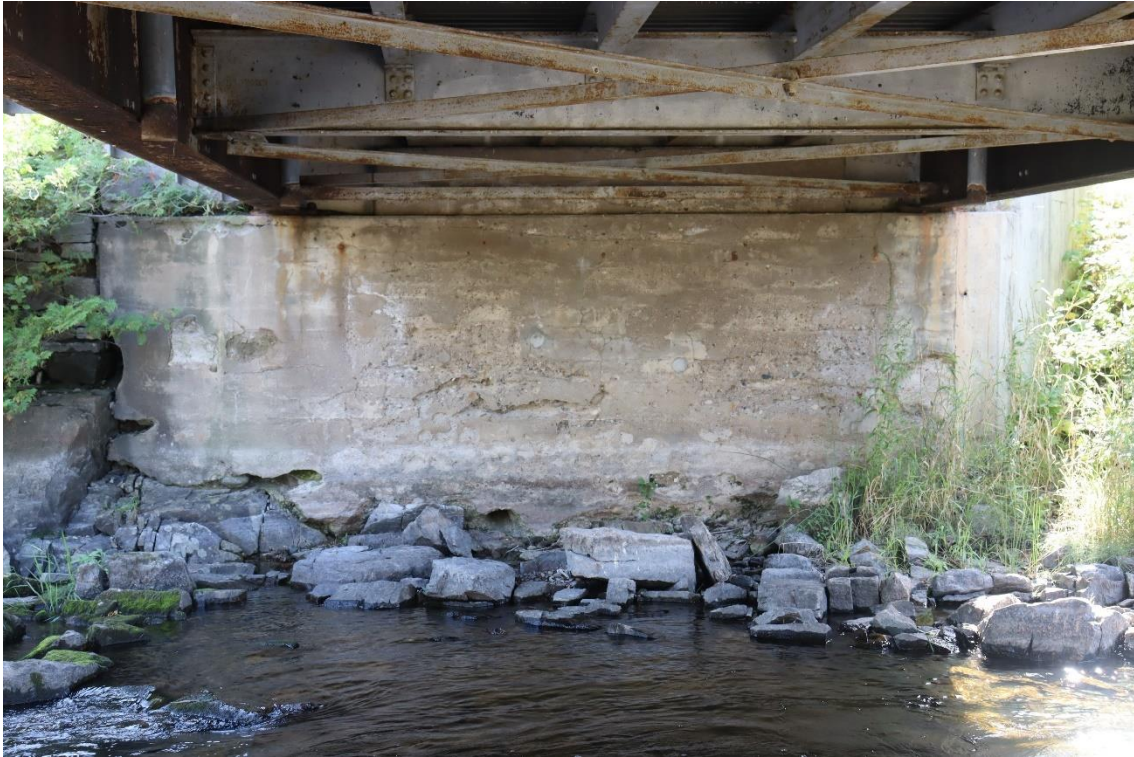
Image 7. East abutment of east bridge

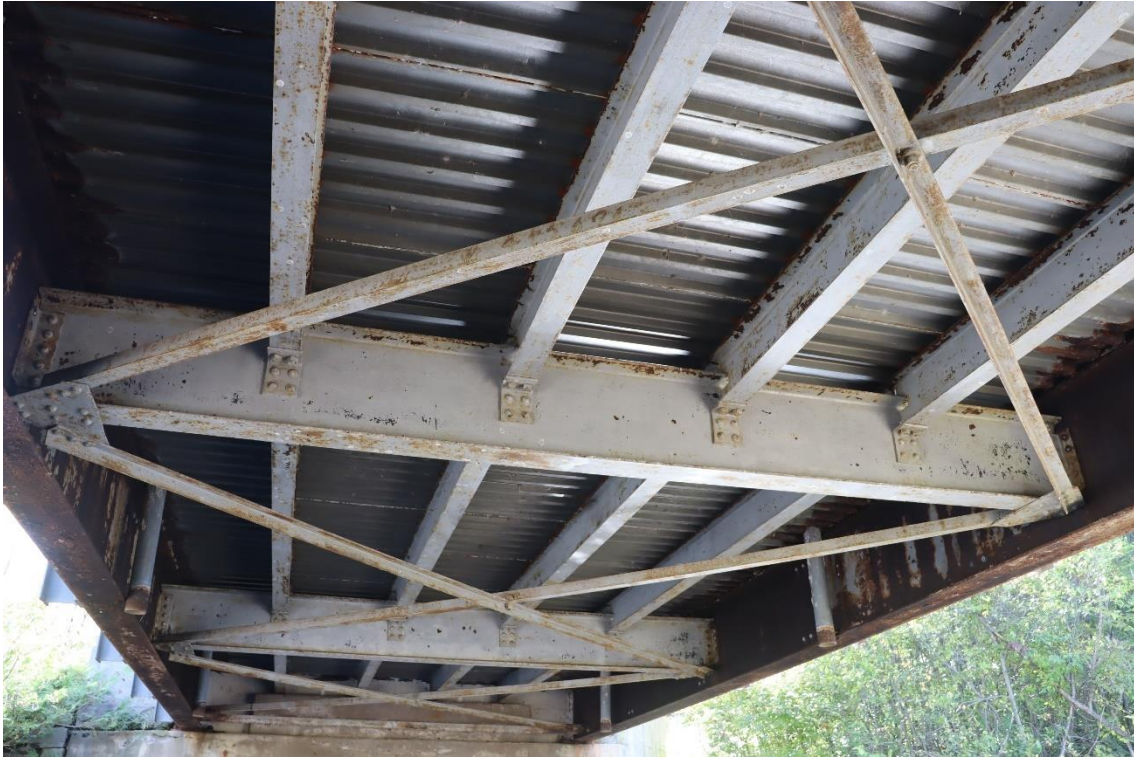
The structural steel framing consists of two exterior 660 mm deep longitudinal girders interconnected by two-460 mm deep transverse floor beams per span. Four lines of 250 mm deep longitudinal stringers spaced at 905 mm directly support the bridge deck between the main girders. Image 9 is representative.

Image 9. Structural steel & soffit of east bridge facing east

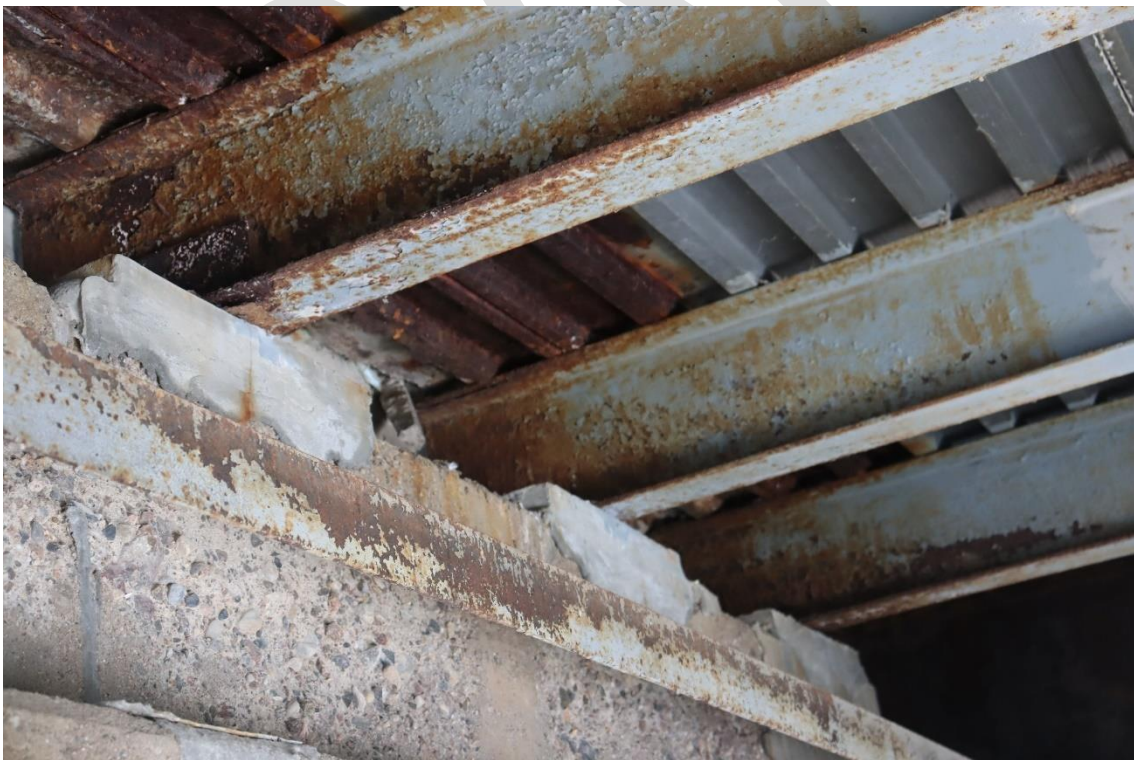
Image 3. Typ. condition of stringer east end of east bridge

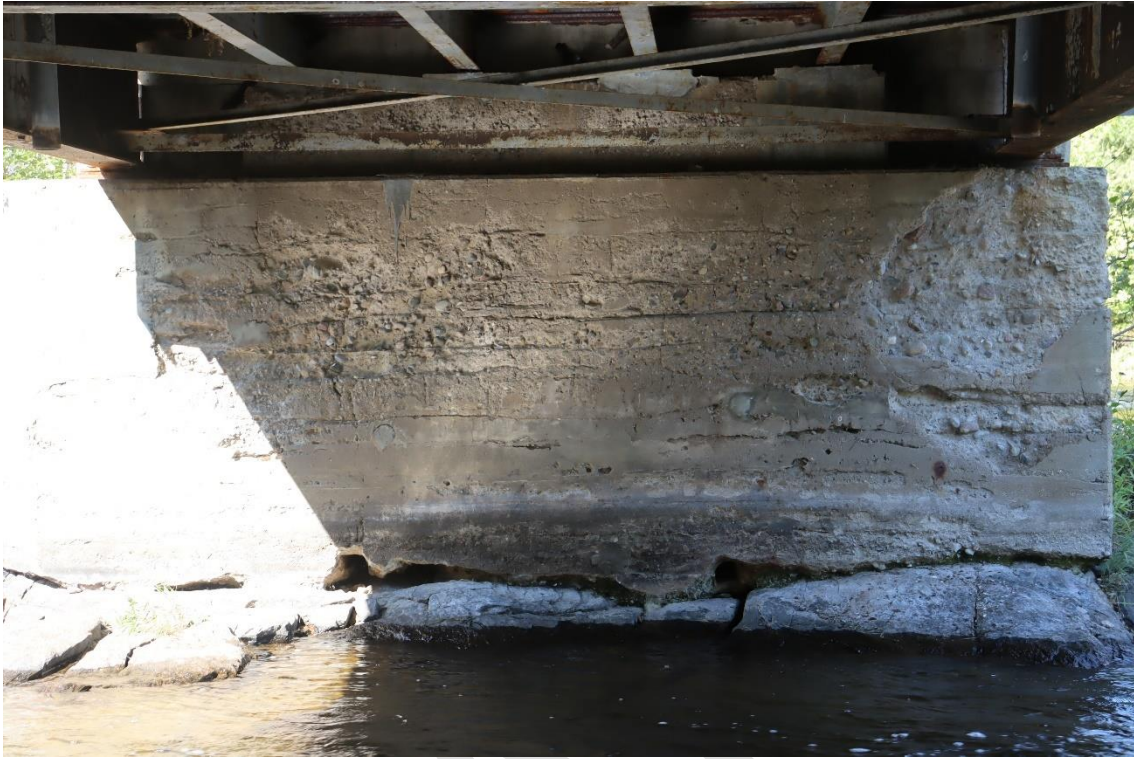
to a depth of 1200 mm in two locations. See Images 13 & 14. The concrete is slowly disintegrating and possibly eroding from hydraulic scour forces. Repair concrete placed in 2000 has debonded and failed in some areas but is largely still in place on the west and middle bridges.

Image 13. West abutment of east bridge

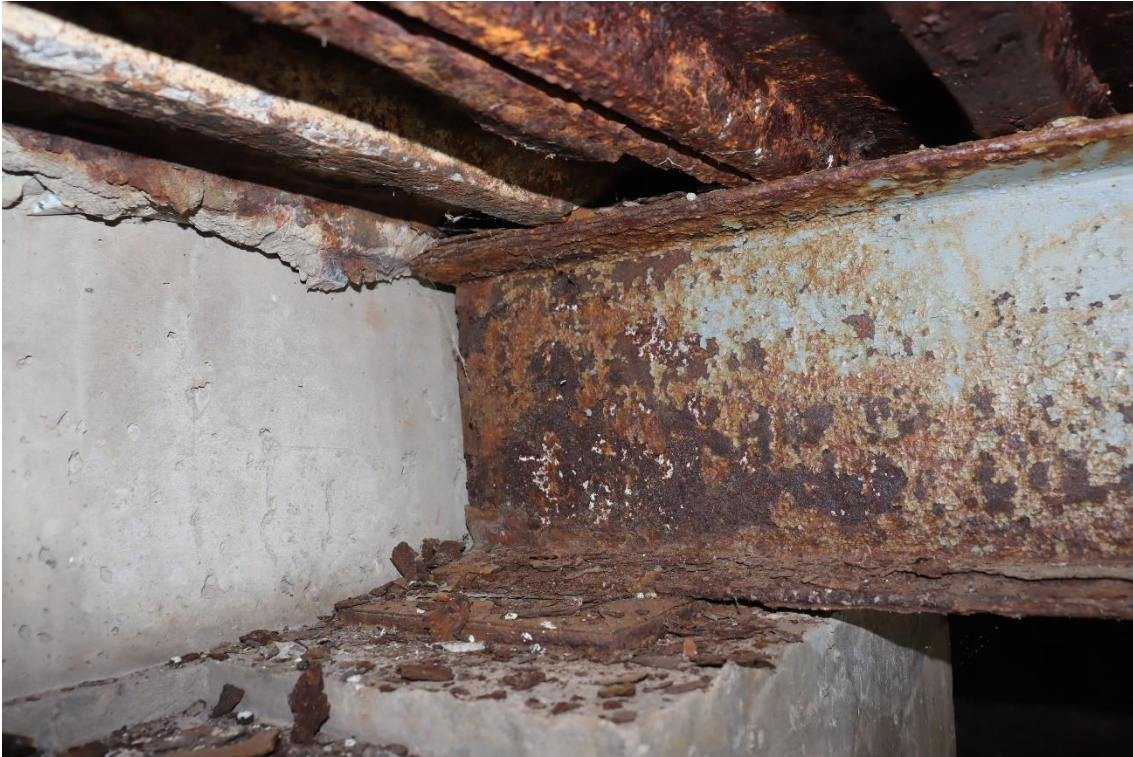
Image 4. Typ. condition of stringer west end of east bridge

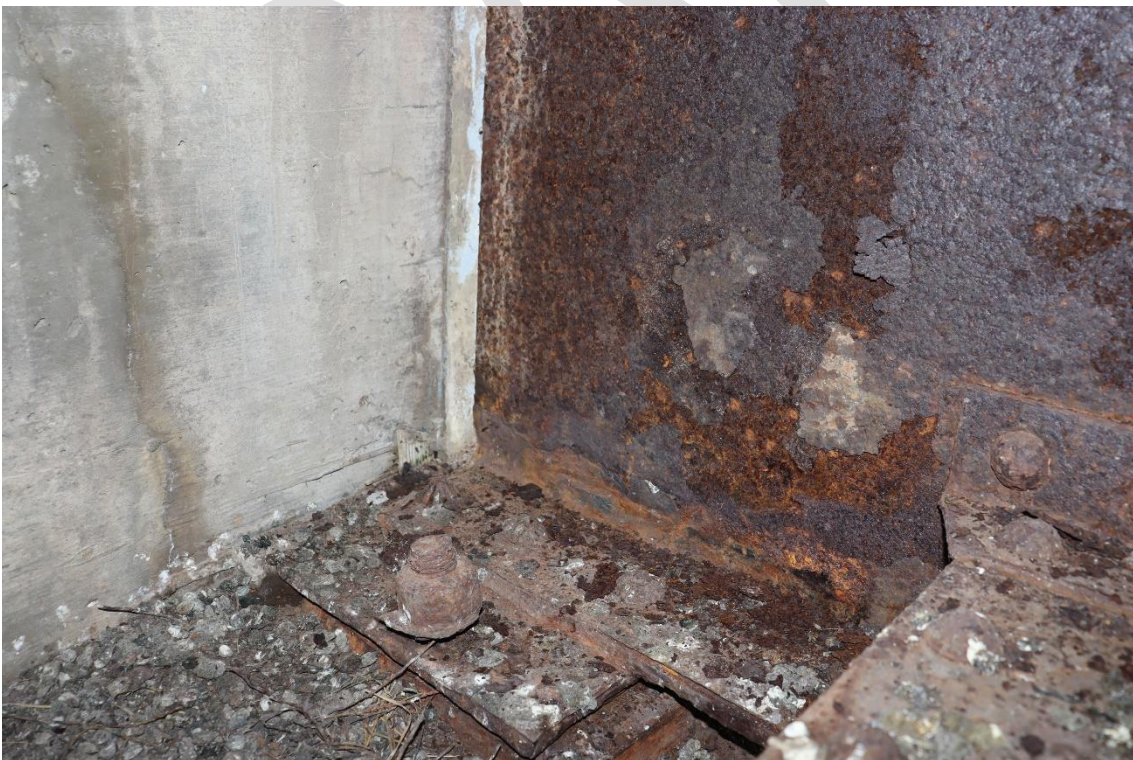
Image 16. Typ. abutment bearing of girders of east bridge

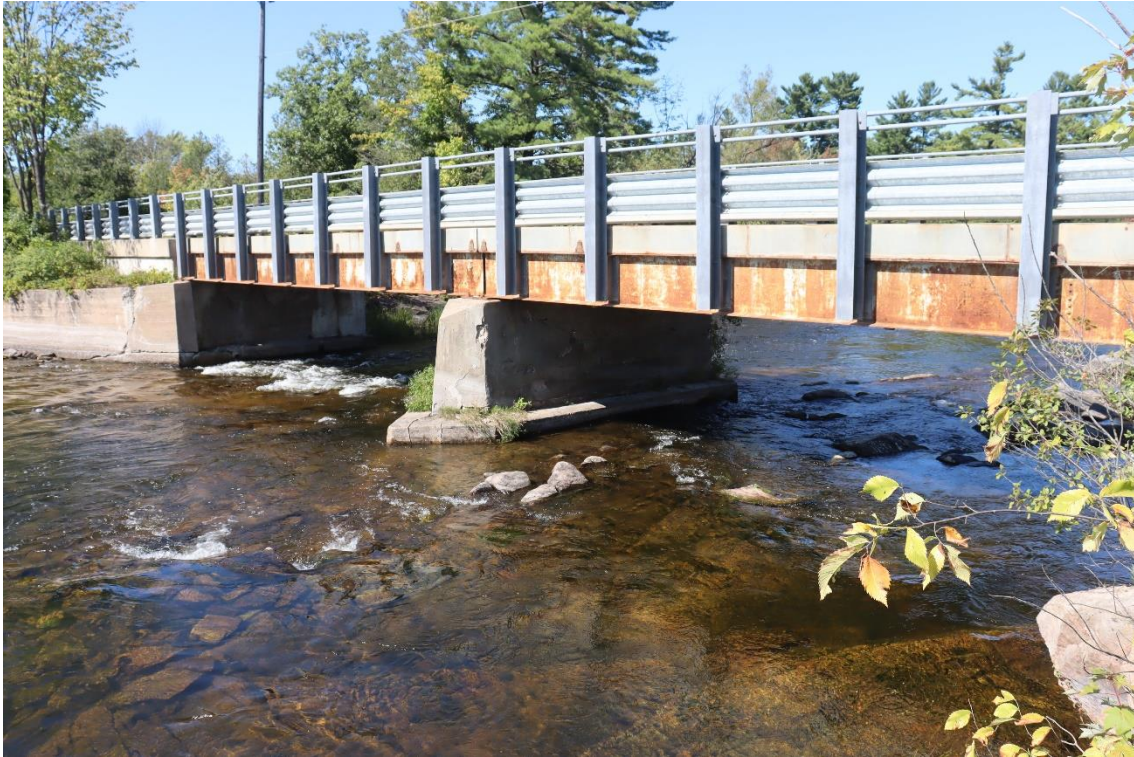
Image 17. South elevation of middle bridge

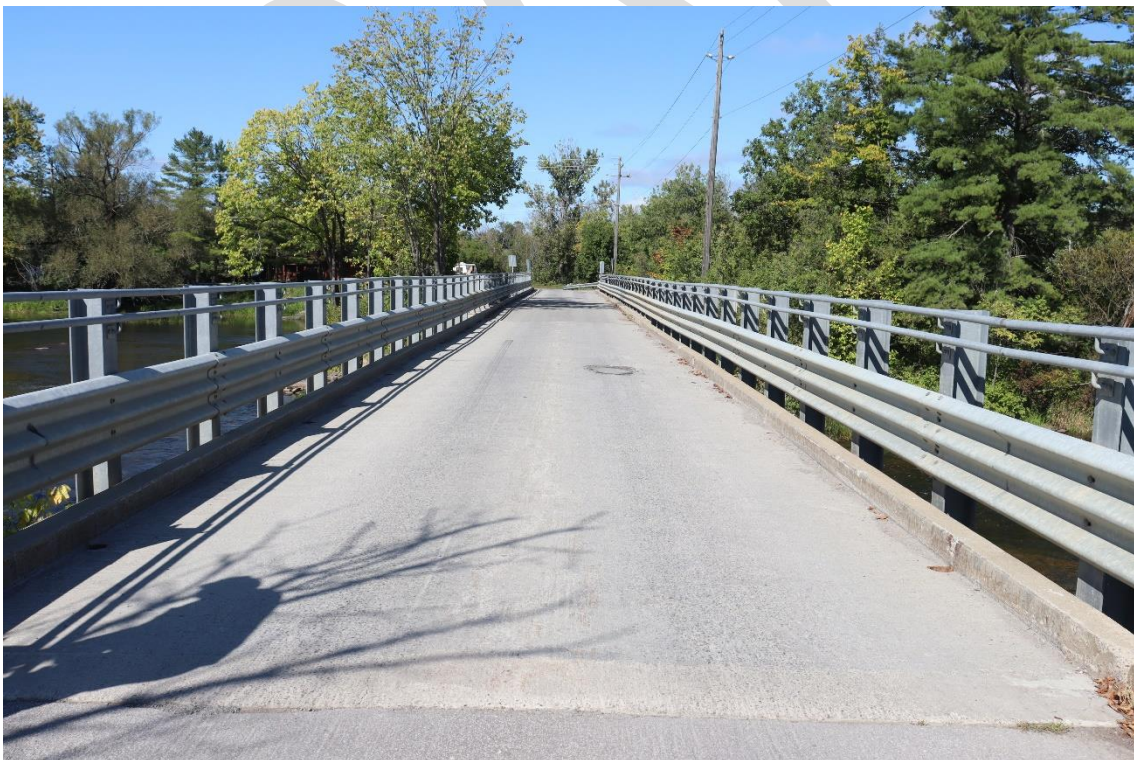
Image 18. East approach of middle bridge

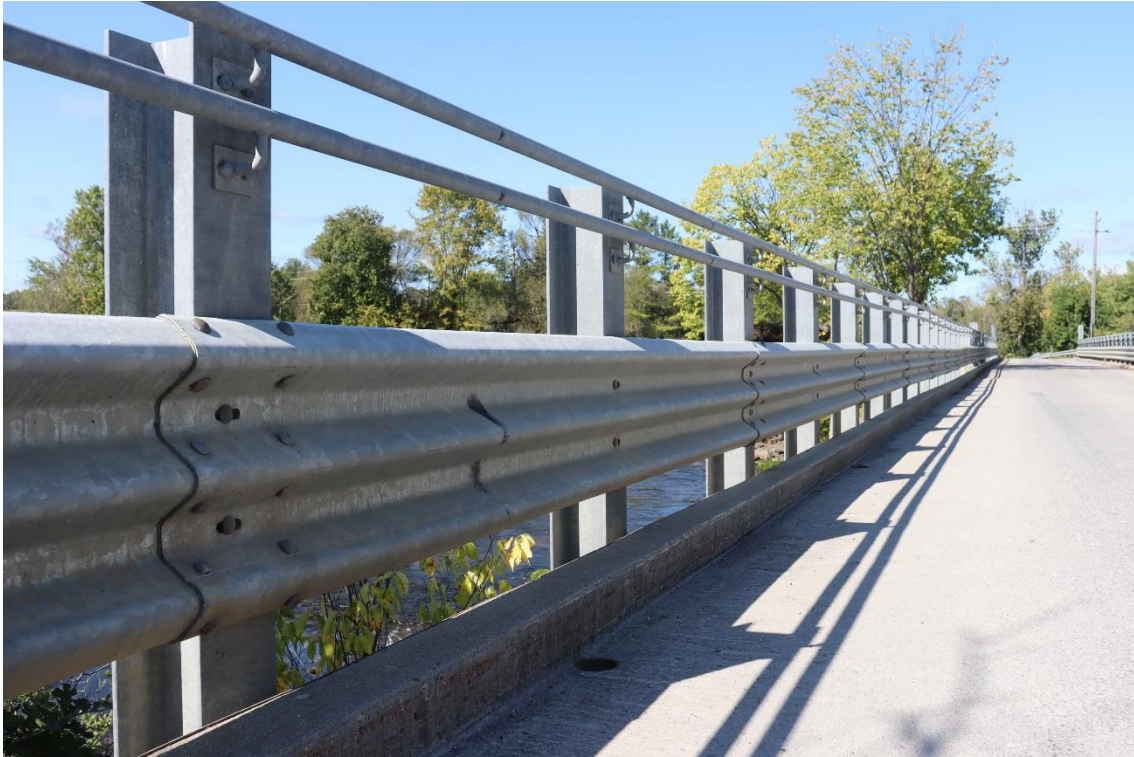
Image 19. Typ. guide rail on middle bridge

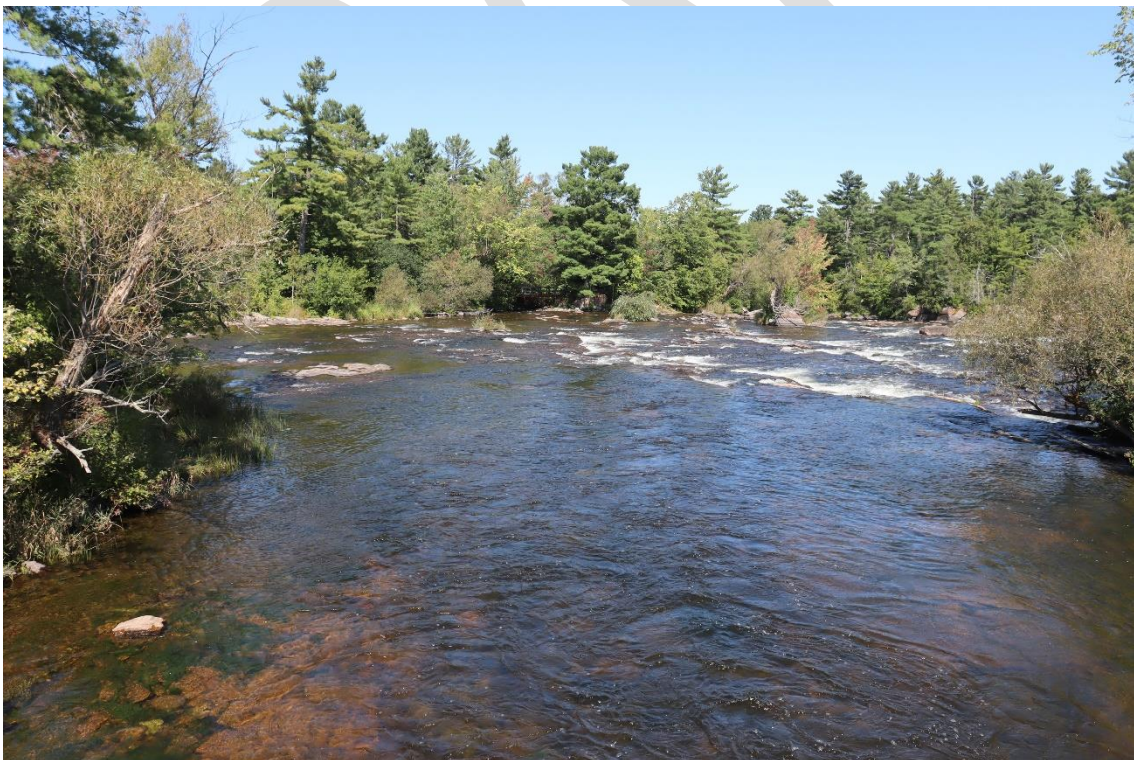
Image 7. North downstream channel of middle bridge

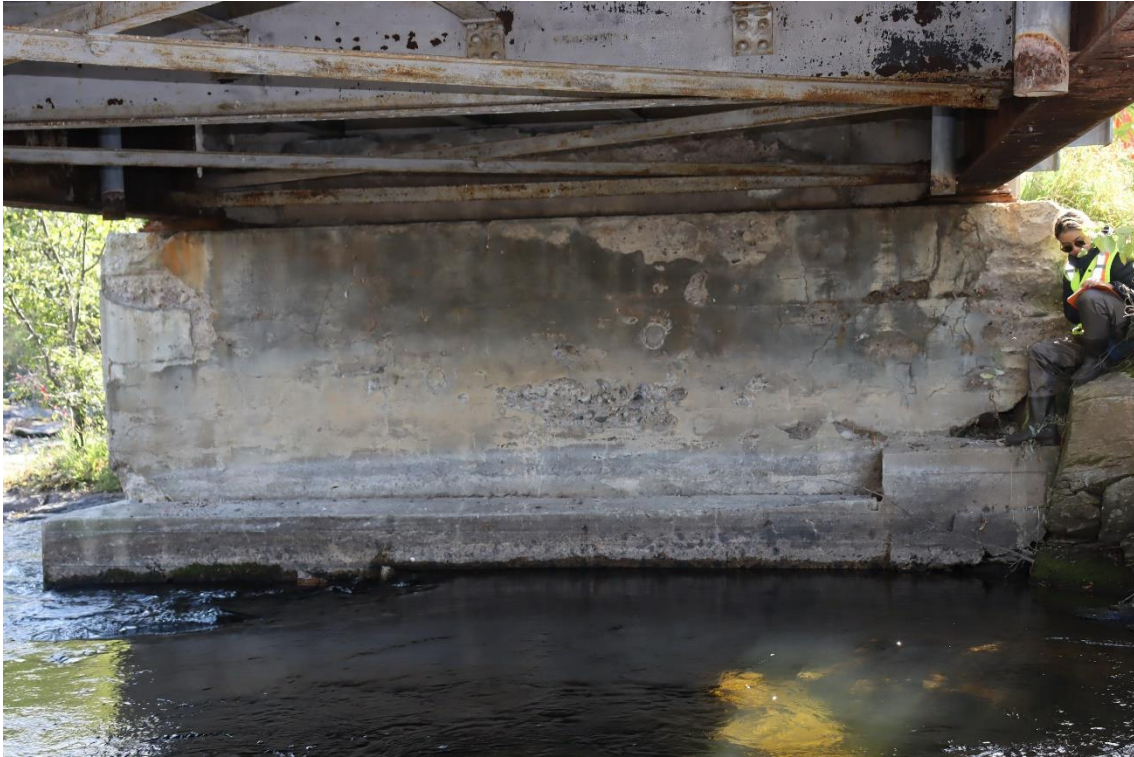
Image 8. East abutment of middle bridge

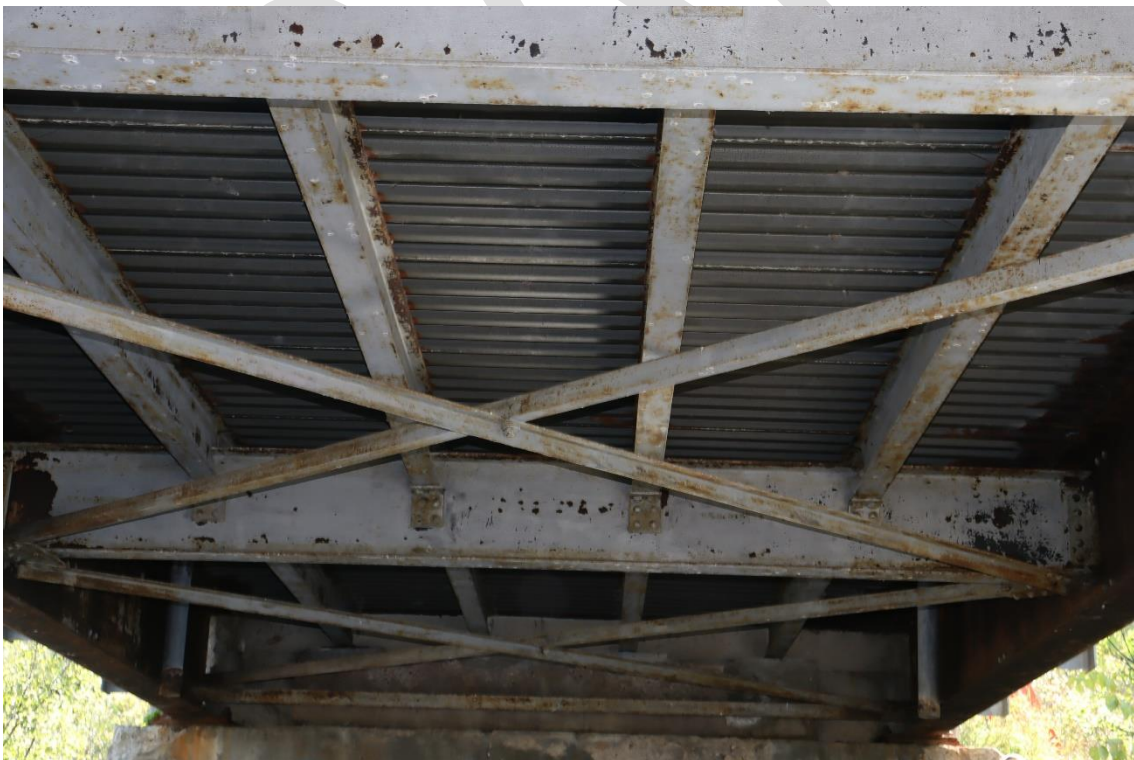
Image 9. Soffit & steel floor system of east span of middle bridge facing east

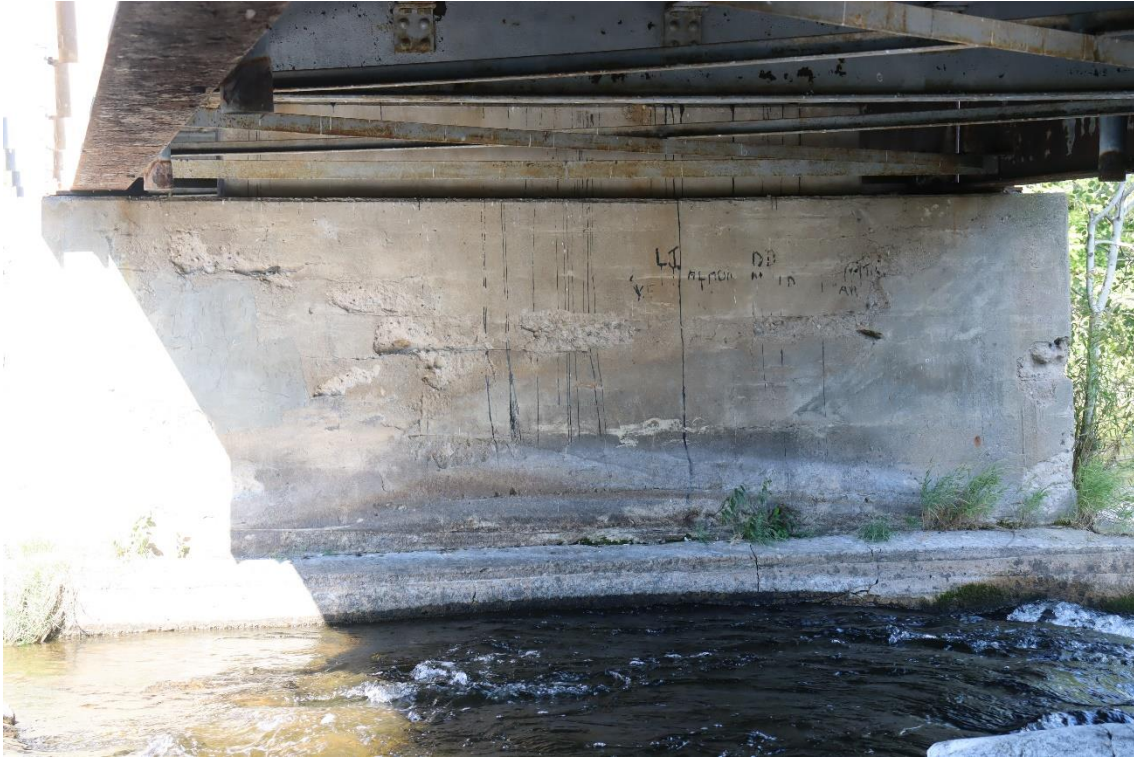
Image 10. East face of pier of middle bridge

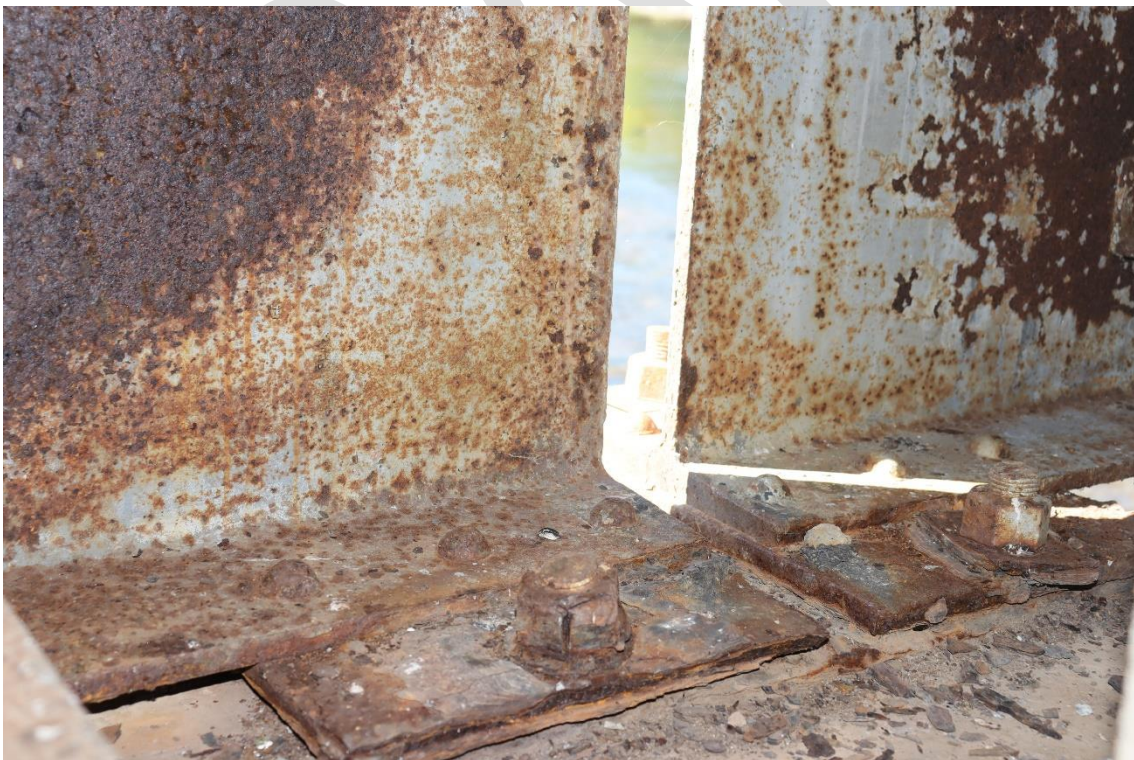
Image 11. Pier bearing of south girders of middle bridge

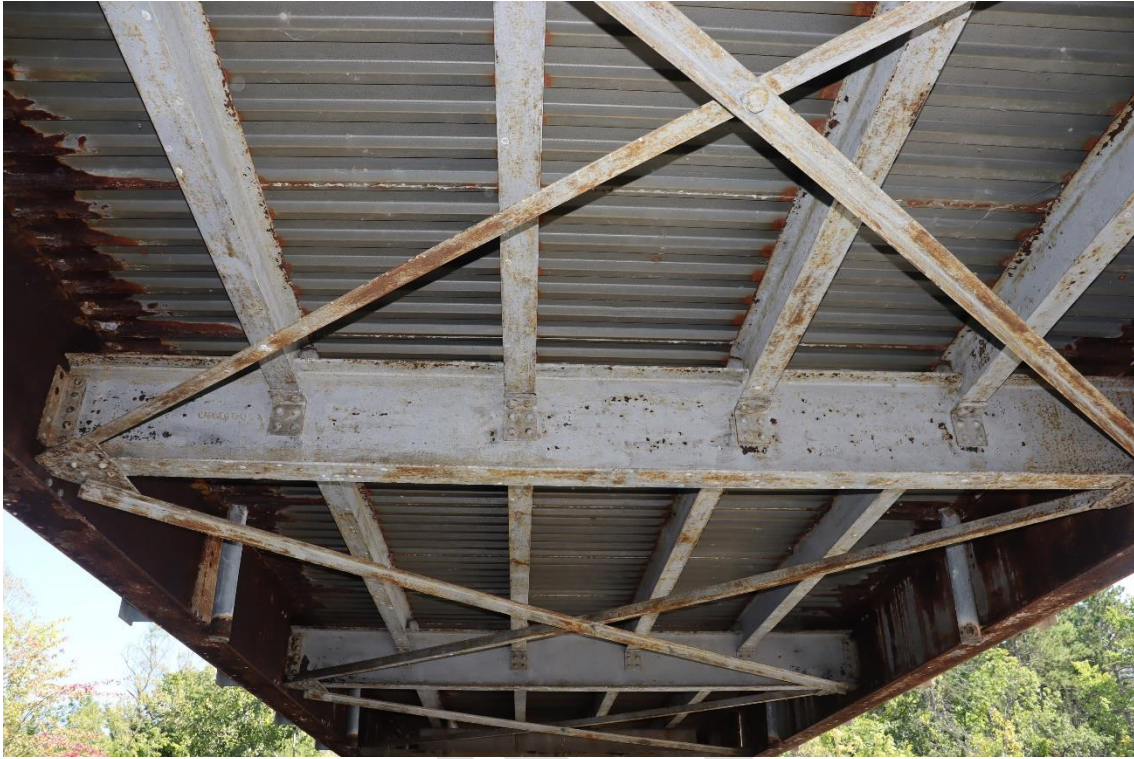
Image 12. Soffit & floor system of west span of middle bridge facing east

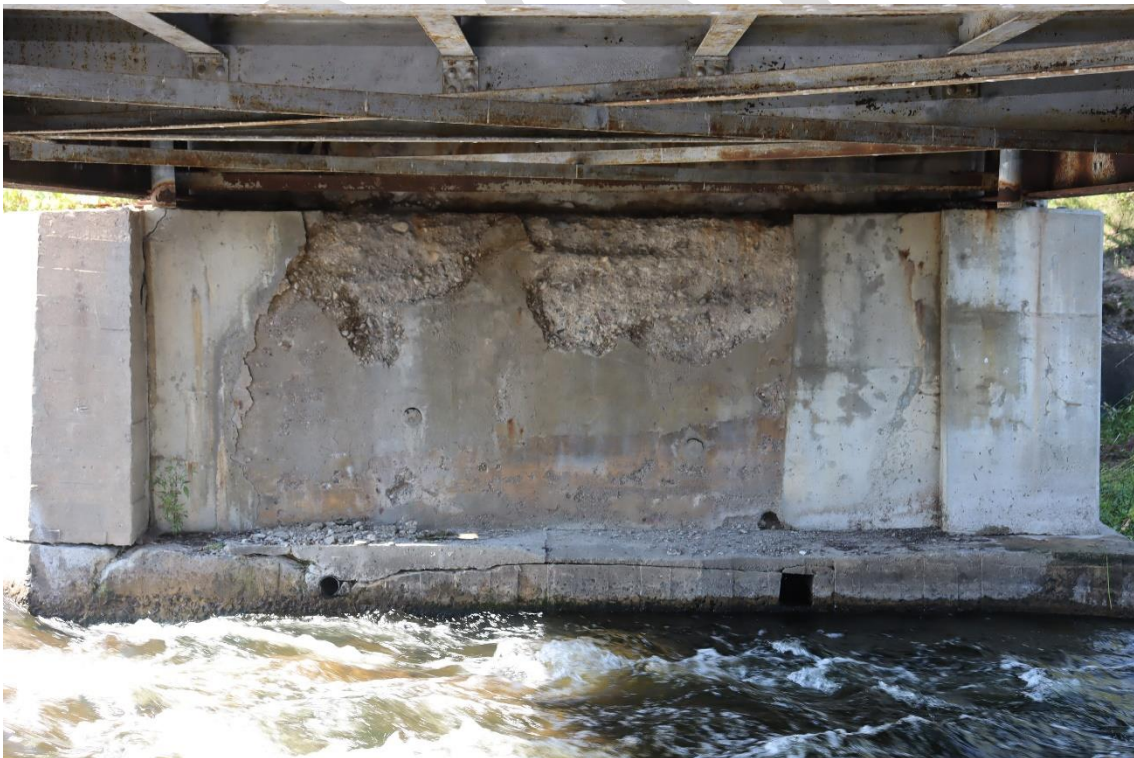
Image 28. West abutment of middle bridge

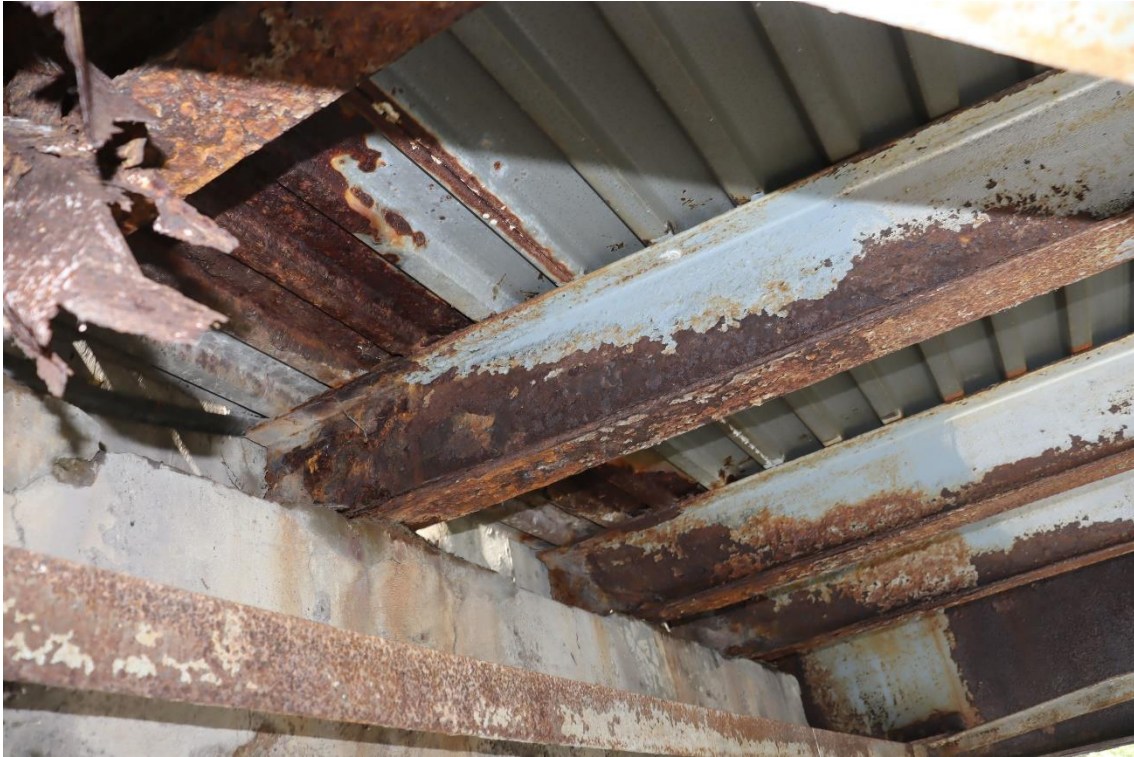
Image 29. General condition of stringer ends of middle bridge at west abutment

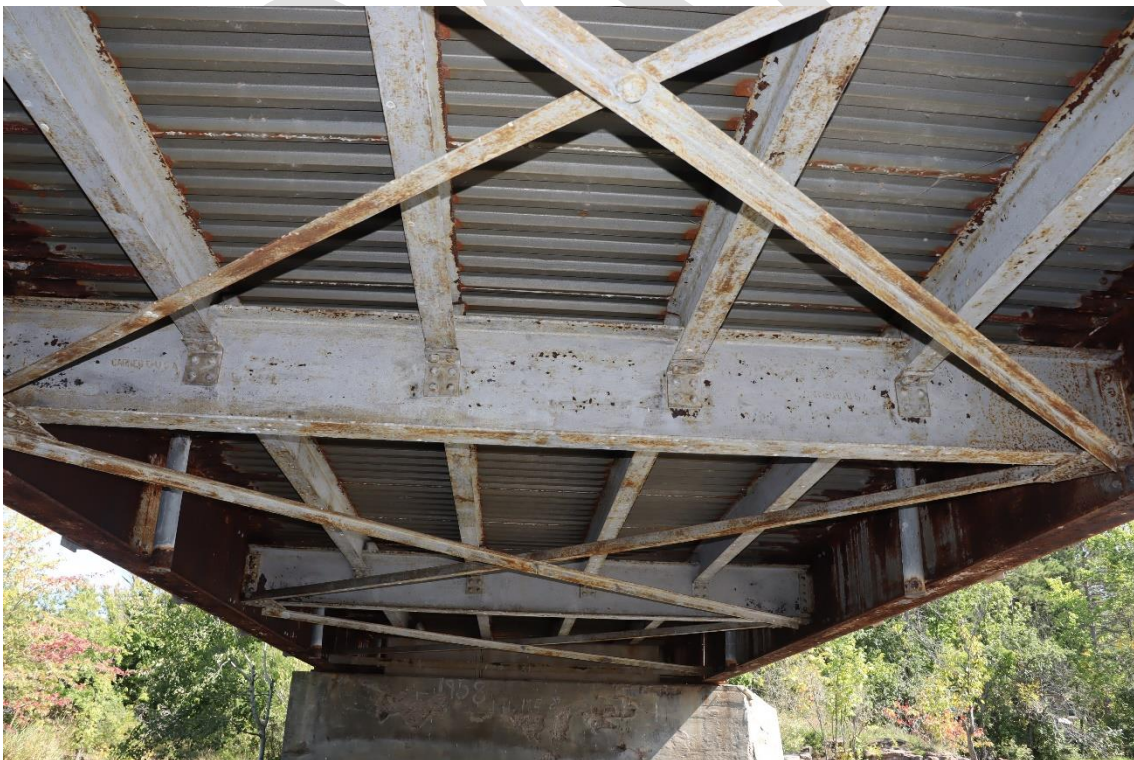
Image 16. Soffit & floor system of west span of middle bridge facing east

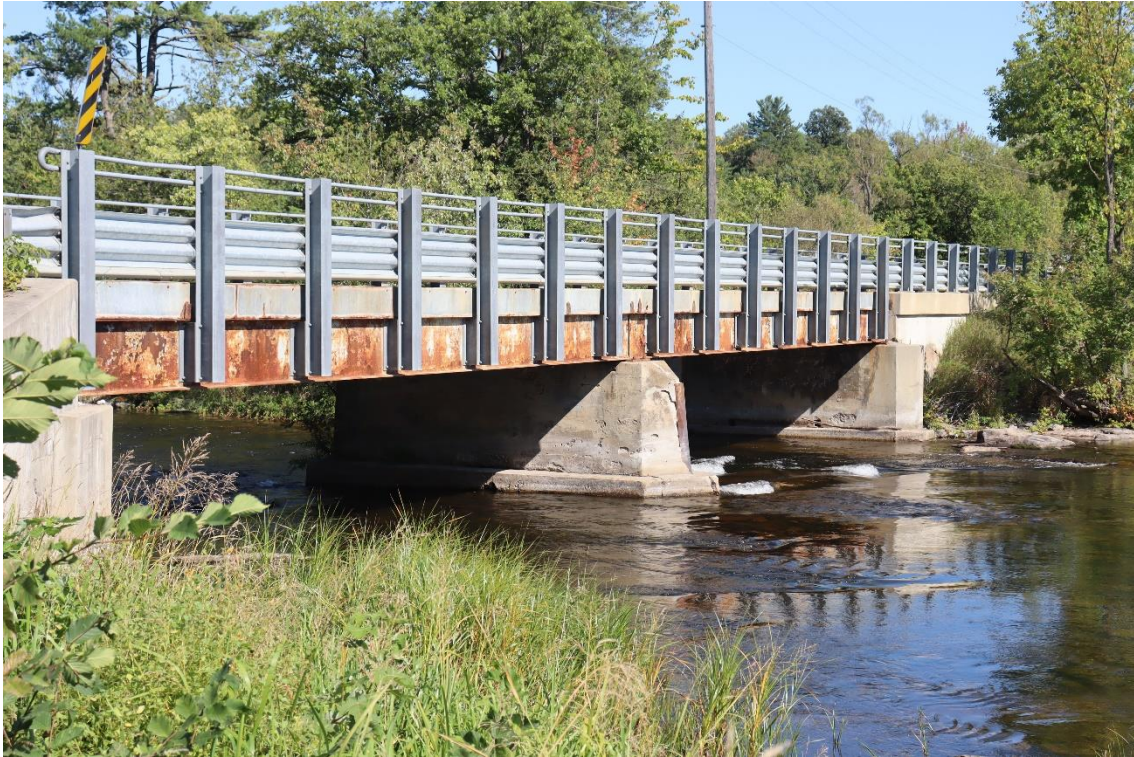
Image 17. South elevation of west bridge
