BLAKENEY BRIDGE REPORT #PW-26-2022

Public Works Committee
October 26, 2022

BLAKENEY BRIDGE ENHANCED INSPECTION REPORT

Lanark County – October 2022

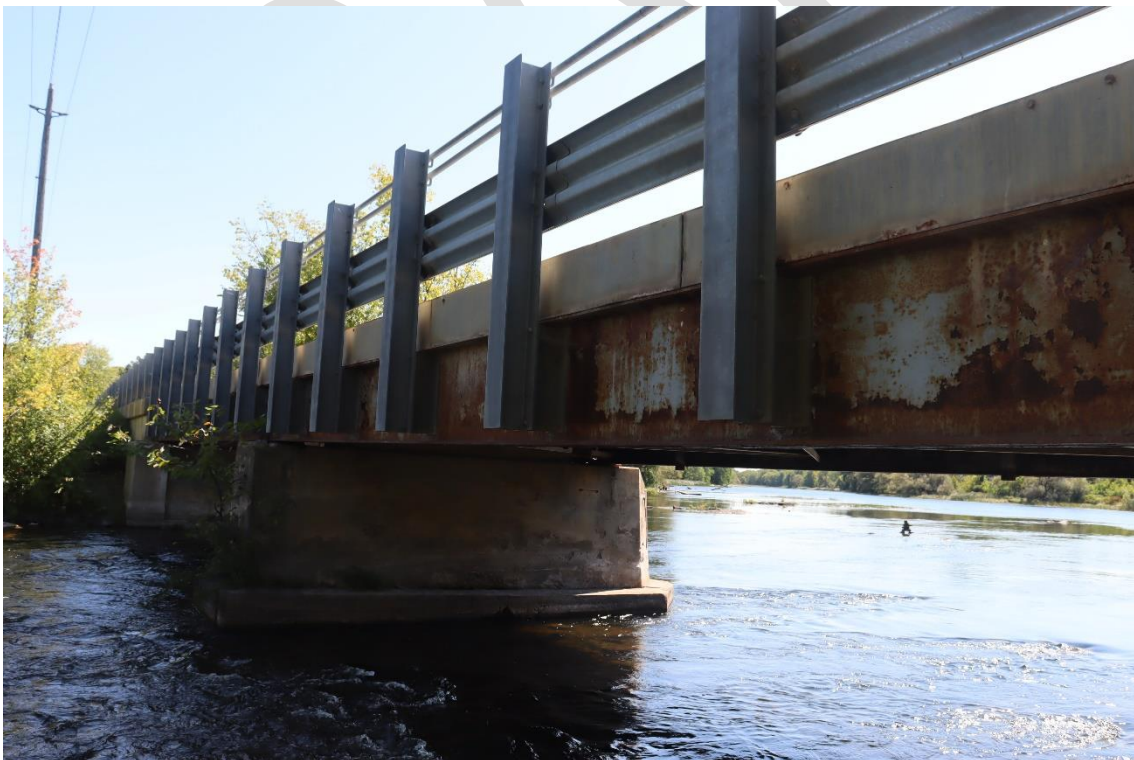
Image 18. North elevation of west bridge

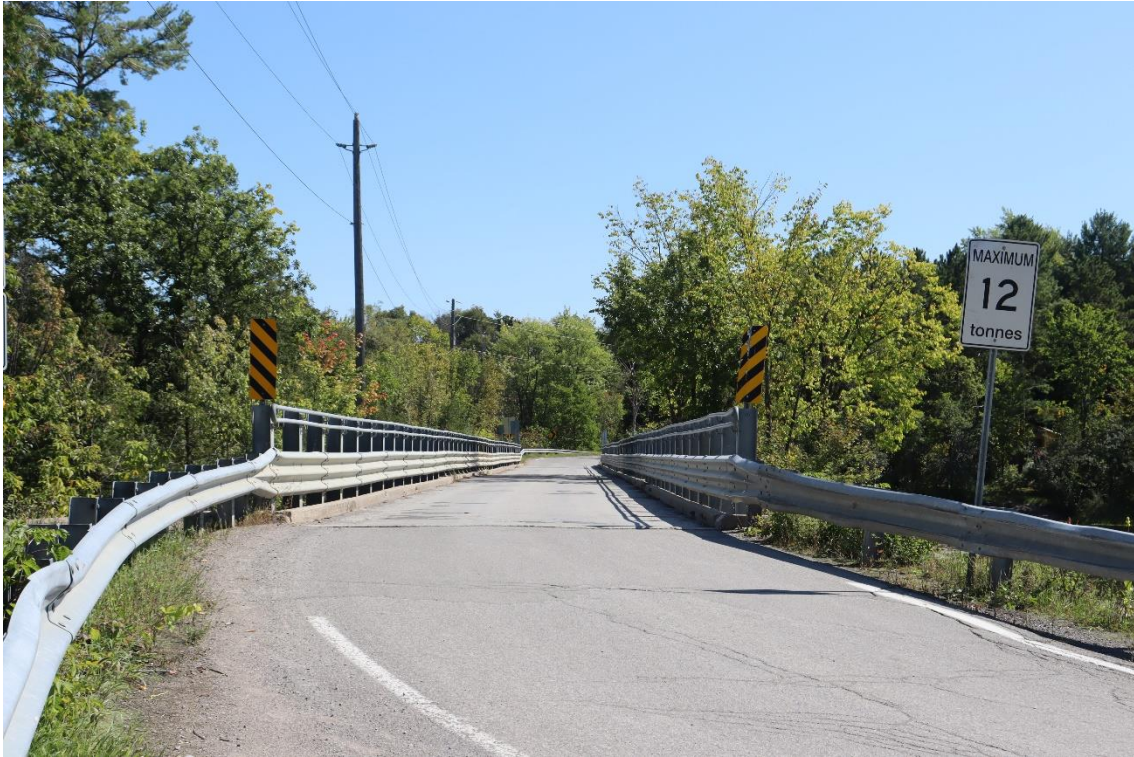
Image 19. West approach of west bridge

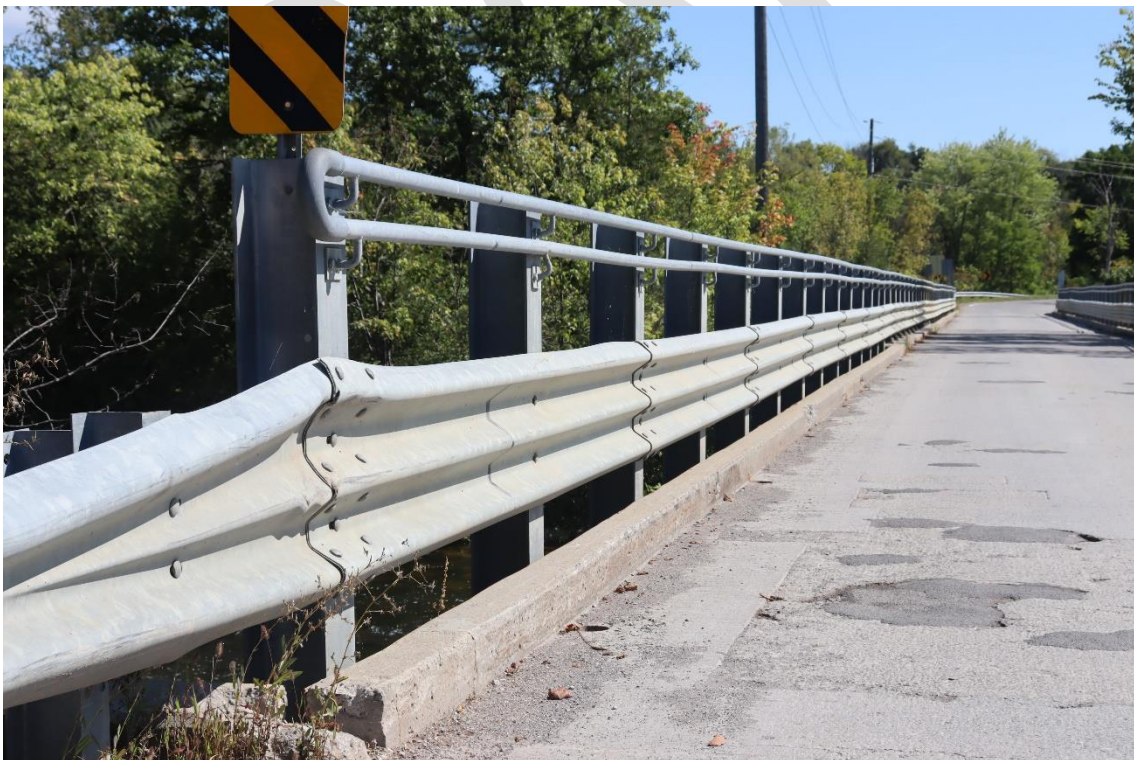
Image 38. Typ. guide rail on west bridge and asphalt condition

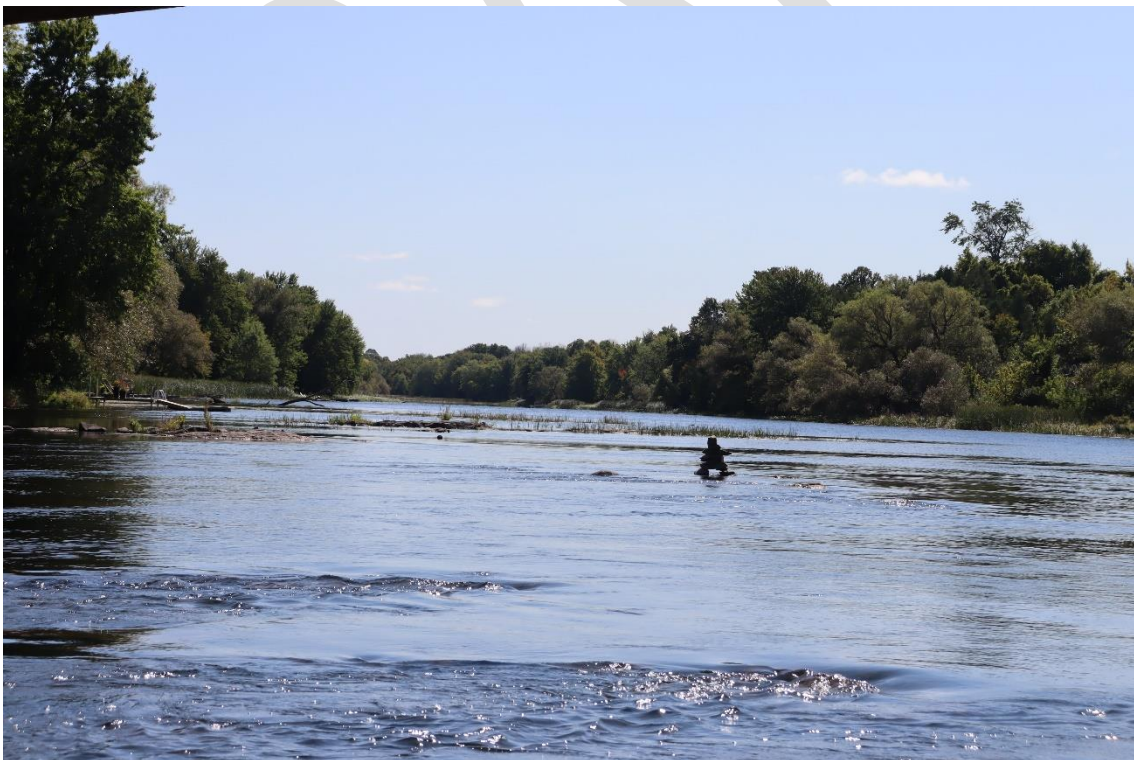
Image 20. South upstream channel of west bridge

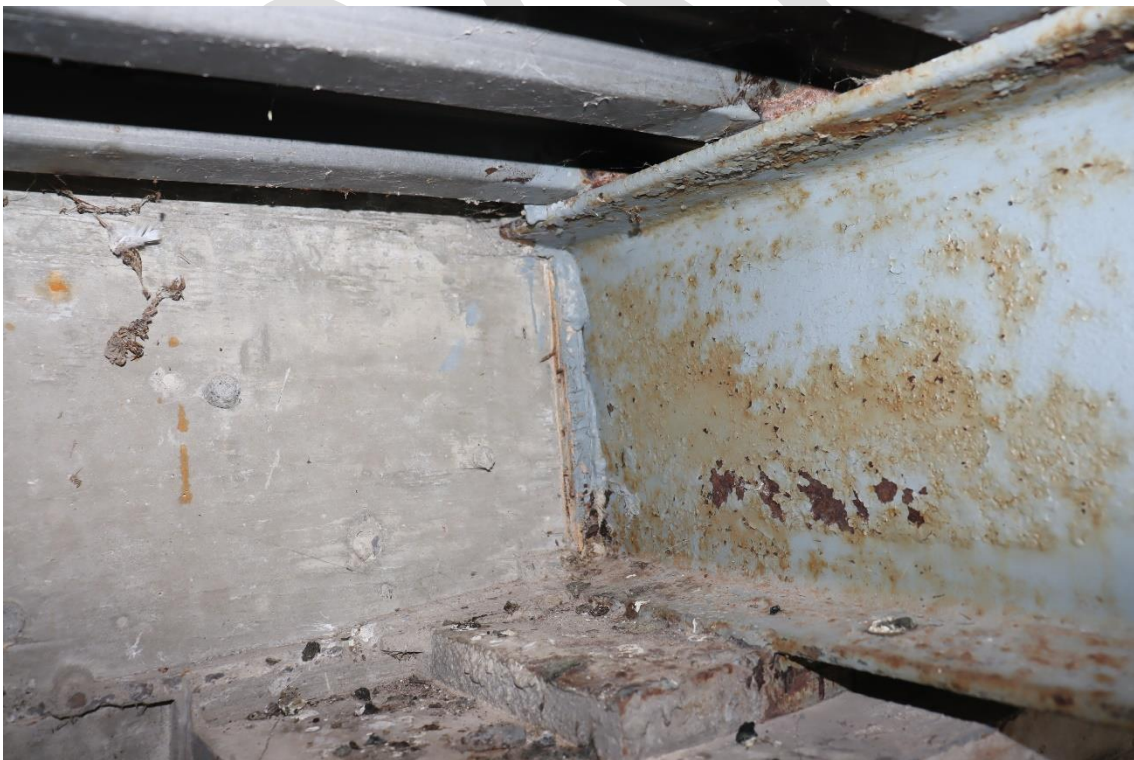
Image 21. Soffit & floor system of east span of west bridge facing west

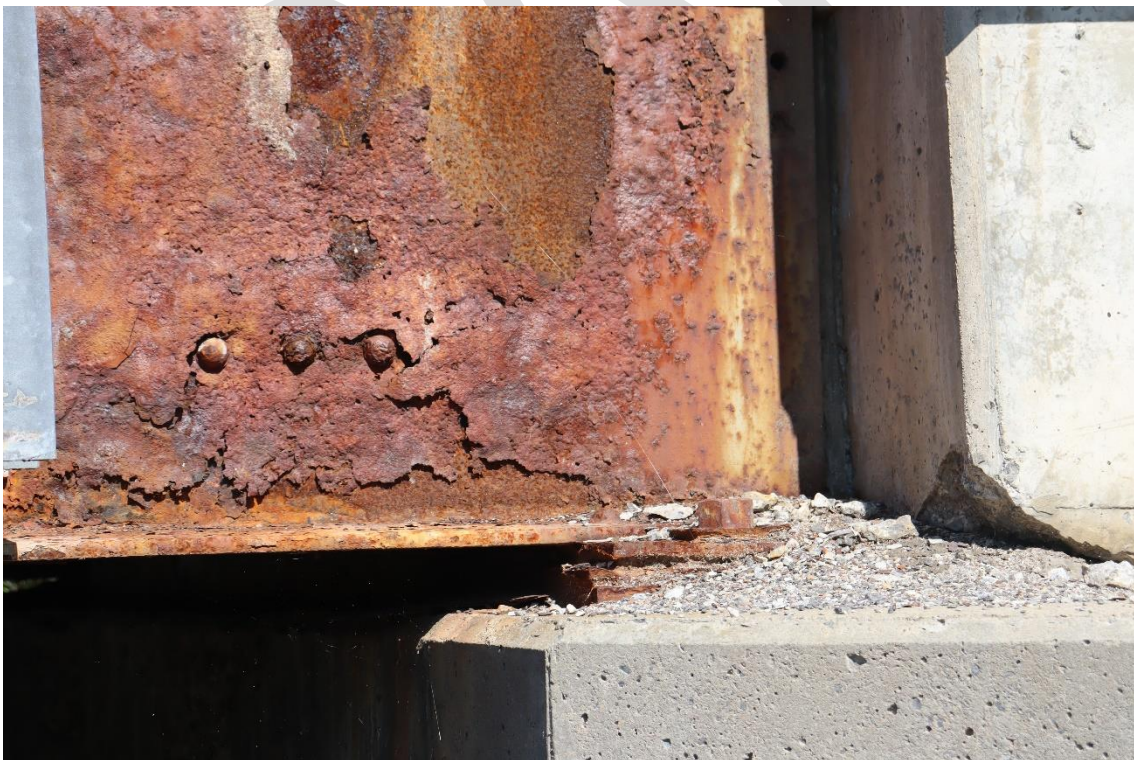
Image 43. Web thinning of north girder end on east abutment of west bridge

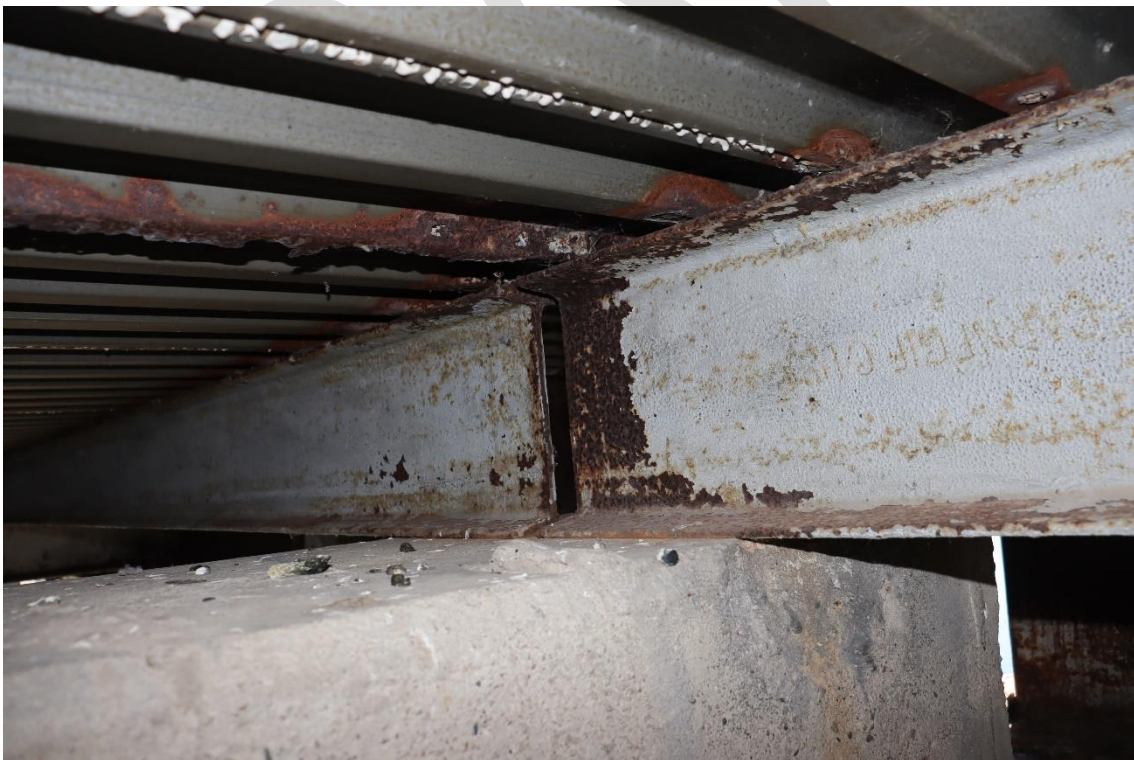
Image 47. Condition of girder ends on pier of west bridge

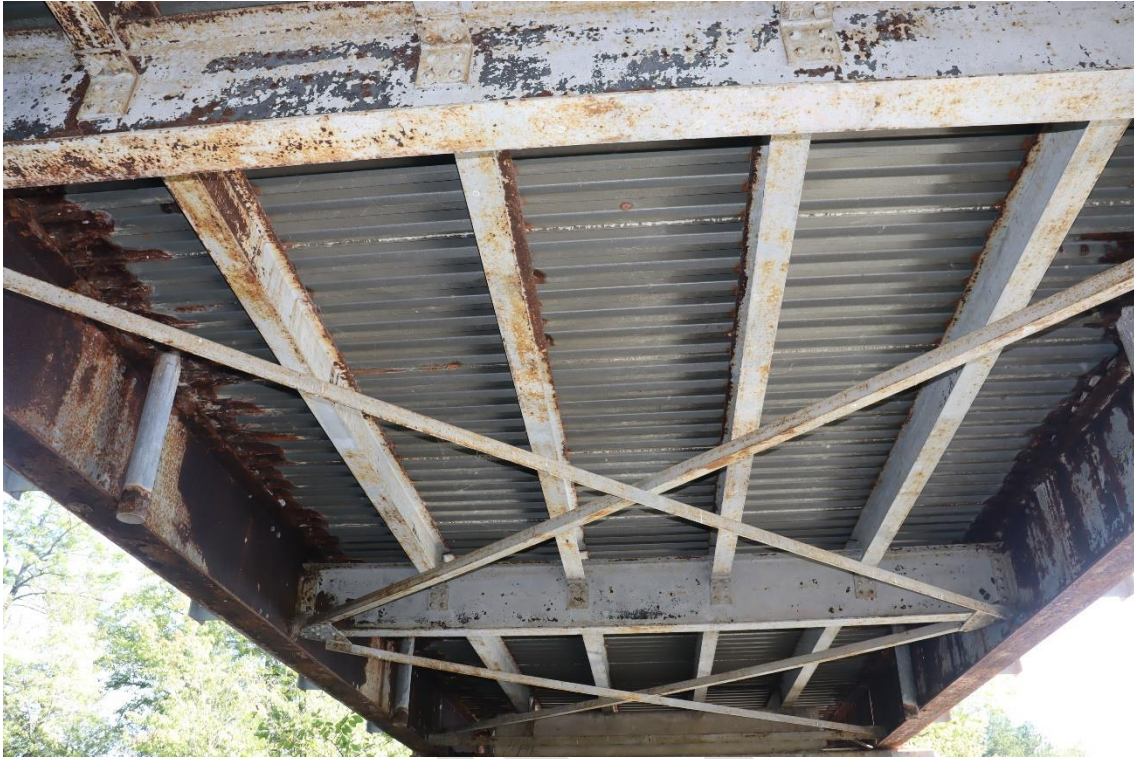
Image 48. Typ. stringer ends on pier of west bridge

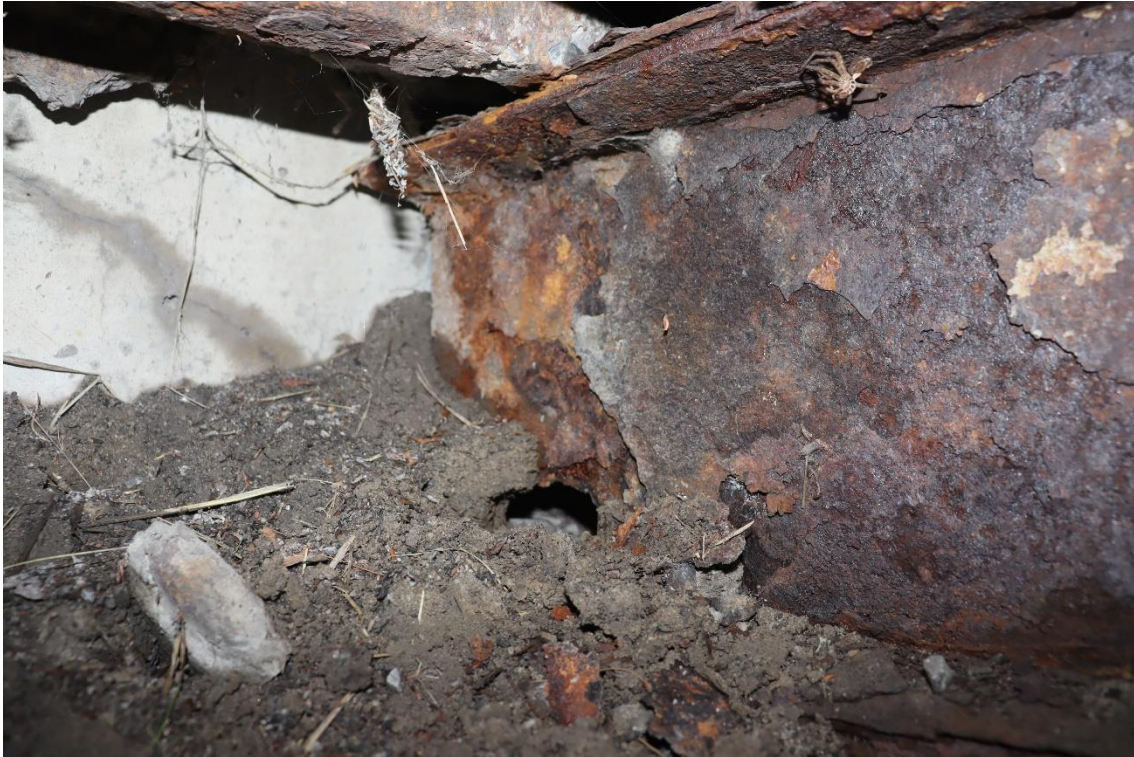
Image 25. Disintegration of ballast wall above west abutment of west bridge

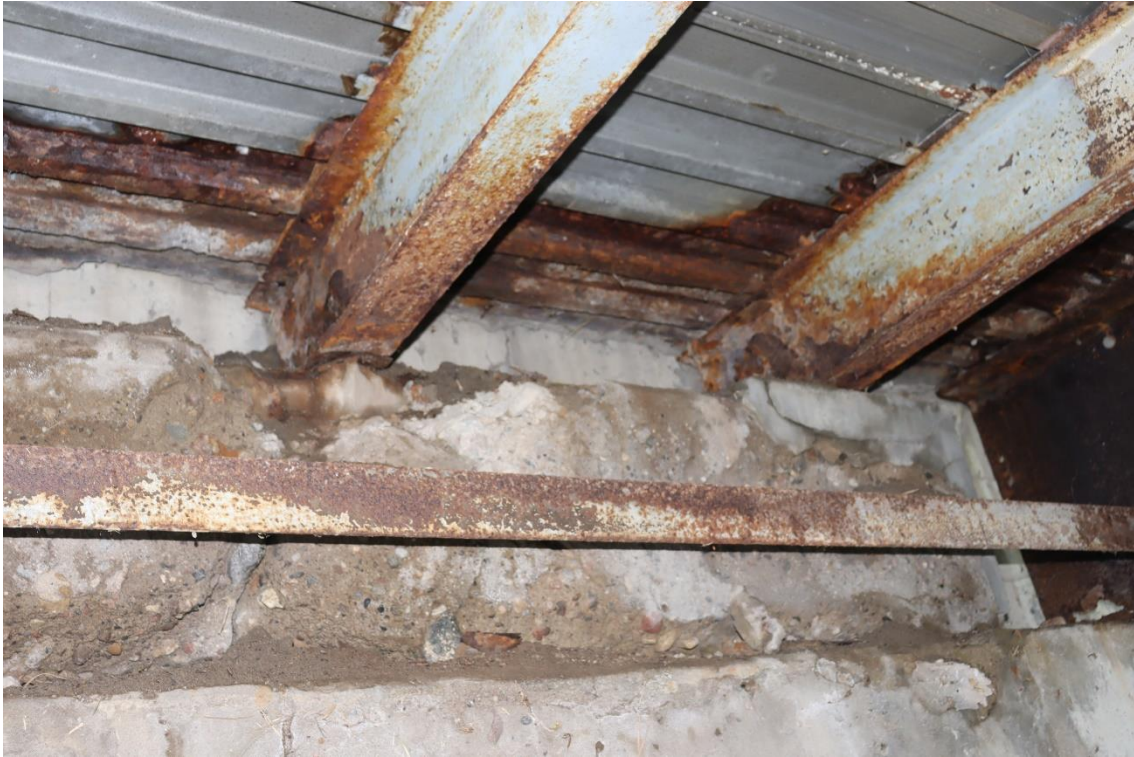
Image 26. West end of Stringer 2 with debris and perforation on west bridge

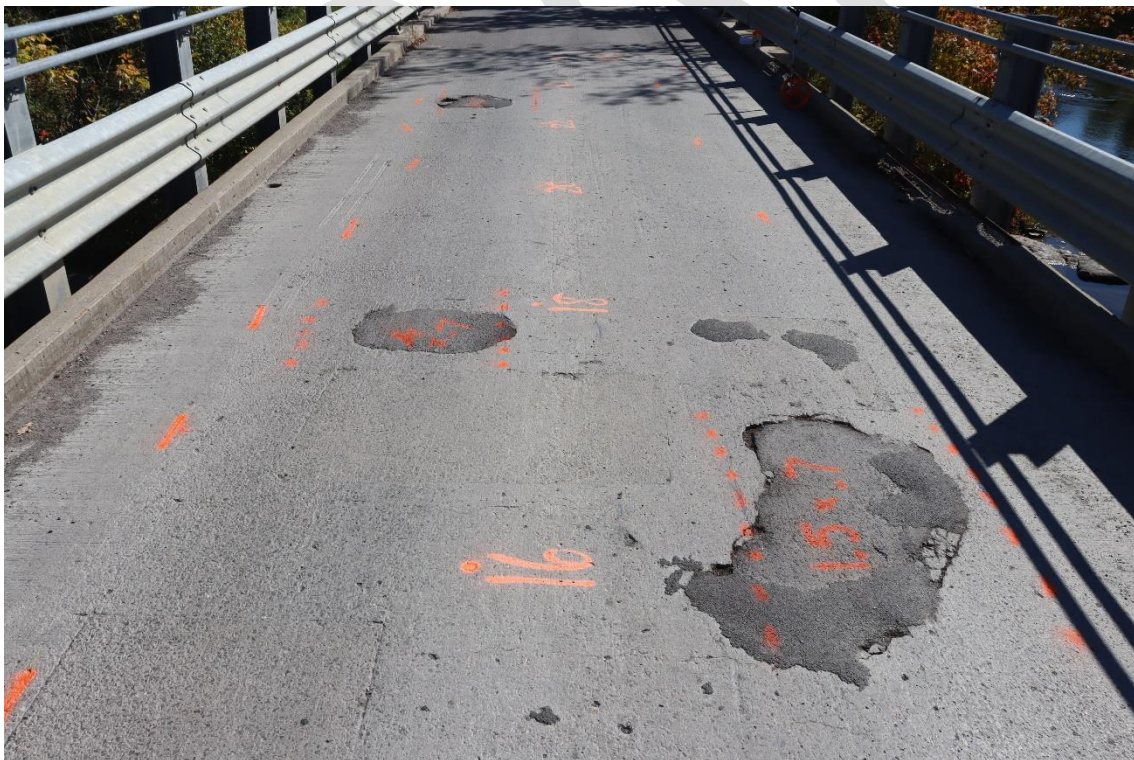
Image 28. West end of west bridge deck condition survey

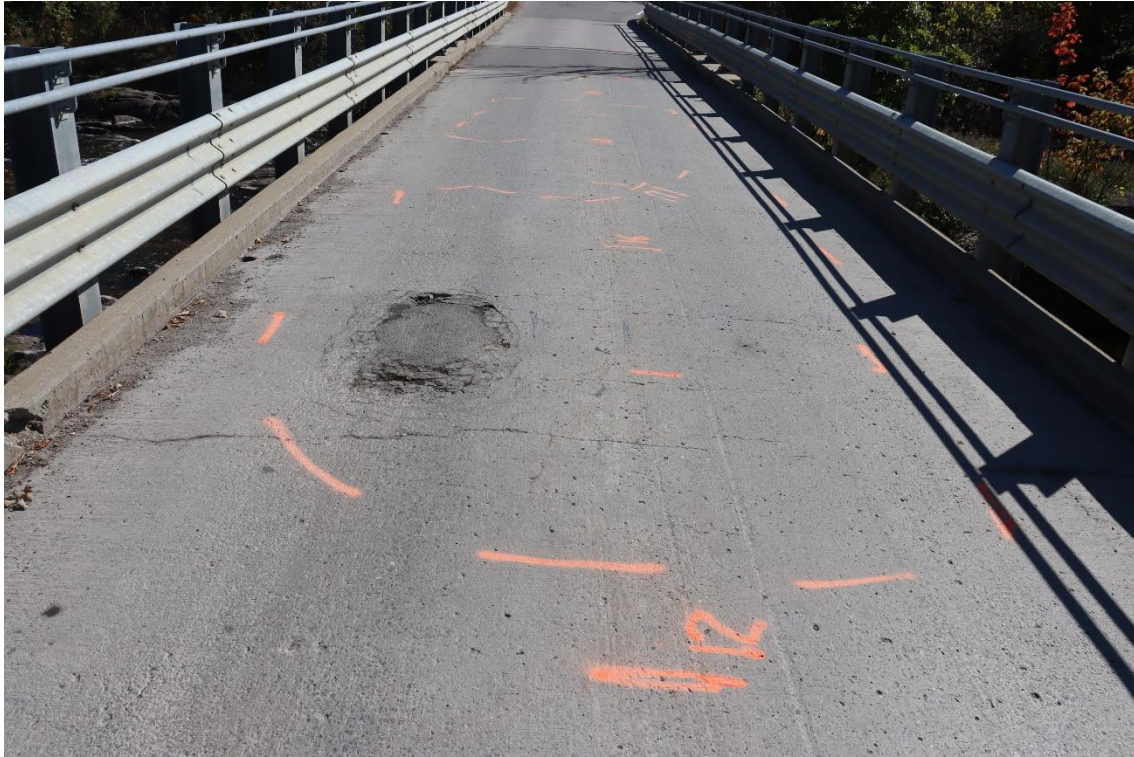
Image 29. East end of west bridge deck condition survey

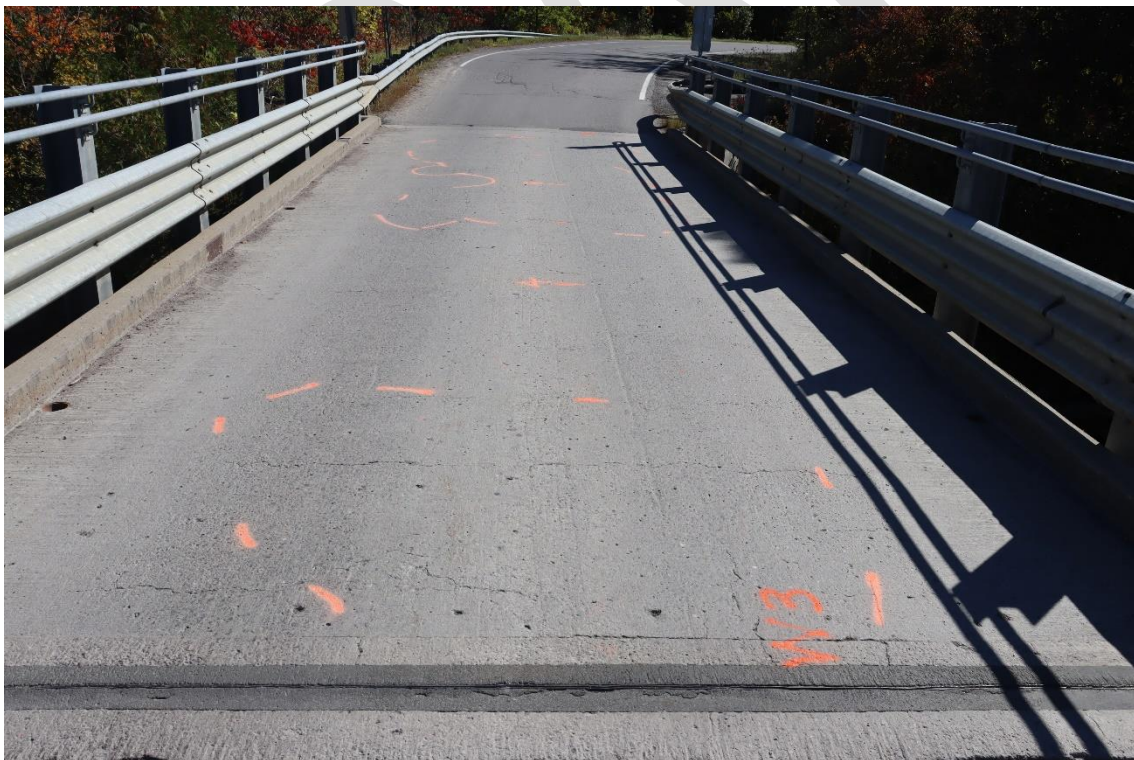
Image 30. Middle to east end of middle bridge deck condition survey
