Subject: **Hydrogeological Assessment and Terrain Analysis**

**Proposed Residential Development**

122 Old Mill Lane Appleton, Ontario

# Hydrogeological Assessment and Terrain Analysis

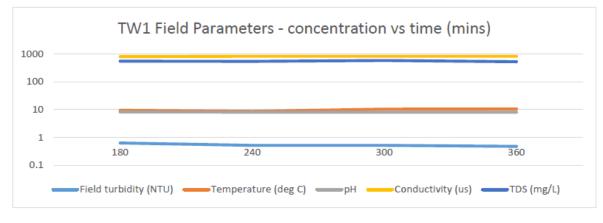
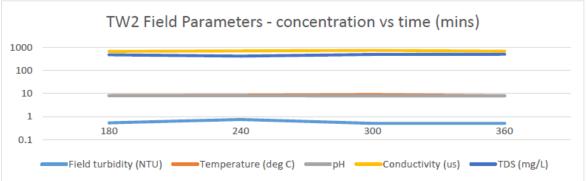
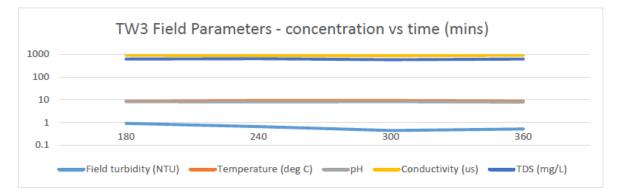
Figure 1 - Test Well Field Parameters

Field parameter results for the final 3.5 hours of each test are shown graphically below:

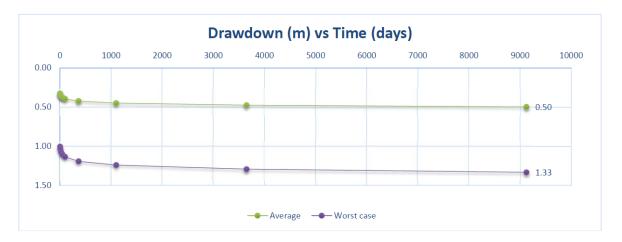
Figure 2 - Maximum Anticipated Drawdown

A potential well interference model was used to reflect a hypothetical stress test scenario for drawdown at the site. The model assumes a series of 28 wells arranged in a concentric circular array. Each well is pumping continuously at a rate of 3,000 L/day, over a period of 20 years.

Analytical model worksheets are presented in Appendix 4. Calculations were based on average and worst case values for Transmissivity and Storativity (as presented in Table 6).

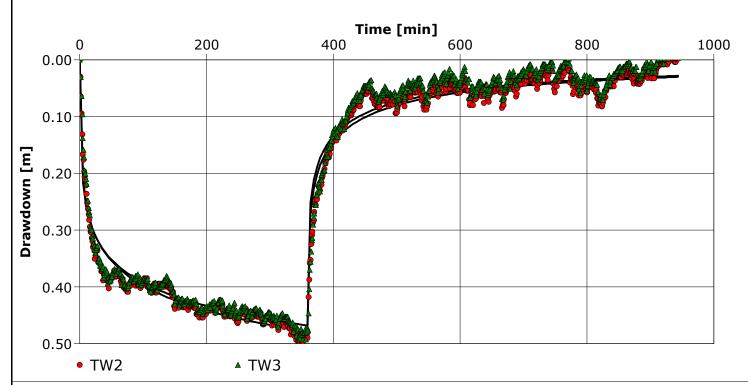
Location: Appleton ON	Pumping Test: Pumping Test 1	Pumping Well: TW1
Test Conducted by: AO		Test Date: 09/07/2015
Analysis Performed by:	Theis	Analysis Date: 30/10/2015
Aquifer Thickness: 12.00 m	Discharge: variable, average rate 1.89 [l/s]

Observation Well	Transmissivity	Hydraulic Conductivity	Storage coefficient	Radial Distance to PW
	[m²/d]	[m/d]		[m]
TW2	2.05 × 10 <sup>2</sup>	1.71 × 10 <sup>1</sup>	3.05 × 10 <sup>-6</sup>	140.36
TW3	2.20 × 10 <sup>2</sup>	1.83 × 10 <sup>1</sup>	4.39 × 10 <sup>-6</sup>	100.9
Average	2.12 × 10 <sup>2</sup>	1.77 × 10 <sup>1</sup>	3.72 × 10 <sup>-6</sup>

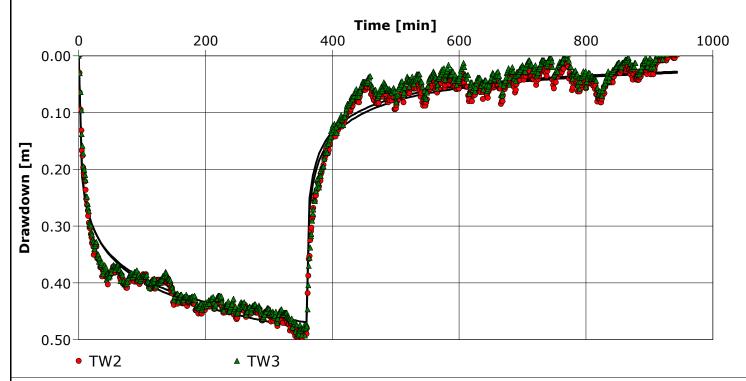
Location: Appleton ON	Pumping Test: Pumping Test 1	Pumping Well: TW1
Test Conducted by: AO		Test Date: 09/07/2015
Analysis Performed by:	Theis Jacob	Analysis Date: 30/10/2015
Aquifer Thickness: 12.00 m	Discharge: variable, average rate 1.89 [l/s]

Observation Well	Transmissivity	Hydraulic Conductivity	Storage coefficient	Radial Distance to PW
	[m²/d]	[m/d]		[m]
TW2	2.08 × 10 <sup>2</sup>	1.73 × 10 <sup>1</sup>	3.20 × 10 <sup>-6</sup>	140.36
TW3	2.22 × 10 <sup>2</sup>	1.85 × 10 <sup>1</sup>	4.64 × 10 <sup>-6</sup>	100.9
Average	2.15 × 10 <sup>2</sup>	1.79 × 10 <sup>1</sup>	3.92 × 10 <sup>-6</sup>

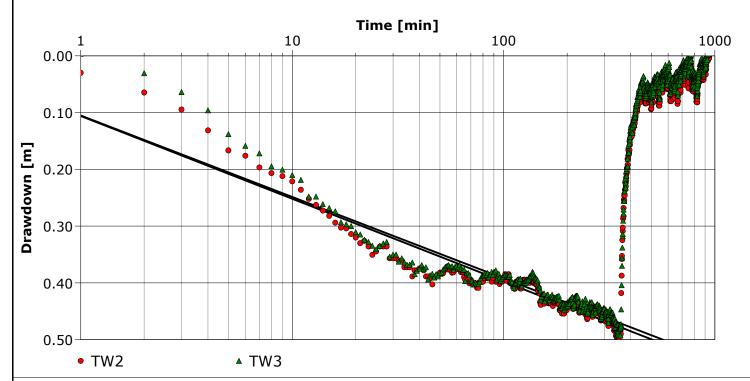
Location: Appleton ON	Pumping Test: Pumping Test 1	Pumping Well: TW1
Test Conducted by: AO		Test Date: 09/07/2015
Analysis Performed by:	Cooper Jacob I	Analysis Date: 30/10/2015
Aquifer Thickness: 12.00 m	Discharge: variable, average rate 1.89 [l/s]

Observation Well	Transmissivity	Hydraulic Conductivity	Storage coefficient	Radial Distance to PW
	[m²/d]	[m/d]		[m]
TW2	2.05 × 10 <sup>2</sup>	1.71 × 10 <sup>1</sup>	3.05 × 10 <sup>-6</sup>	140.36
TW3	2.09 × 10 <sup>2</sup>	1.74 × 10 <sup>1</sup>	5.87 × 10 <sup>-6</sup>	100.9
Average	2.07 × 10 <sup>2</sup>	1.72 × 10 <sup>1</sup>	4.46 × 10 <sup>-6</sup>

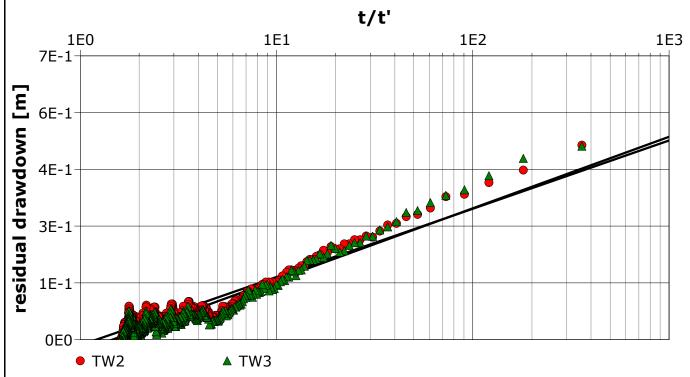
Location: Appleton ON	Pumping Test: Pumping Test 1	Pumping Well: TW1
Test Conducted by: AO		Test Date: 09/07/2015
Analysis Performed by:	Theis Recovery	Analysis Date: 30/10/2015
Aguifer Thickness: 12 00 m	Discharge: variable, average rate 1.89 [l/s]

Observation Well	Transmissivity	Hydraulic Conductivity	Radial Distance to PW
	[m²/d]	[m/d]	[m]
TW2	1.77 × 10 <sup>2</sup>	1.48 × 10 <sup>1</sup>	140.36
TW3	1.70 × 10 <sup>2</sup>	1.41 × 10 <sup>1</sup>	100.9
Average	1.73 × 10 <sup>2</sup>	1.45 × 10 <sup>1</sup>

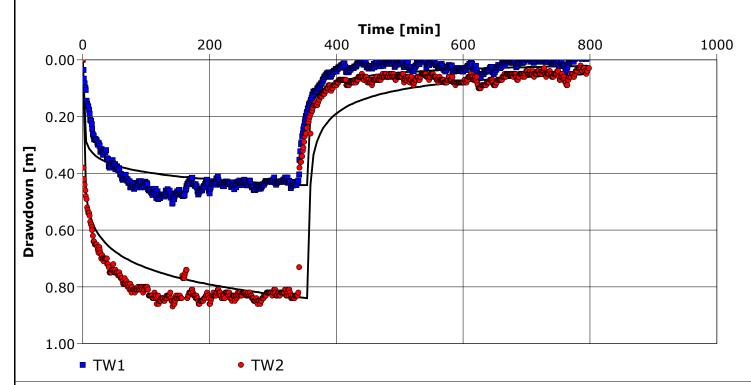
Location: Appleton ON	Pumping Test: Pumping Test 2	Pumping Well: TW3
Test Conducted by: AO		Test Date: 10/07/2015
Analysis Performed by:	Theis	Analysis Date: 30/10/2015

Observation Well	Transmissivity	Hydraulic Conductivity	Storage coefficient	Radial Distance to PW
	[m²/d]	[m/d]		[m]
TW1	3.58 × 10 <sup>2</sup>	2.98 × 10 <sup>1</sup>	1.00 × 10 <sup>-7</sup>	100.9
TW2	1.53 × 10 <sup>2</sup>	1.27 × 10 <sup>1</sup>	1.00 × 10 <sup>-7</sup>	206.94
Average	2.56 × 10 <sup>2</sup>	2.13 × 10 <sup>1</sup>	1.00 × 10 <sup>-7</sup>

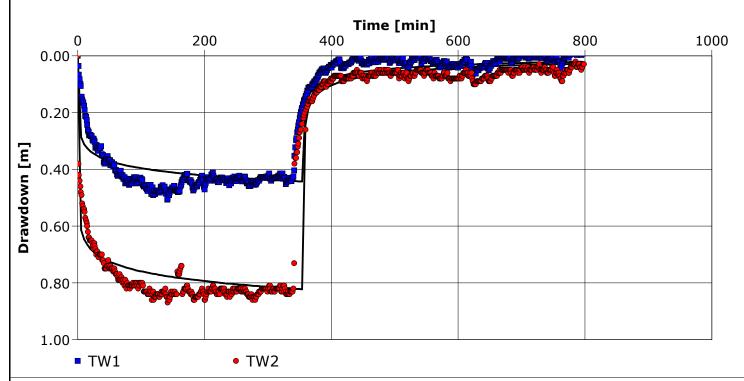
Location: Appleton ON	Pumping Test: Pumping Test 2	Pumping Well: TW3	
Test Conducted by: AO		Test Date: 10/07/2015	
Analysis Performed by: Theis Jacob		Analysis Date: 30/10/2015	
Aquifer Thickness: 12.00 m	Discharge: variable, average rate 1.89 [l/s]

Observation Well	Transmissivity	Hydraulic Conductivity	Storage coefficient	Radial Distance to PW
	[m²/d]	[m/d]		[m]
TW1	3.65 × 10 <sup>2</sup>	3.04 × 10 <sup>1</sup>	1.00 × 10 <sup>-7</sup>	100.9
TW2	2.80 × 10 <sup>2</sup>	2.33 × 10 <sup>1</sup>	1.37 × 10 <sup>-10</sup>	206.94
Average	3.22 × 10 <sup>2</sup>	2.68 × 10 <sup>1</sup>	5.01 × 10 <sup>-8</sup>

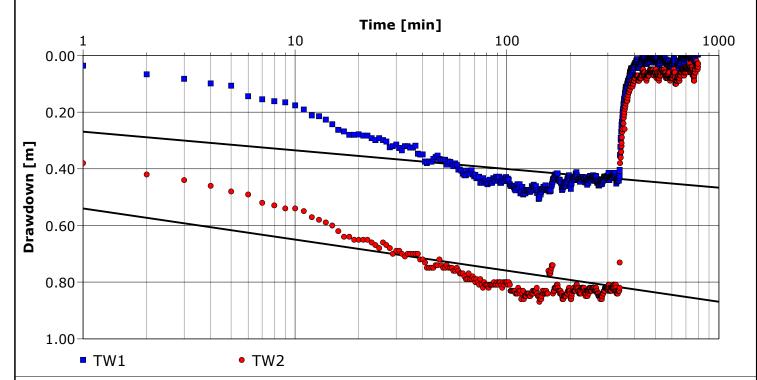
Pumping Test: Pumping Test 2	Pumping Well: TW3
	Test Date: 10/07/2015
Cooper Jacob I	Analysis Date: 16/11/2015

Observation Well	Transmissivity	Hydraulic Conductivity	Storage coefficient	Radial Distance to PW	
	[m²/d]	[m/d]		[m]	
TW1	4.56 × 10 <sup>2</sup>	3.80 × 10 <sup>1</sup>	5.39 × 10 <sup>-9</sup>	100.9	
TW2	2.73 × 10 <sup>2</sup>	2.27 × 10 <sup>1</sup>	1.17 × 10 <sup>-10</sup>	206.94	
Average	3.65 × 10 <sup>2</sup>	3.04 × 10 <sup>1</sup>	2.75 × 10 <sup>-9</sup>

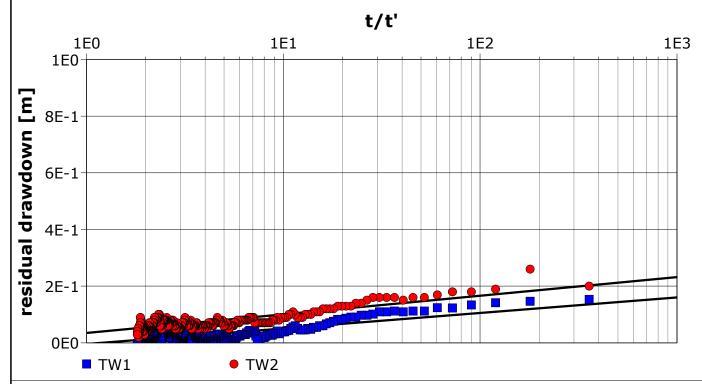
Location: Appleton ON	Pumping Test: Pumping Test 2	Pumping Well: TW3	
Test Conducted by: AO		Test Date: 10/07/2015	
Analysis Performed by:	Theis RECOVERY	Analysis Date: 16/11/2015	
Aquifer Thickness: 12.00 m	Discharge: variable, average rate 1.89 [l/s]

Observation Well	Transmissivity	Hydraulic Conductivity	Radial Distance to PW	
	[m²/d]	[m/d]	[m]	
TW1	5.45 × 10 <sup>2</sup>	4.54 × 10 <sup>1</sup>	100.9	
TW2	4.52 × 10 <sup>2</sup>	3.77 × 10 <sup>1</sup>	206.94	
Average	4.98 × 10 <sup>2</sup>	4.15 × 10 <sup>1</sup>

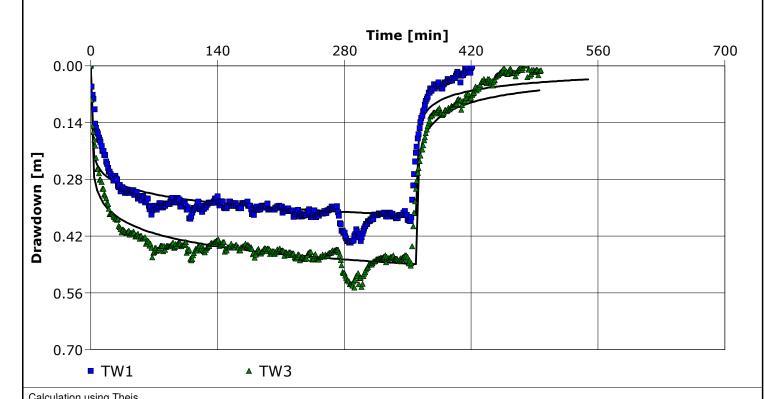
Location: Appleton ON	Pumping Test: Pumping Test 3	Pumping Well: TW2
Test Conducted by: AO		Test Date: 13/07/2015
Analysis Performed by:	Theis	Analysis Date: 30/10/2015
Aquifer Thickness: 12.00 m	Discharge: variable, average rate 1.89 [l/s]

Calculation using meis								
Observation Well	Transmissivity	Hydraulic Conductivity	Storage coefficient	Radial Distance to PW				
	[m²/d]	[m/d]		[m]				
TW1	4.12 × 10 <sup>2</sup>	3.43 × 10 <sup>1</sup>	1.00 × 10 <sup>-7</sup>	140.36				
TW3	$2.79 \times 10^2$	2.33 × 10 <sup>1</sup>	1.00 × 10 <sup>-7</sup>	206.94				
Average	$3.46 \times 10^2$	2.88 × 10 <sup>1</sup>	1.00 × 10 <sup>-7</sup>

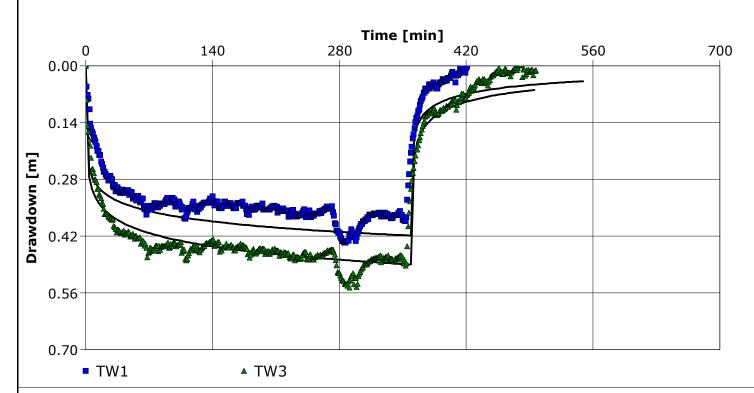
Location: Appleton ON	Pumping Test: Pumping Test 3	Pumping Well: TW2
Test Conducted by: AO		Test Date: 13/07/2015
Analysis Performed by:	Theis Jacob	Analysis Date: 30/10/2015
Aquifer Thickness: 12.00 m	Discharge: variable, average rate 1.89 [l/s]

Observation Well	Transmissivity	Hydraulic Conductivity	Storage coefficient	Radial Distance to PW
	[m²/d]	[m/d]		[m]
TW1	3.65 × 10 <sup>2</sup>	3.04 × 10 <sup>1</sup>	1.00 × 10 <sup>-7</sup>	140.36
TW3	2.85 × 10 <sup>2</sup>	2.37 × 10 <sup>1</sup>	1.00 × 10 <sup>-7</sup>	206.94
Average	3.25 × 10 <sup>2</sup>	2.71 × 10 <sup>1</sup>	1.00 × 10 <sup>-7</sup>

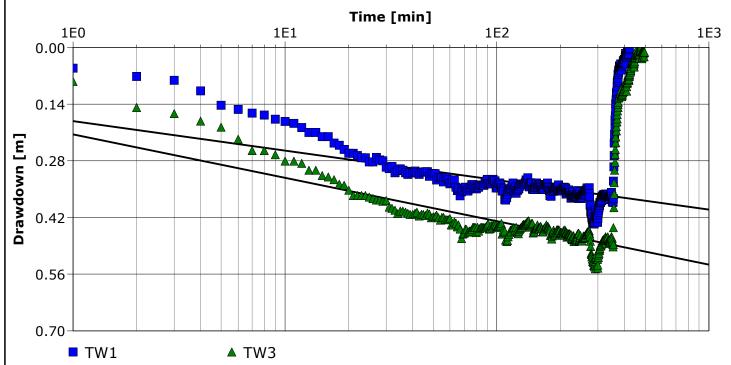
Location: Appleton ON	Pumping Test: Pumping Test 3	Pumping Well: TW2
Test Conducted by: AO		Test Date: 13/07/2015
Analysis Performed by:	Cooper Jacob I	Analysis Date: 16/11/2015
Aquifer Thickness: 12.00 m	Discharge: variable, average rate 1.89 [l/s]

Observation Well	Transmissivity	Hydraulic Conductivity	Storage coefficient	Radial Distance to PW	
	[m²/d]	[m/d]		[m]	
TW1	4.12 × 10 <sup>2</sup>	3.43 × 10 <sup>1</sup>	1.00 × 10 <sup>-7</sup>	140.36	
TW3	2.79 × 10 <sup>2</sup>	2.33 × 10 <sup>1</sup>	1.00 × 10 <sup>-7</sup>	206.94	
Average	3.46 × 10 <sup>2</sup>	2.88 × 10 <sup>1</sup>	1.00 × 10 <sup>-7</sup>

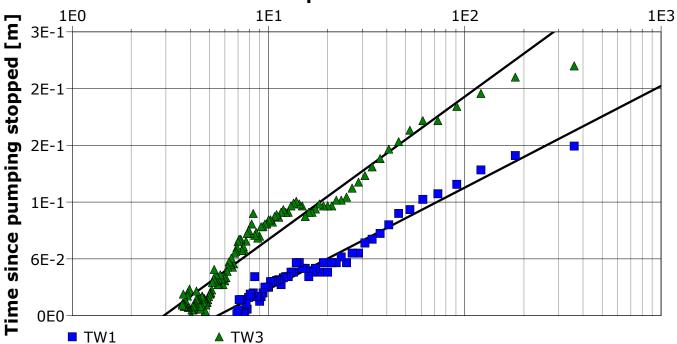
Location: Appleton ON	Pumping Test: Pumping Test 3	Pumping Well: TW2
Test Conducted by: AO		Test Date: 13/07/2015
Analysis Performed by:	Theis Recovery	Analysis Date: 30/10/2015
Aguifer Thickness: 12.00 m	Discharge: variable, average rate 1.89 [l/s]

Observation Well	Transmissivity	Hydraulic Conductivity	Radial Distance to PW
	[m²/d]	[m/d]	[m]
TW1	2.78 × 10 <sup>2</sup>	2.32 × 10 <sup>1</sup>	140.36
TW3	1.98 × 10 <sup>2</sup>	1.65 × 10 <sup>1</sup>	206.94
Average	2.38 × 10 <sup>2</sup>	1.98 × 10 <sup>1</sup>

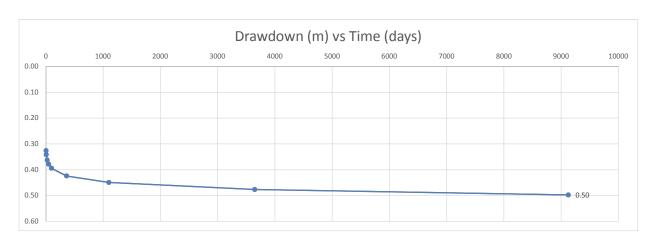
#### Analysis Assumes Continuous Pumping of 28 Wells

1st Well Grouping	4	2nd Well Grouping	8	3rd Well Grouping	16	
Time (days)	u	W(u)	u	W(u)	u	W(u)	Drawdown
5	1.1E-07	15.47	3.2E-07	14.37	5.4E-07	13.86	0.33
10	5.4E-08	16.16	1.6E-07	15.06	2.7E-07	14.55	0.34
25	2.2E-08	17.08	6.5E-08	15.98	1.1E-07	15.47	0.36
50	1.1E-08	17.77	3.2E-08	16.67	5.4E-08	16.16	0.38
100	5.4E-09	18.46	1.6E-08	17.37	2.7E-08	16.85	0.39
365	1.5E-09	19.76	4.4E-09	18.66	7.4E-09	18.15	0.42
1100	4.9E-10	20.86	1.5E-09	19.76	2.4E-09	19.25	0.45
3650	1.5E-10	22.06	4.4E-10	20.96	7.4E-10	20.45	0.48
9125	5.9E-11	22.98	1.8E-10	21.88	2.9E-10	21.37	0.50

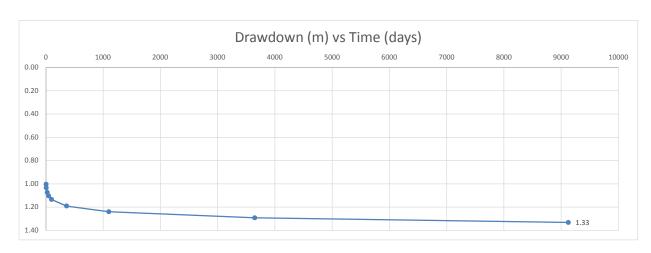
#### Analysis Assumes Continuous Pumping of 28 Wells

1st Well Grouping	4	2nd Well Grouping	8	3rd Well Grouping	16	
Time (days)	u	W(u)	u	W(u)	u	W(u)	Drawdown
5	1.7E-11	24.21	5.2E-11	23.11	8.6E-11	22.60	1.00
10	8.6E-12	24.90	2.6E-11	23.80	4.3E-11	23.29	1.03
25	3.4E-12	25.82	1.0E-11	24.72	1.7E-11	24.21	1.07
50	1.7E-12	26.51	5.2E-12	25.41	8.6E-12	24.90	1.10
100	8.6E-13	27.20	2.6E-12	26.11	4.3E-12	25.59	1.13
365	2.4E-13	28.50	7.1E-13	27.40	1.2E-12	26.89	1.19
1100	7.8E-14	29.60	2.3E-13	28.50	3.9E-13	27.99	1.24
3650	2.4E-14	30.80	7.1E-14	29.70	1.2E-13	29.19	1.29
9125	9.4E-15	31.72	2.8E-14	30.62	4.7E-14	30.11	1.33

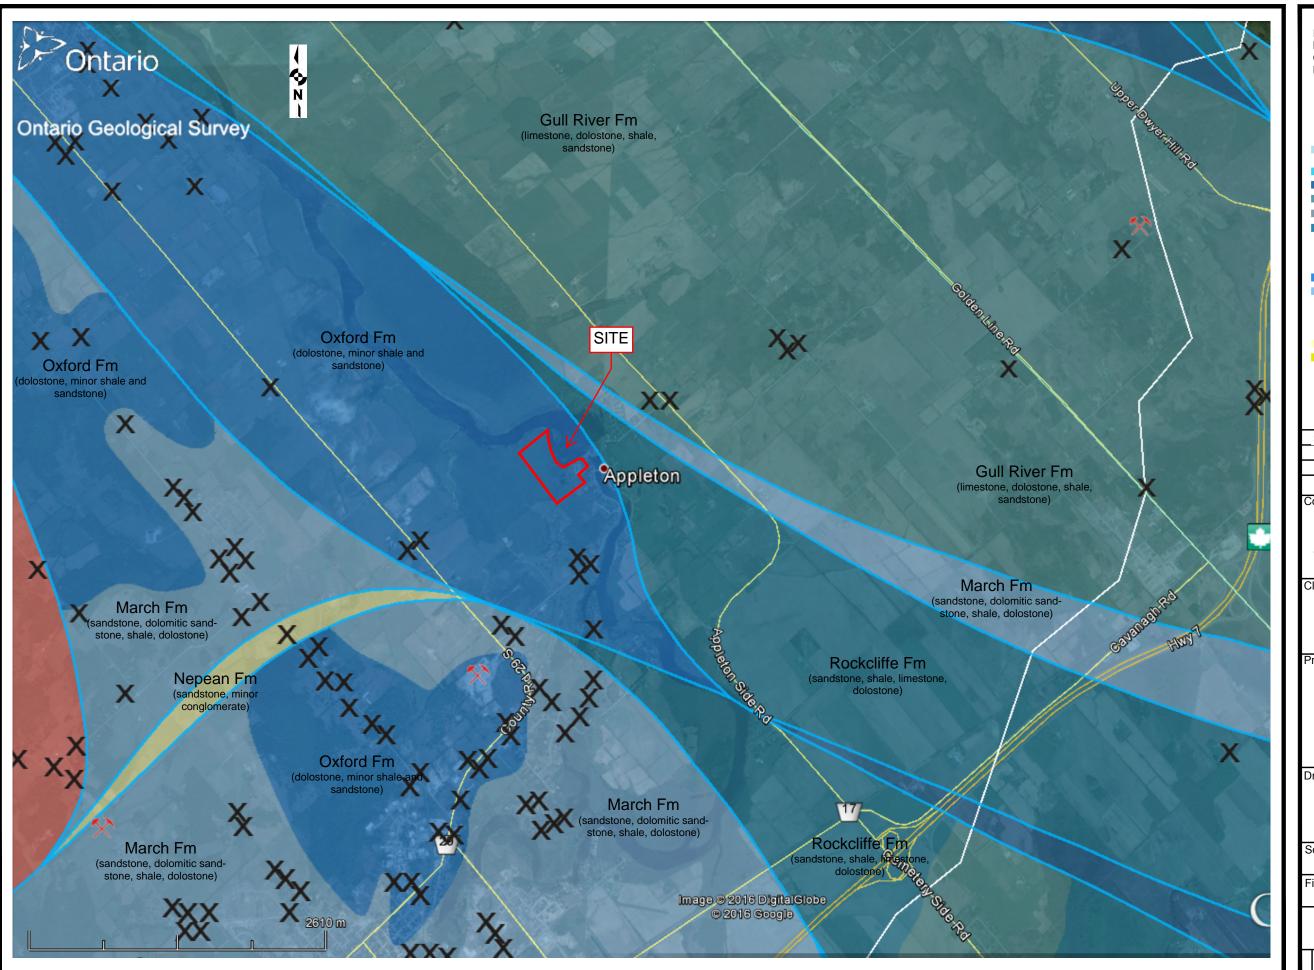
FIGURE 3

REF: Armstrong, D.K. and Dodge, J.E.P. Paleozoic Geology Map of Southern
Ontario; Ontario Geological Survey, Miscellaneous Release--Data 219

Middle Ordovician
Simcoe Group

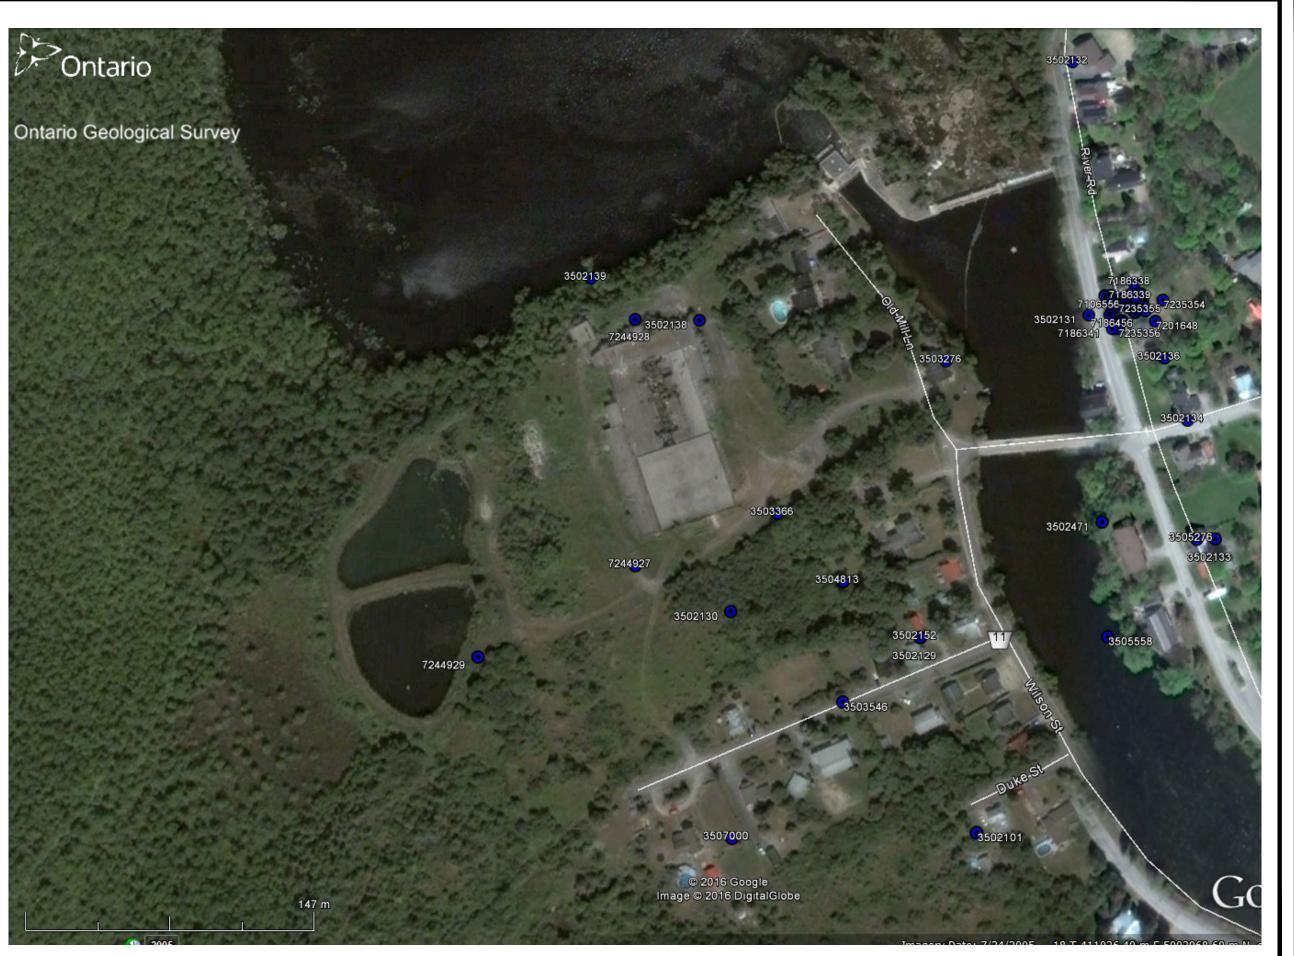
FIGURE 4

The locations of MOECC Water Well Records located within a 500 m radius of the site are included on Figure 4 - MECP Water Well Location Plan (Please note: well location accuracy
