BLAKENEY BRIDGE REPORT #PW-26-2022

Public Works Committee
October 26, 2022

BLAKENEY BRIDGE ENHANCED INSPECTION REPORT

Lanark County – October 2022

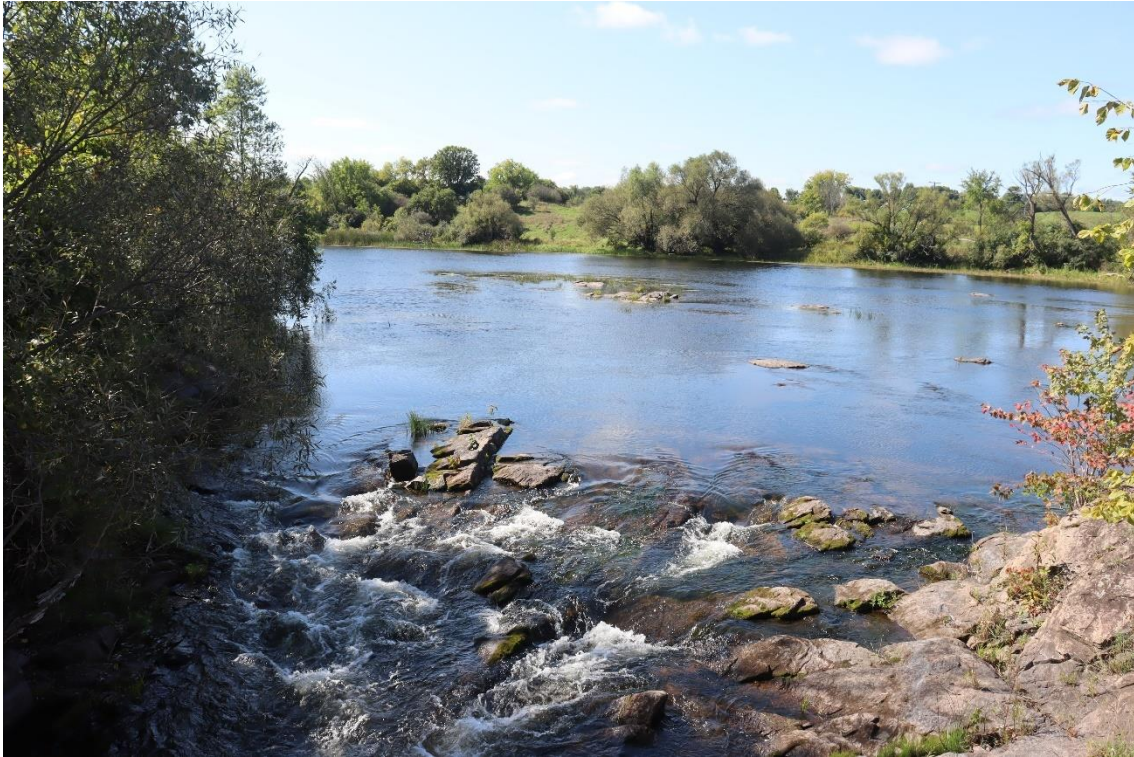
Image 5. North upstream channel of east bridge

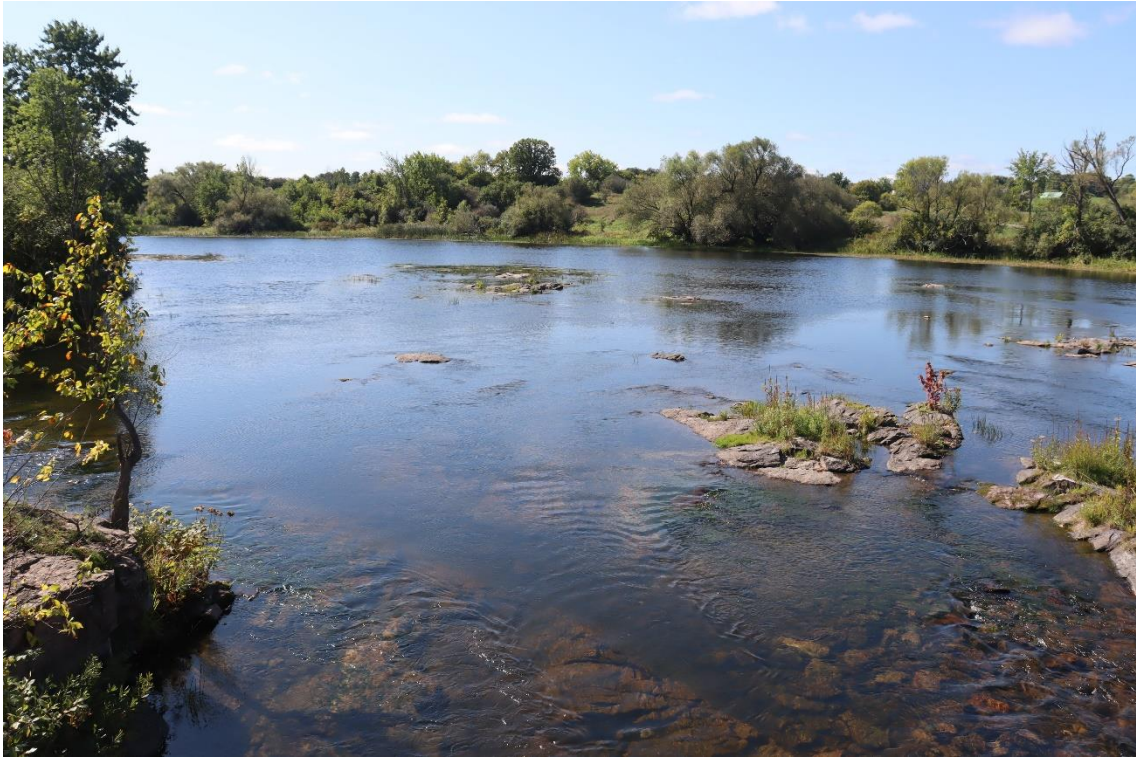
Image 6. South upstream channel of middle bridge
